UNITED STATES
NUCLEAR REGULATORY COMMISSION
REGION II
101 MARIETTA STREET, N.W., SUITE 2900
ATLANTA, GEORGIA 30323-0199

SUBJECT: FEBRUARY 9, 1994 ST. LUCIE NUCLEAR STATION EXERCISE

This memo transmits the Exercise Scenario Package (Exercise Objectives, Narrative Summary, and Scenario Timeline) and provides work assignments and planning guidance for the St. Lucie Nuclear Station emergency preparedness exercise on February 9, 1994. You are reminded that the Exercise Scenario Package contains confidential information and should be treated as such until after the exercise is terminated. The work assignments are provided as Enclosure 1 to this memo, along with the inspection requirements for your assigned emergency response facility as listed in Inspection Procedure 82301. These assignments are for reference in your planning. Last minute changes may necessitate some minor adjustments; however, the assignments should be consistent with your experience and interest.

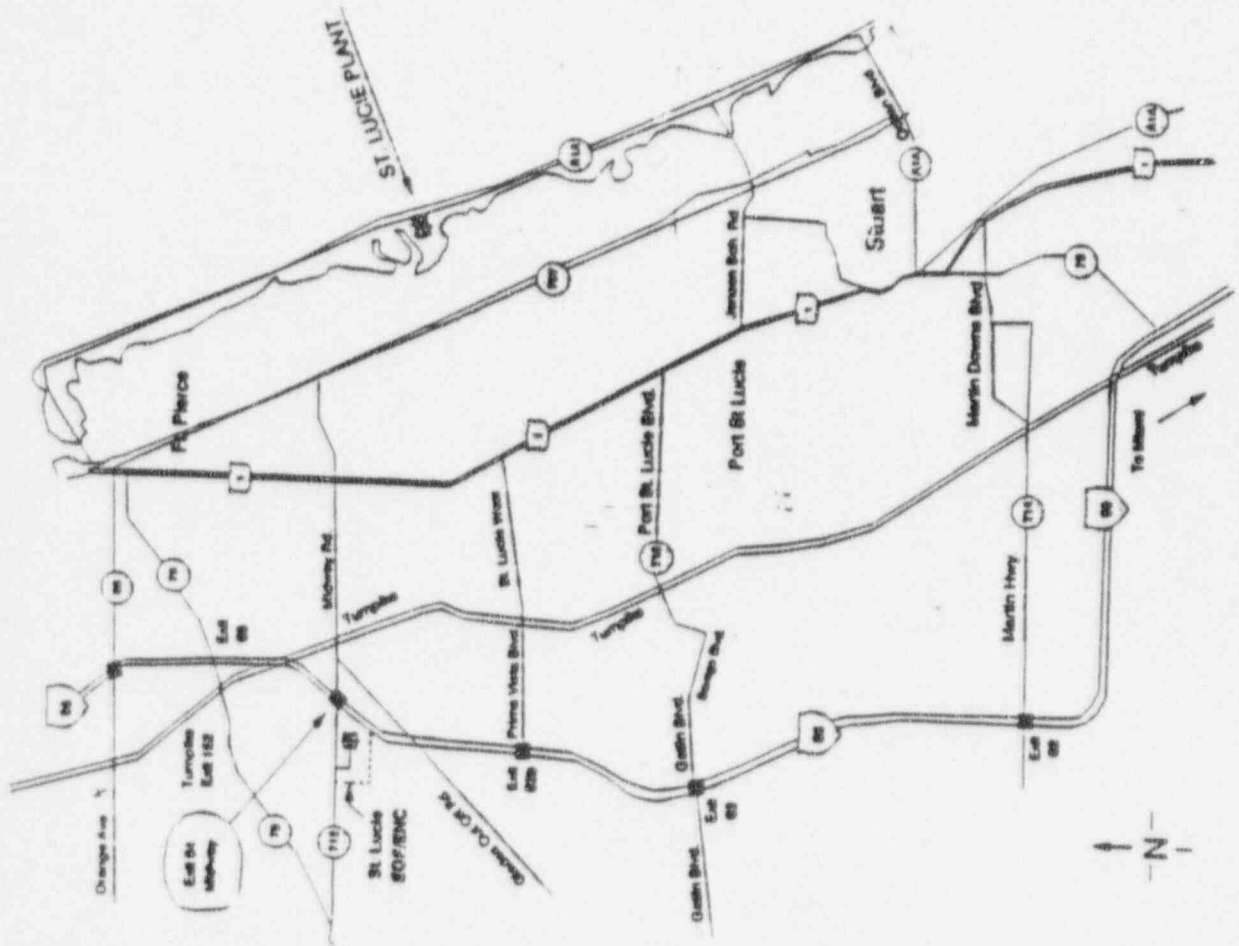
EMERGENCY RESPONSE FACILITIES EOF/ENC LOCATION

EOF LOCATION: Florida Power and Light
 9001 West Midway Road
 Fort Pierce, Florida
 (Intersection of State Route 712 and I-95; approximately
 10.5 miles west of the St. Lucie Plant)

JPIC LOCATION: Florida Power and Light
 9001 West Midway Road
 Fort Pierce, Florida

Enclosure 3 is a map of the highway route from West Palm Beach Airport to lodging, EOF, and site locations. Enclosure 4 is a map of the Site area and offsite Emergency Response Facilities.

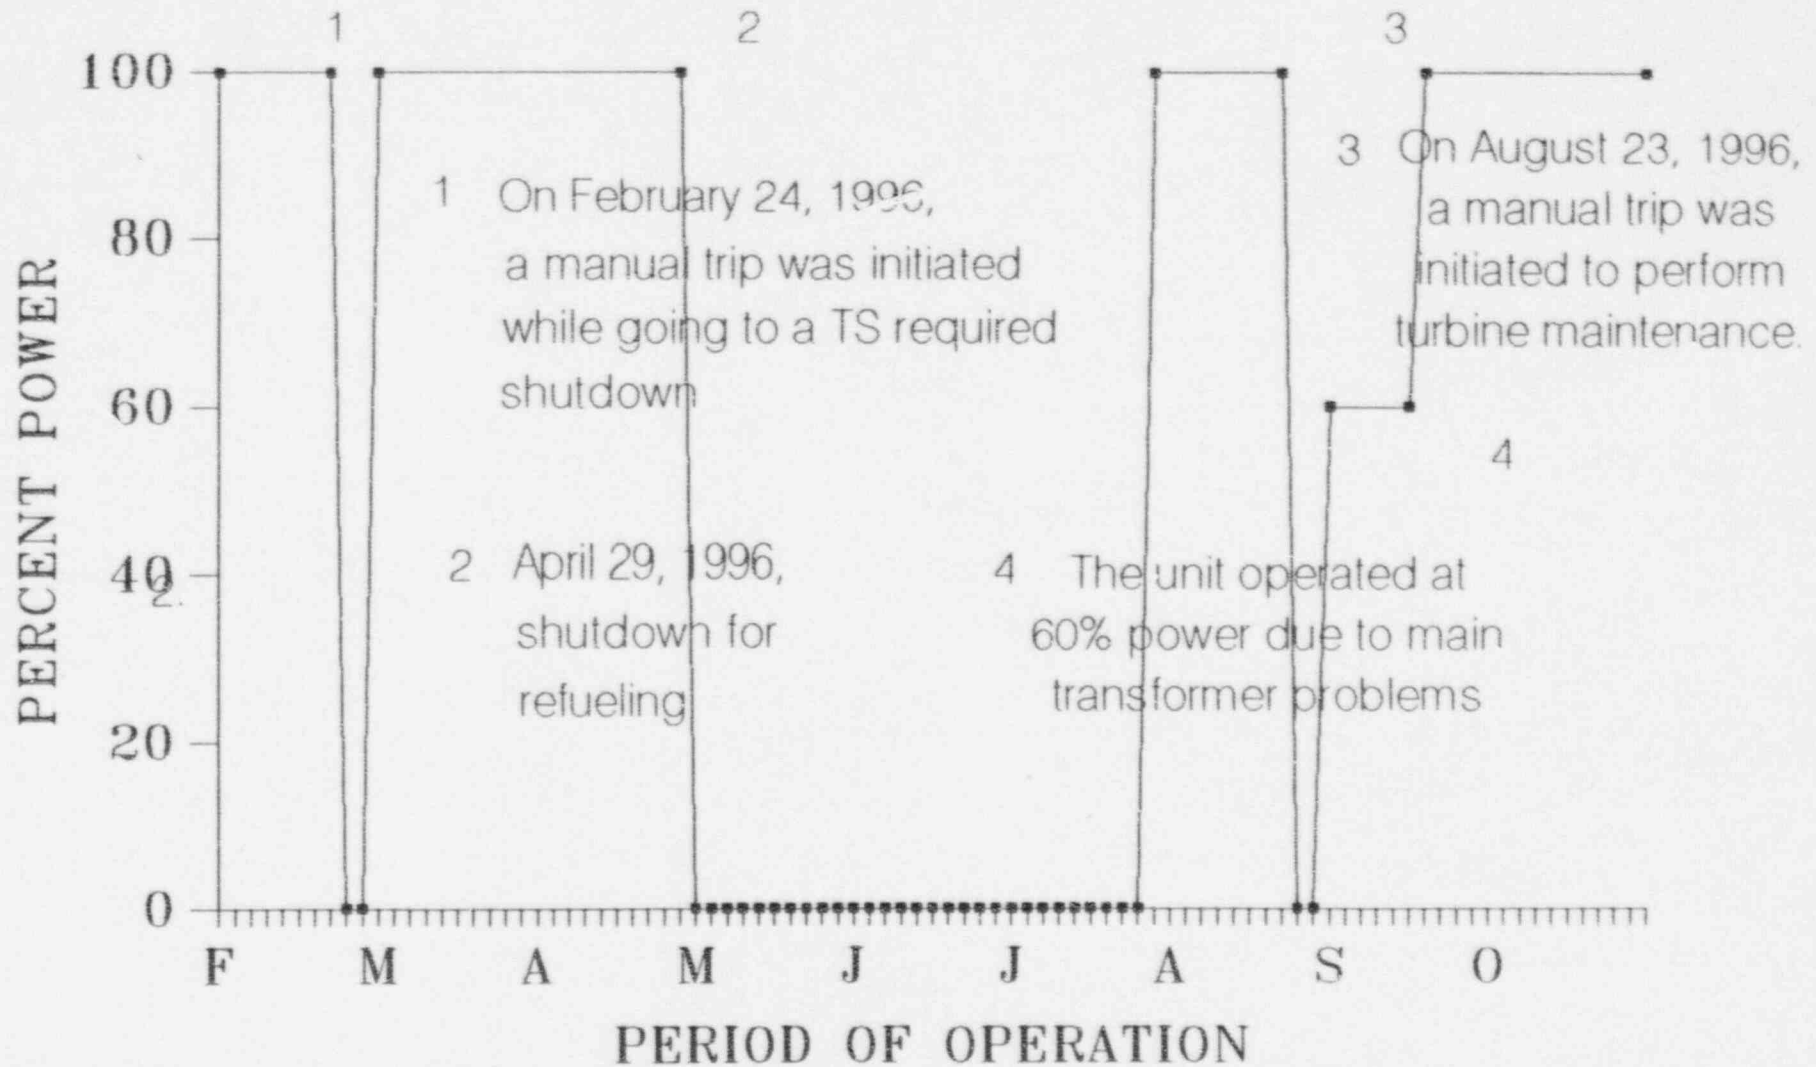
ST. LUCIE UNIT 1

Operational Period February 1996 through October 18, 1996

Graph does not include power reductions
for routine repairs, waterbox cleaning,
or required repairs.

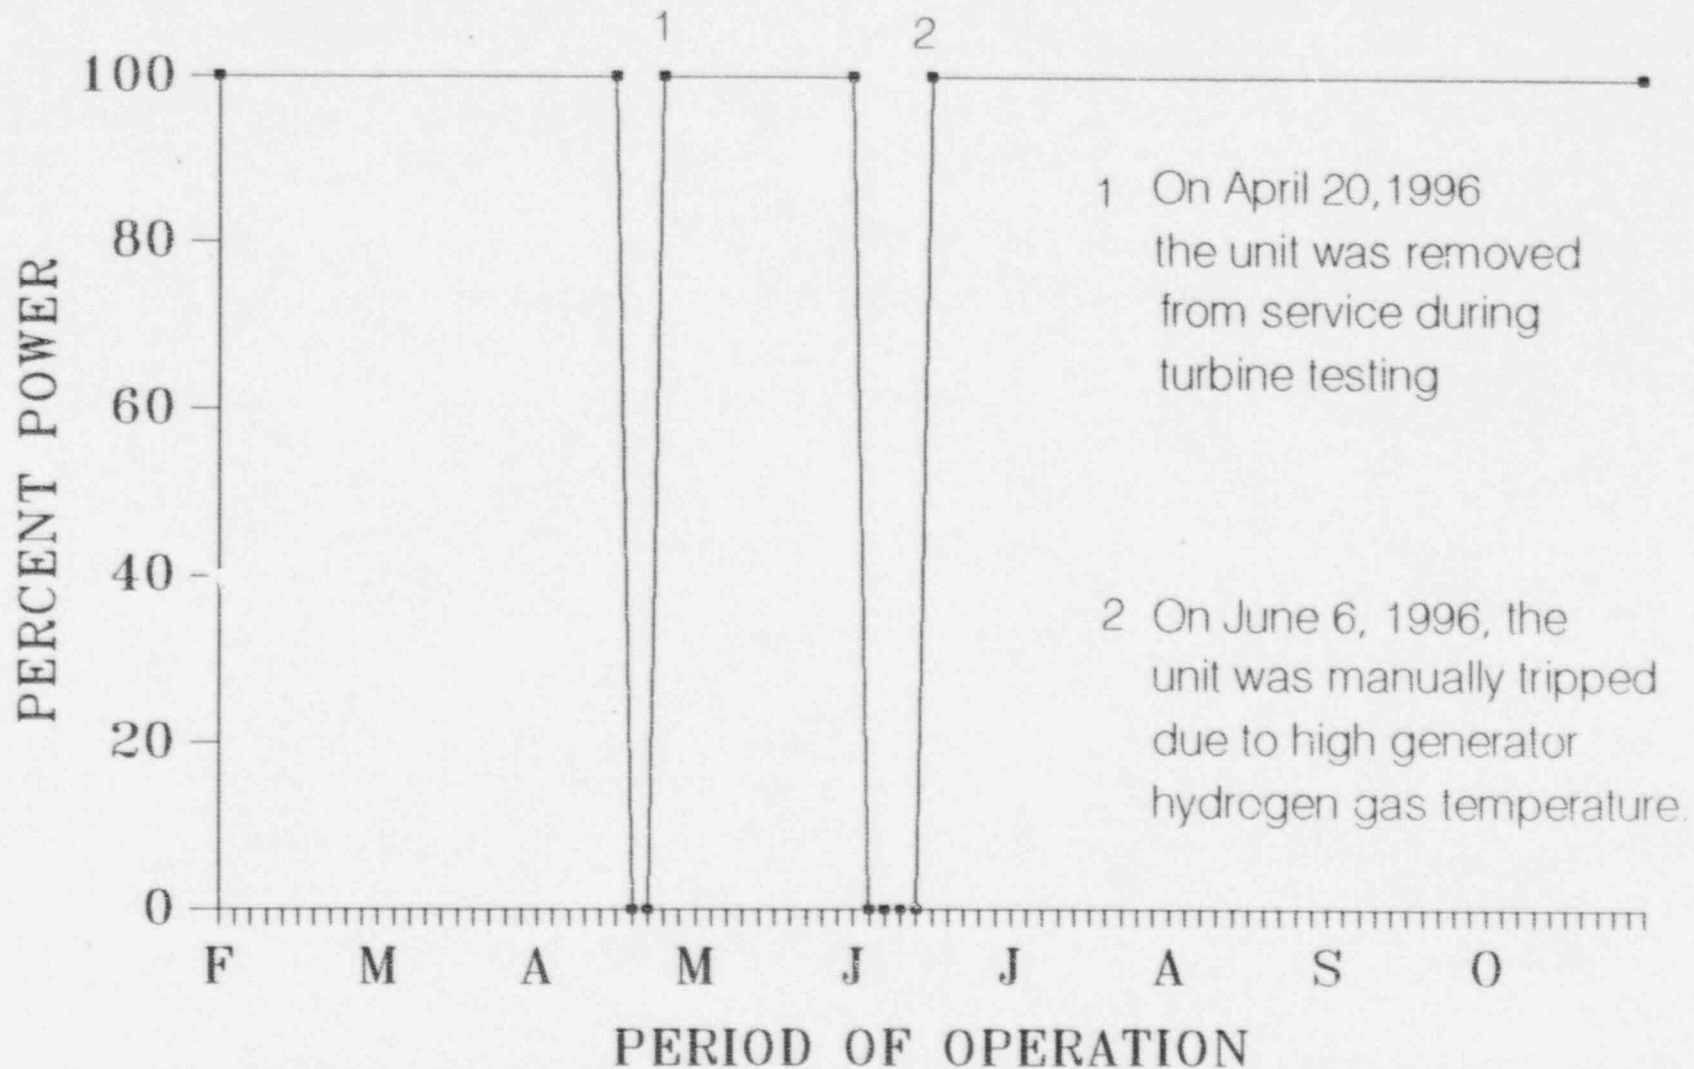
ST. LUCIE UNIT 2
Operational Period February 1995
through October 18, 1996

Graph does not include power reductions
for routine repairs, waterbox cleaning,
or required repairs.

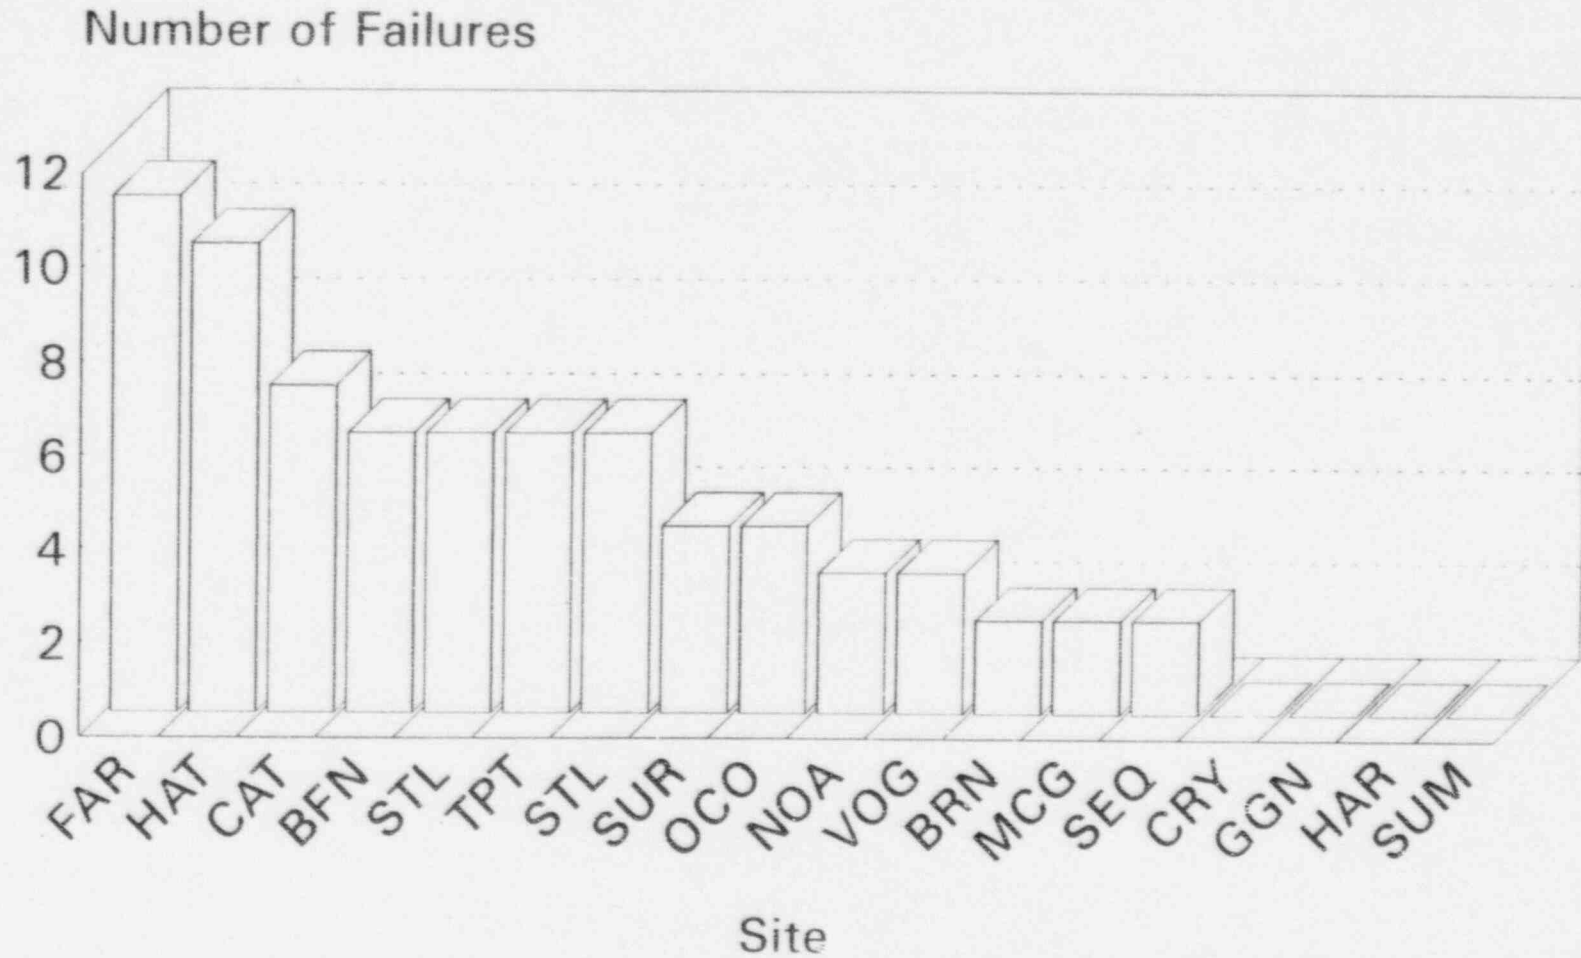
TOTAL ELECTRICAL COMPONENT FAILURES

1994 - 1995

Based on Site Issues Matrix/LEAs
Does not include Personnel Errors

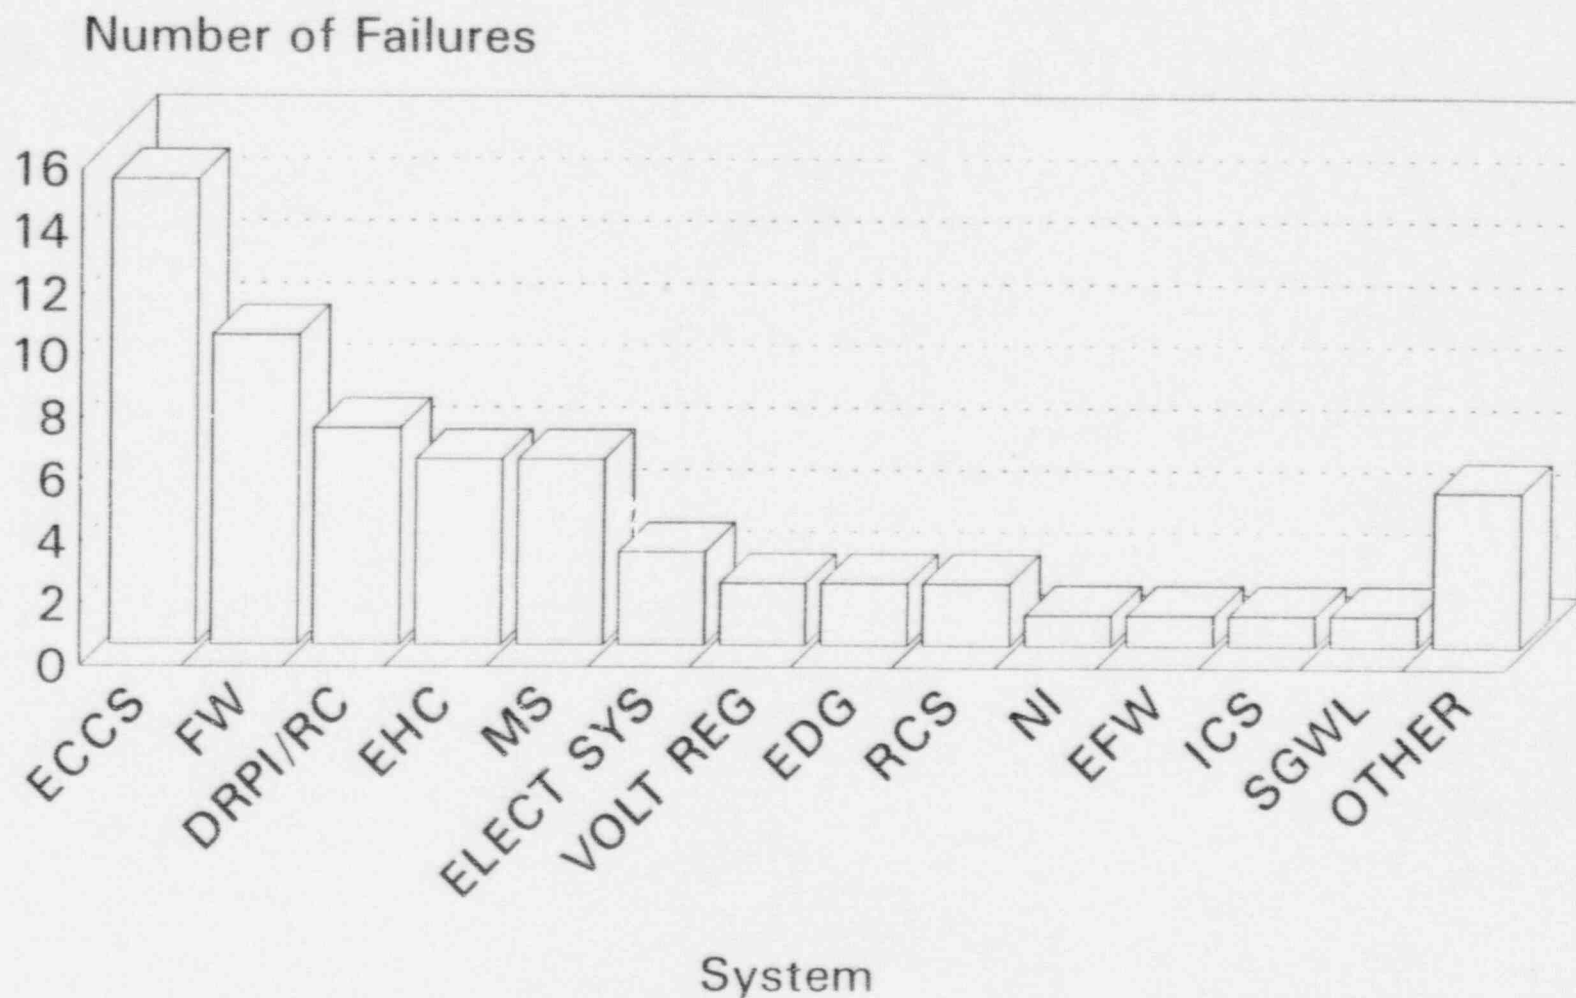
TOTAL ELECTRICAL COMPONENT FAILURES BY SYSTEM

1994 - 1995

Based on Site Issues Matrix/LERs
Does not include personnel errors

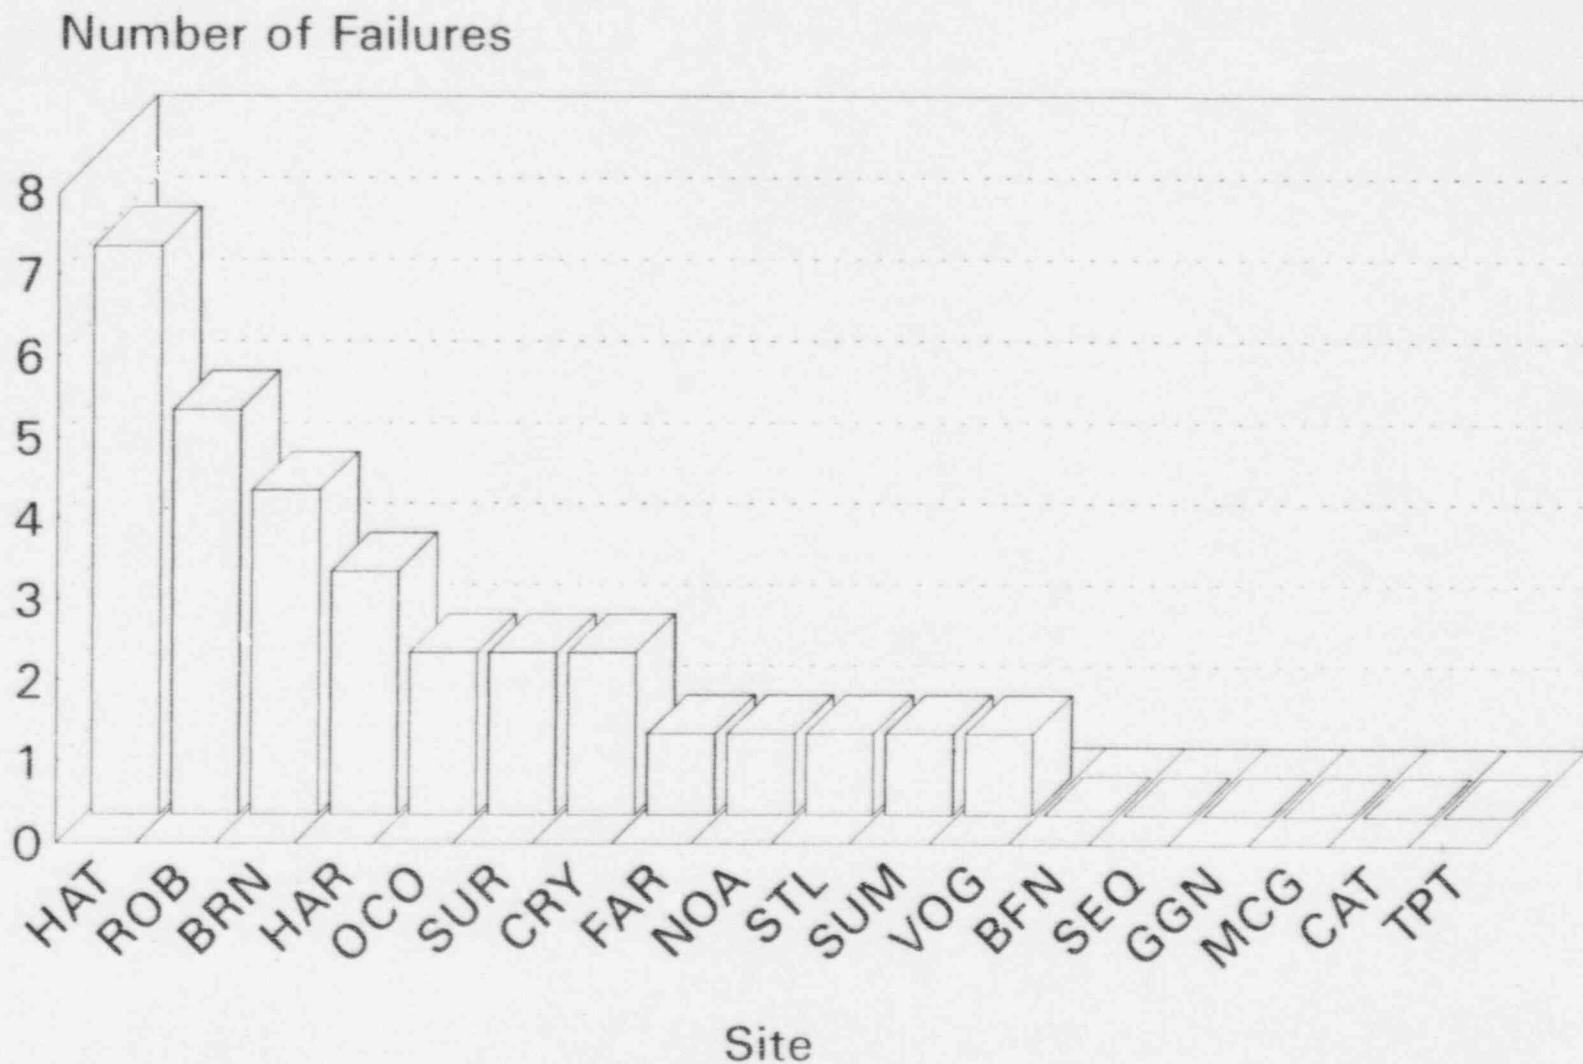
TOTAL COMPONENT PERSONNEL ERRORS - ELECTRICAL SYSTEMS

1994 - 1995

Based on Site Issues Matrix/LEAs

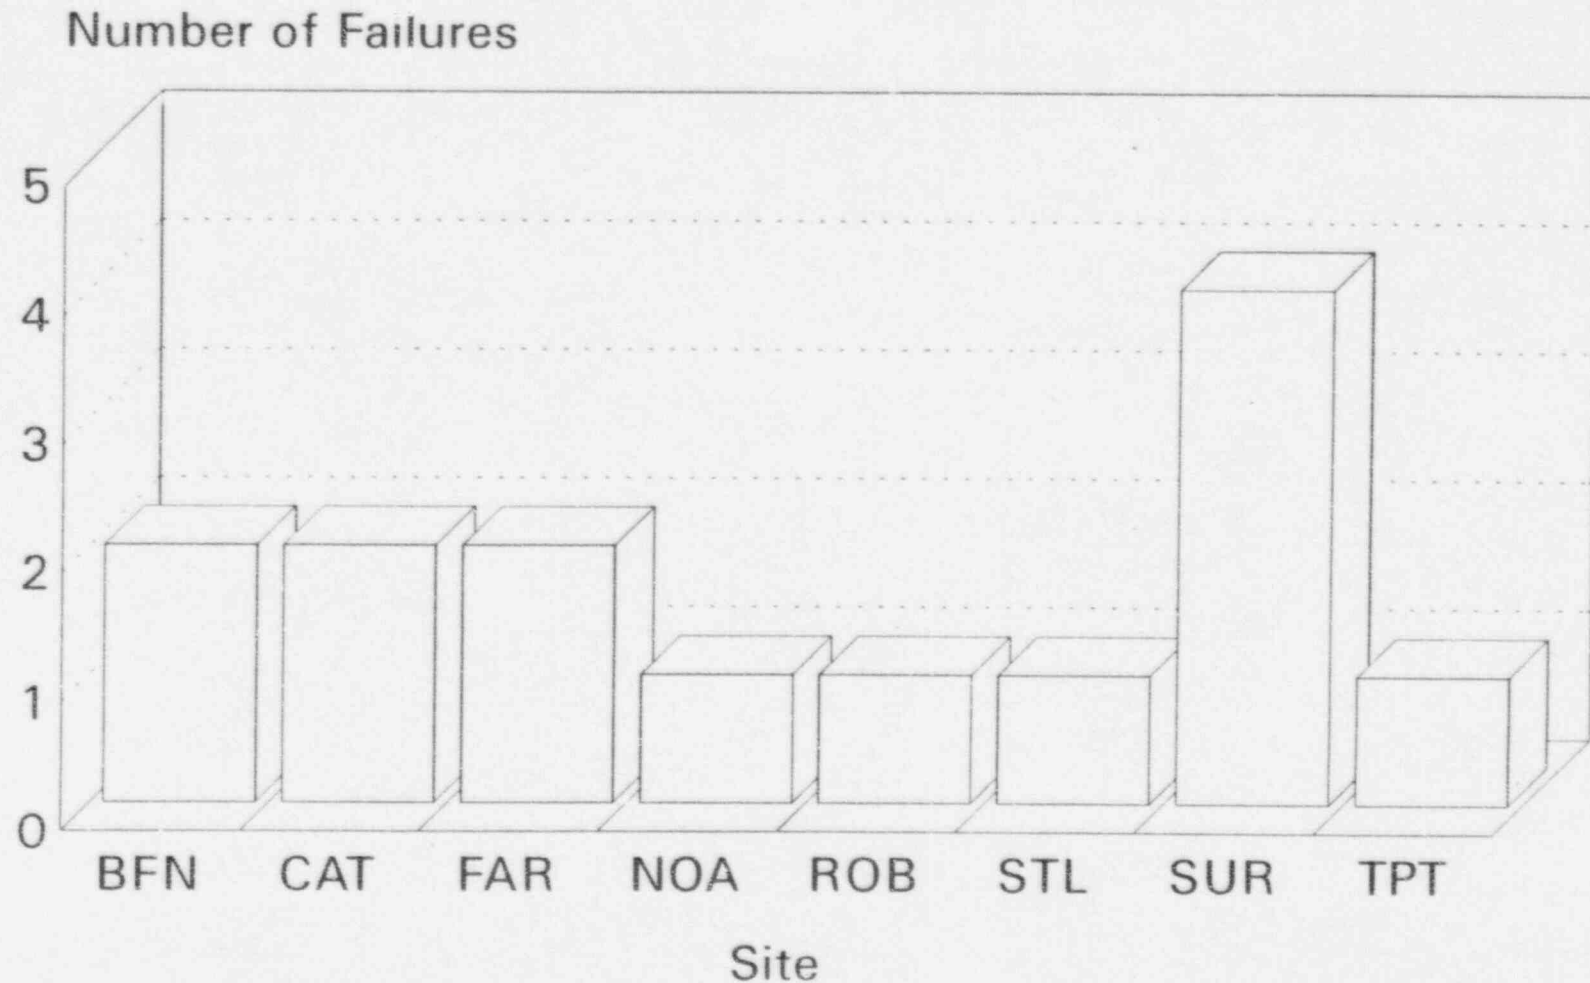
SIGNIFICANT CIRCUIT CARD FAILURES

1994 - 1995

Based on Site Issues Matrix/LERs

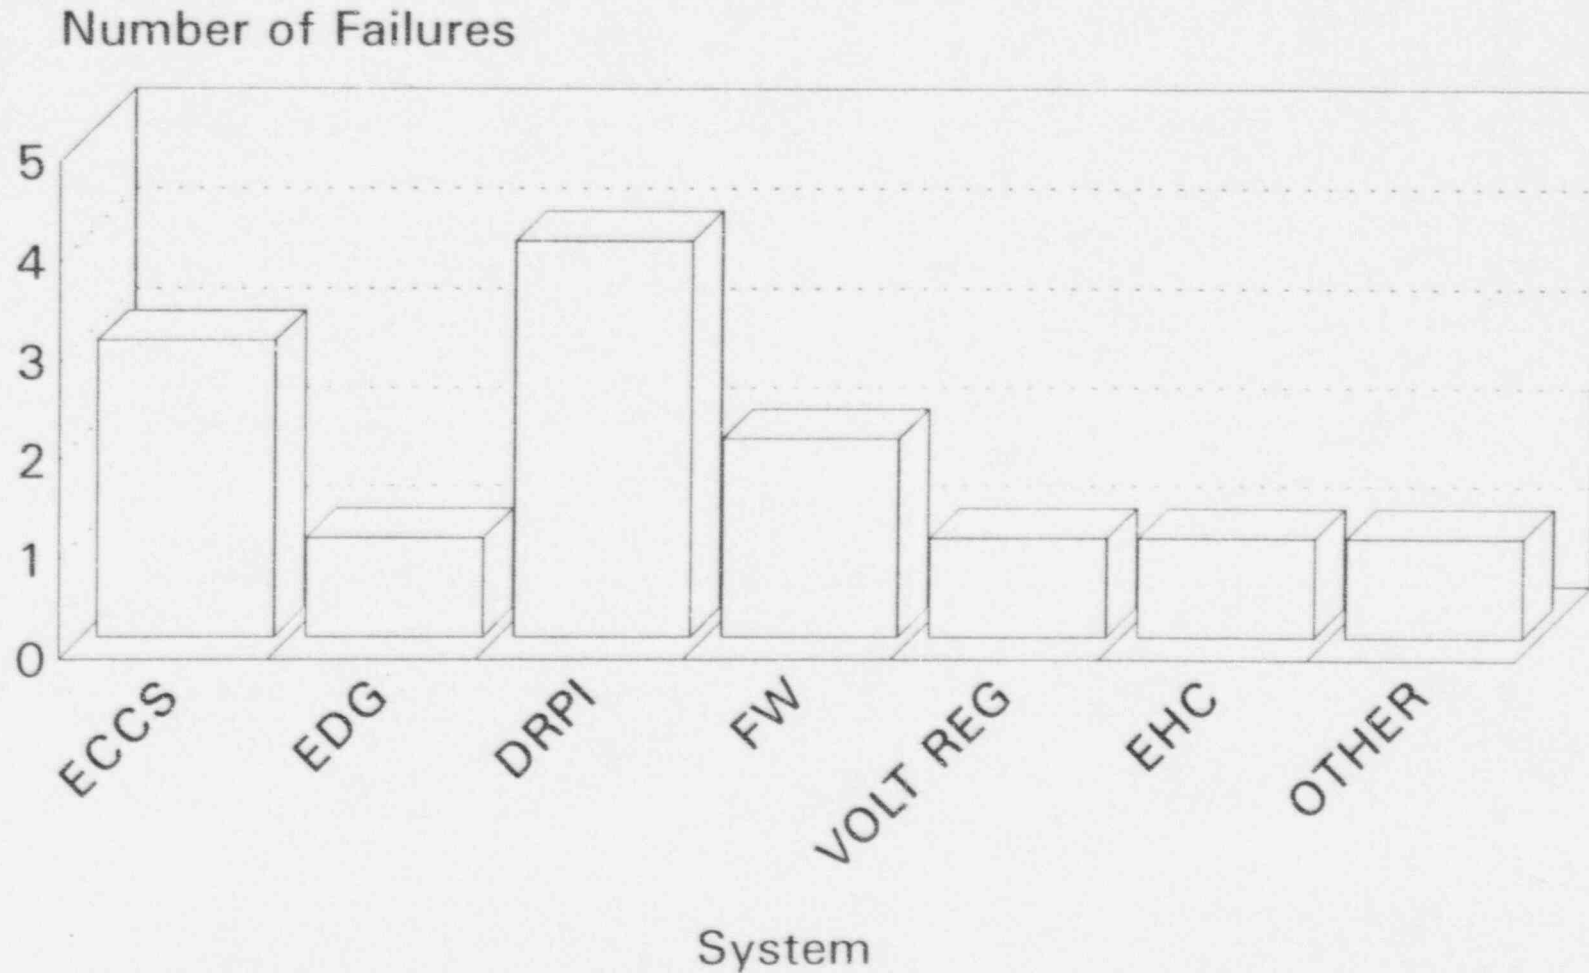
CIRCUIT CARD FAILURE BY SYSTEM

1994 - 1995

Based on Site Issues Matrix/LERs

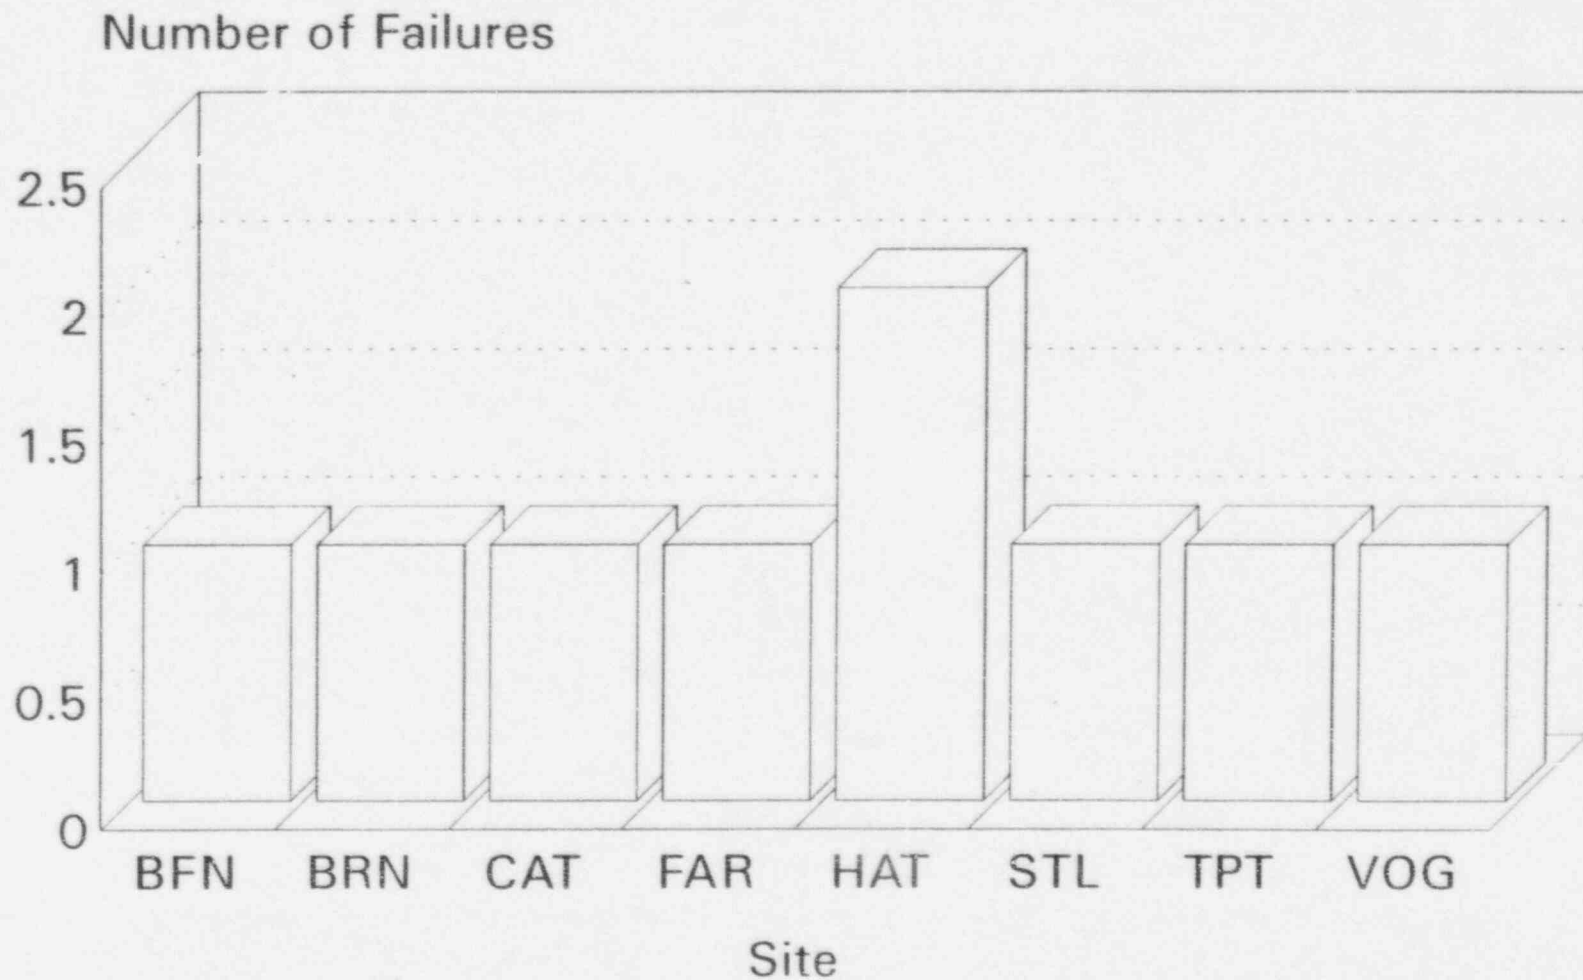
SIGNIFICANT CONTROLLER FAILURES

1994 - 1995

Based on Site Issues Matrix/LERs

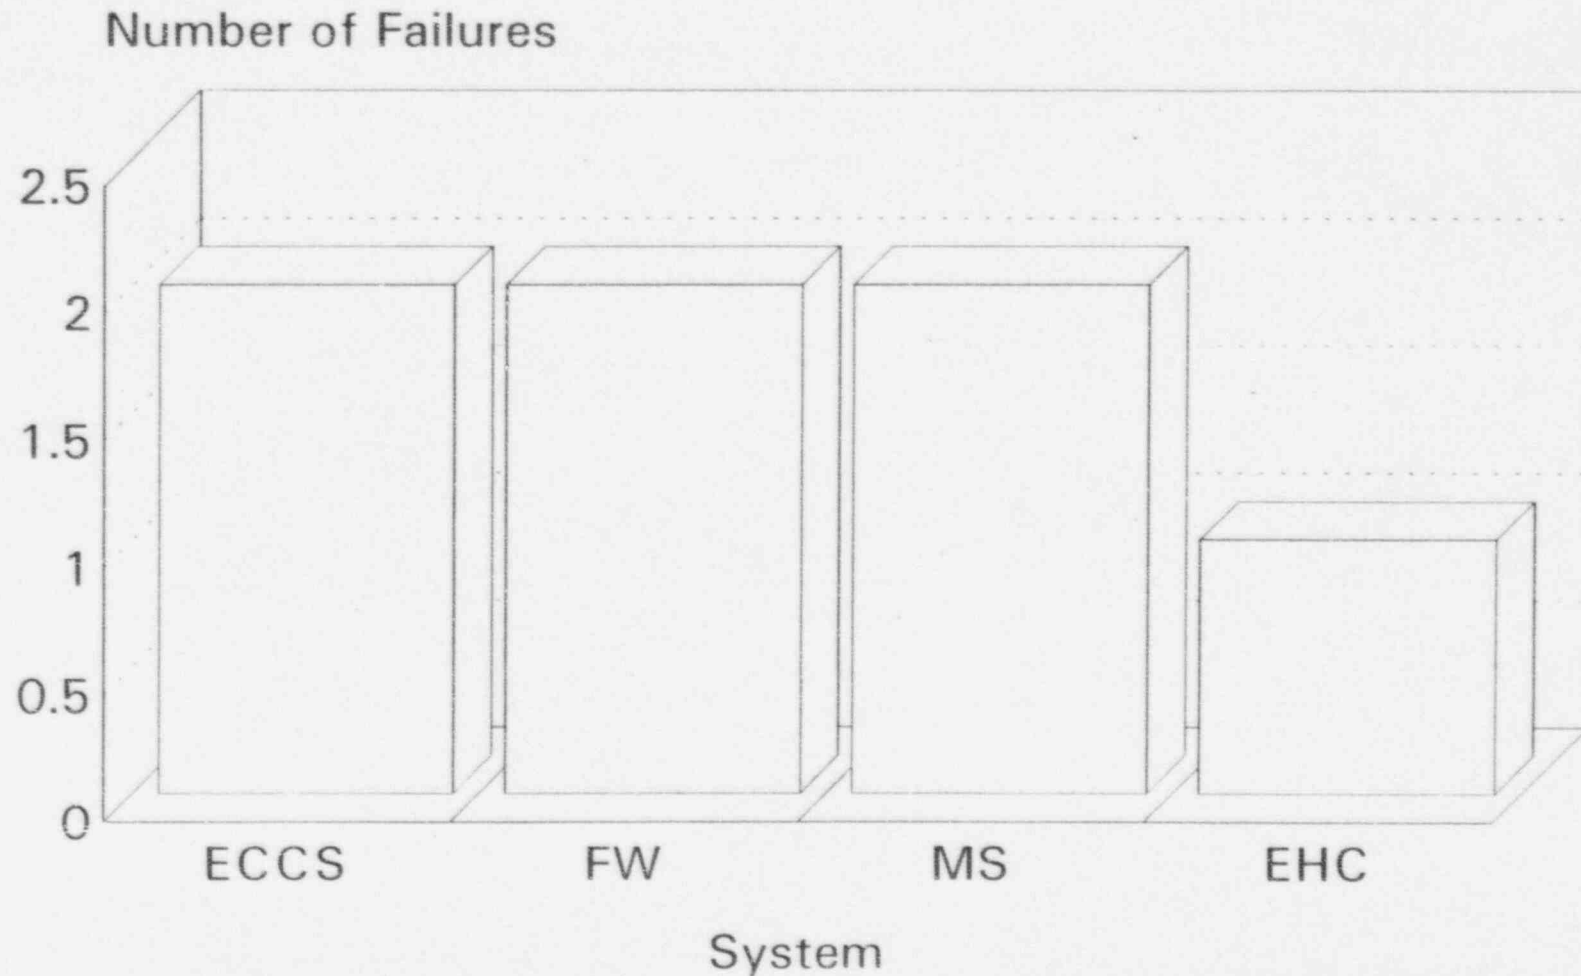
CONTROLLER FAILURES BY SYSTEM

1994 - 1995

Based on Site Issues Matrix/LERs

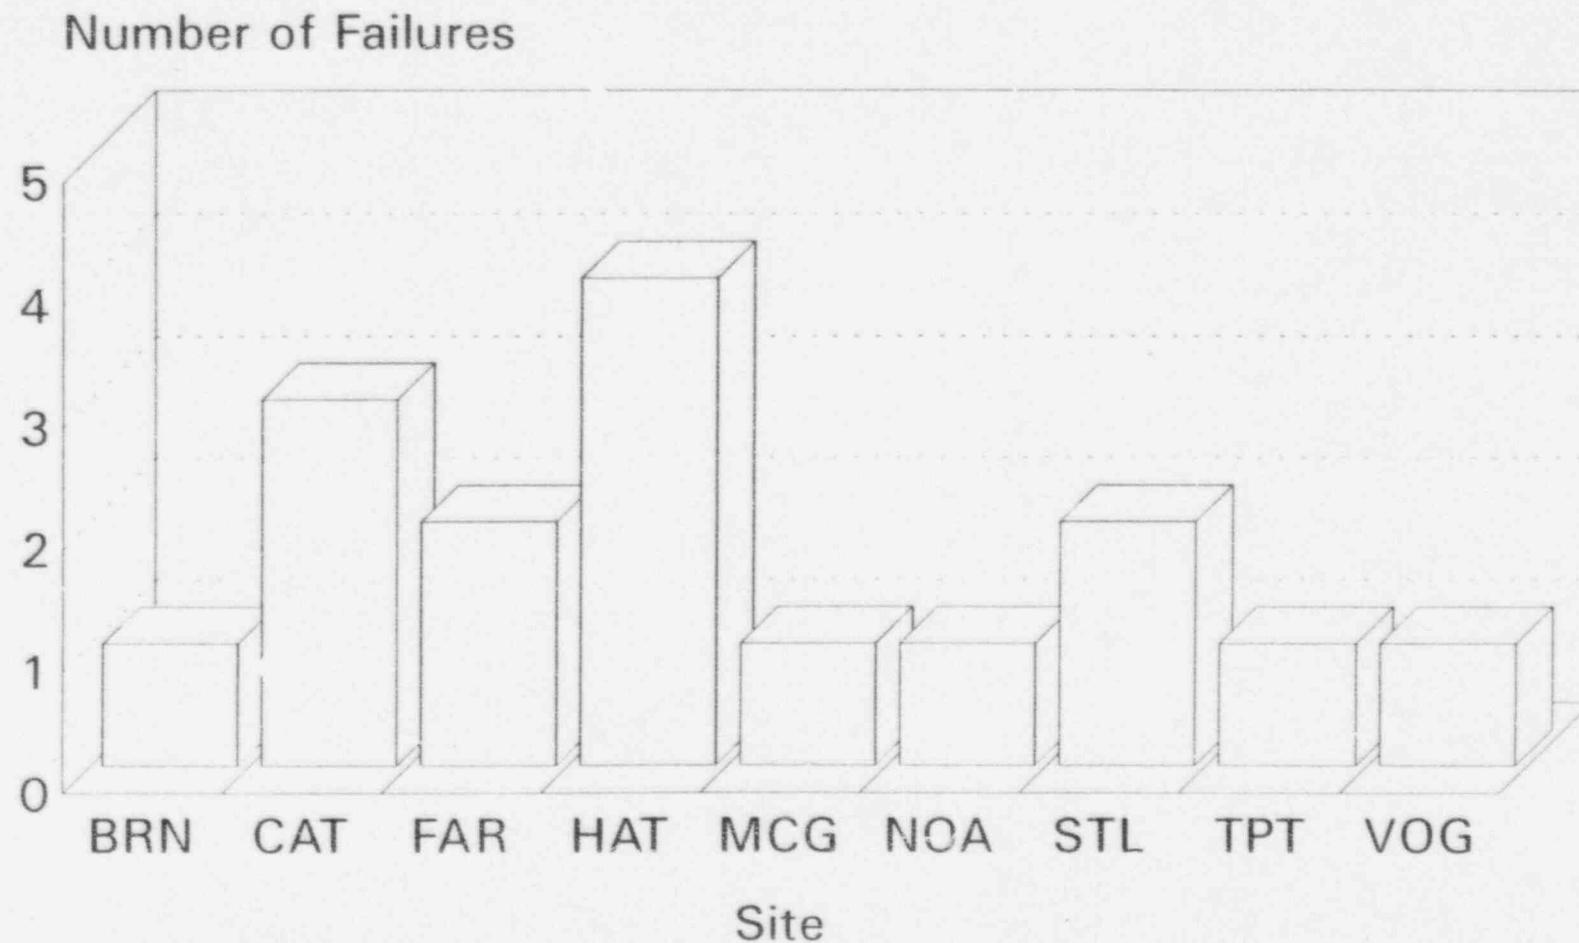
SIGNIFICANT RELAY FAILURES

1994 - 1995

Based on Site Issues Matrix/LERs

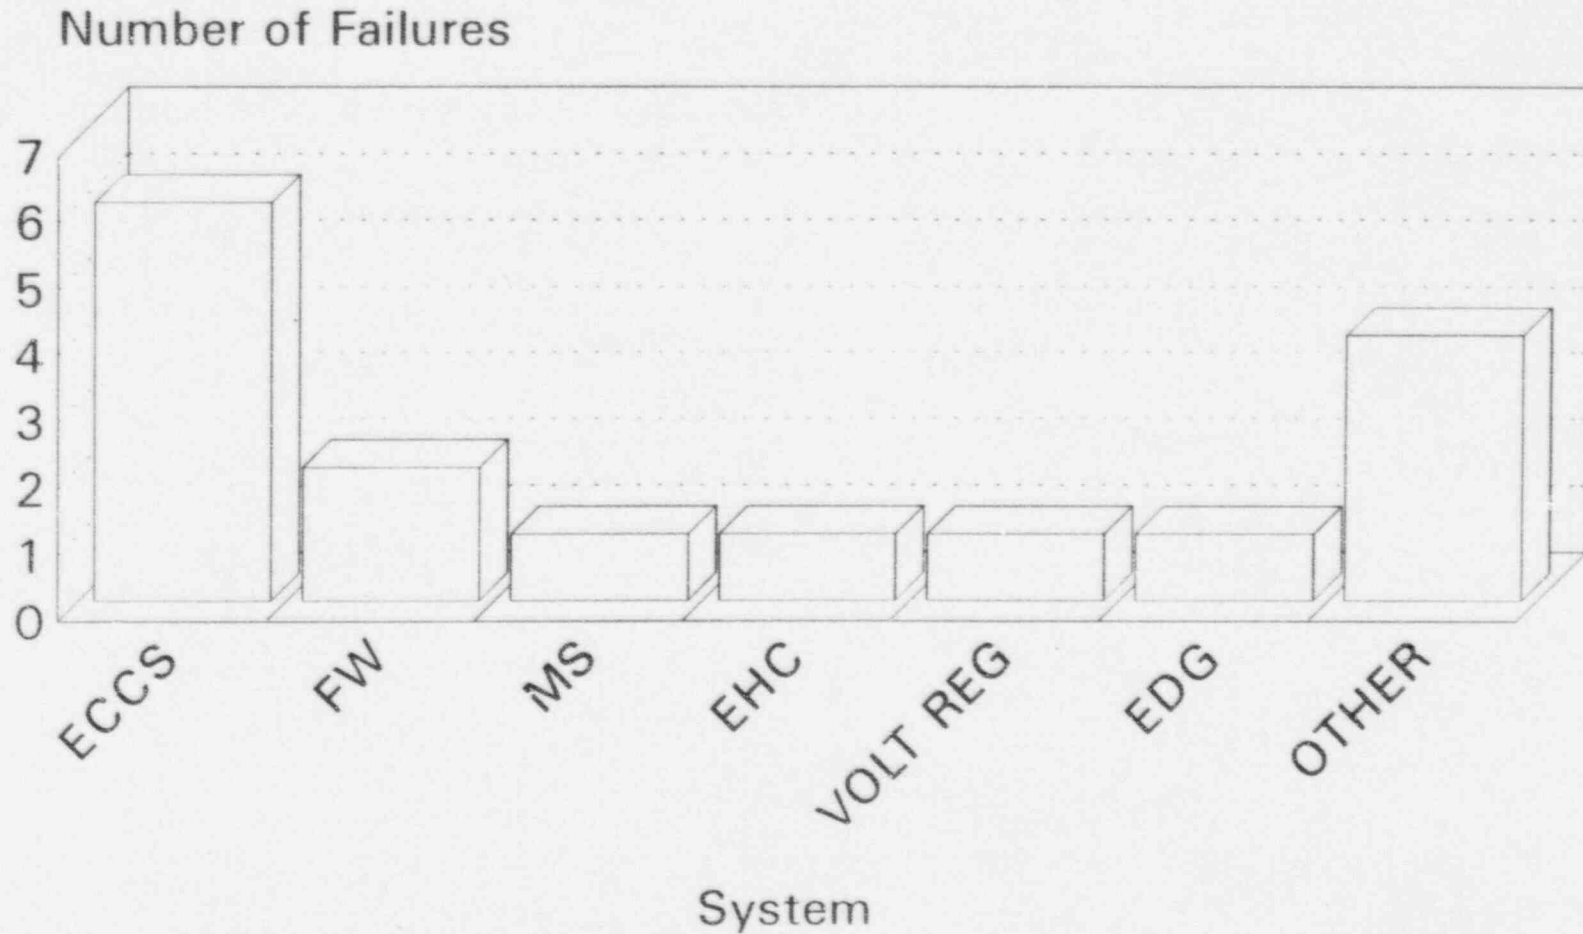
RELAY FAILURES BY SYSTEM

1994 - 1995

Based on Site Issues Matrix/LERs

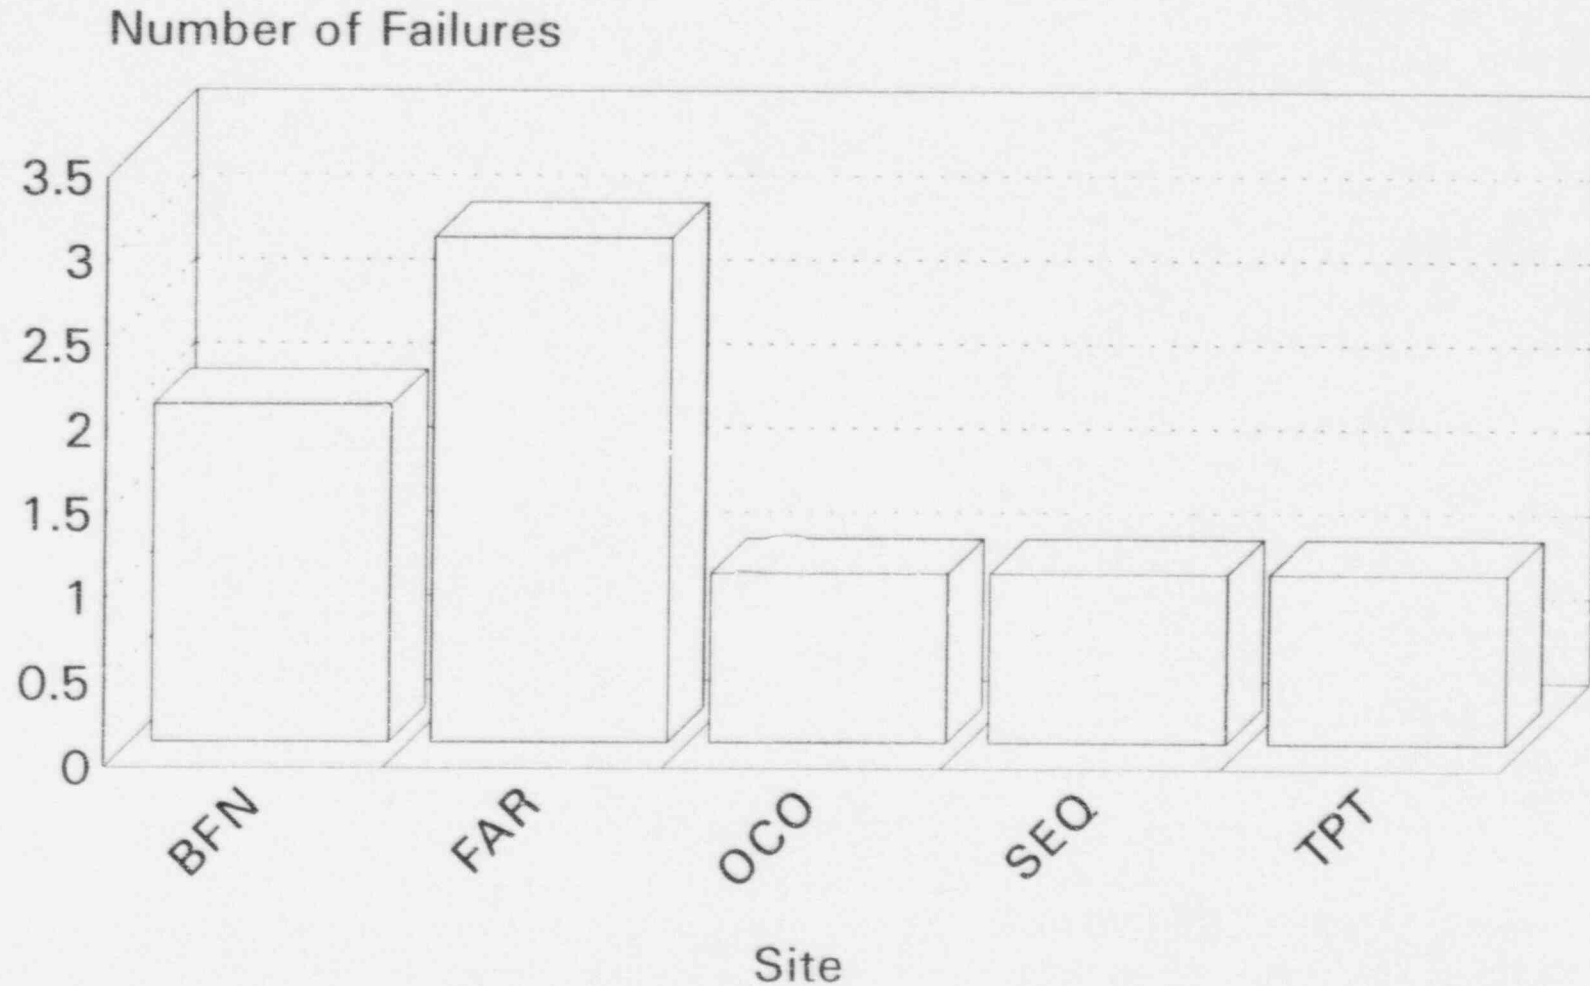
SIGNIFICANT POWER SUPPLY FAILURES

1994 - 1995

Based on Site Issues Matrix/LERs

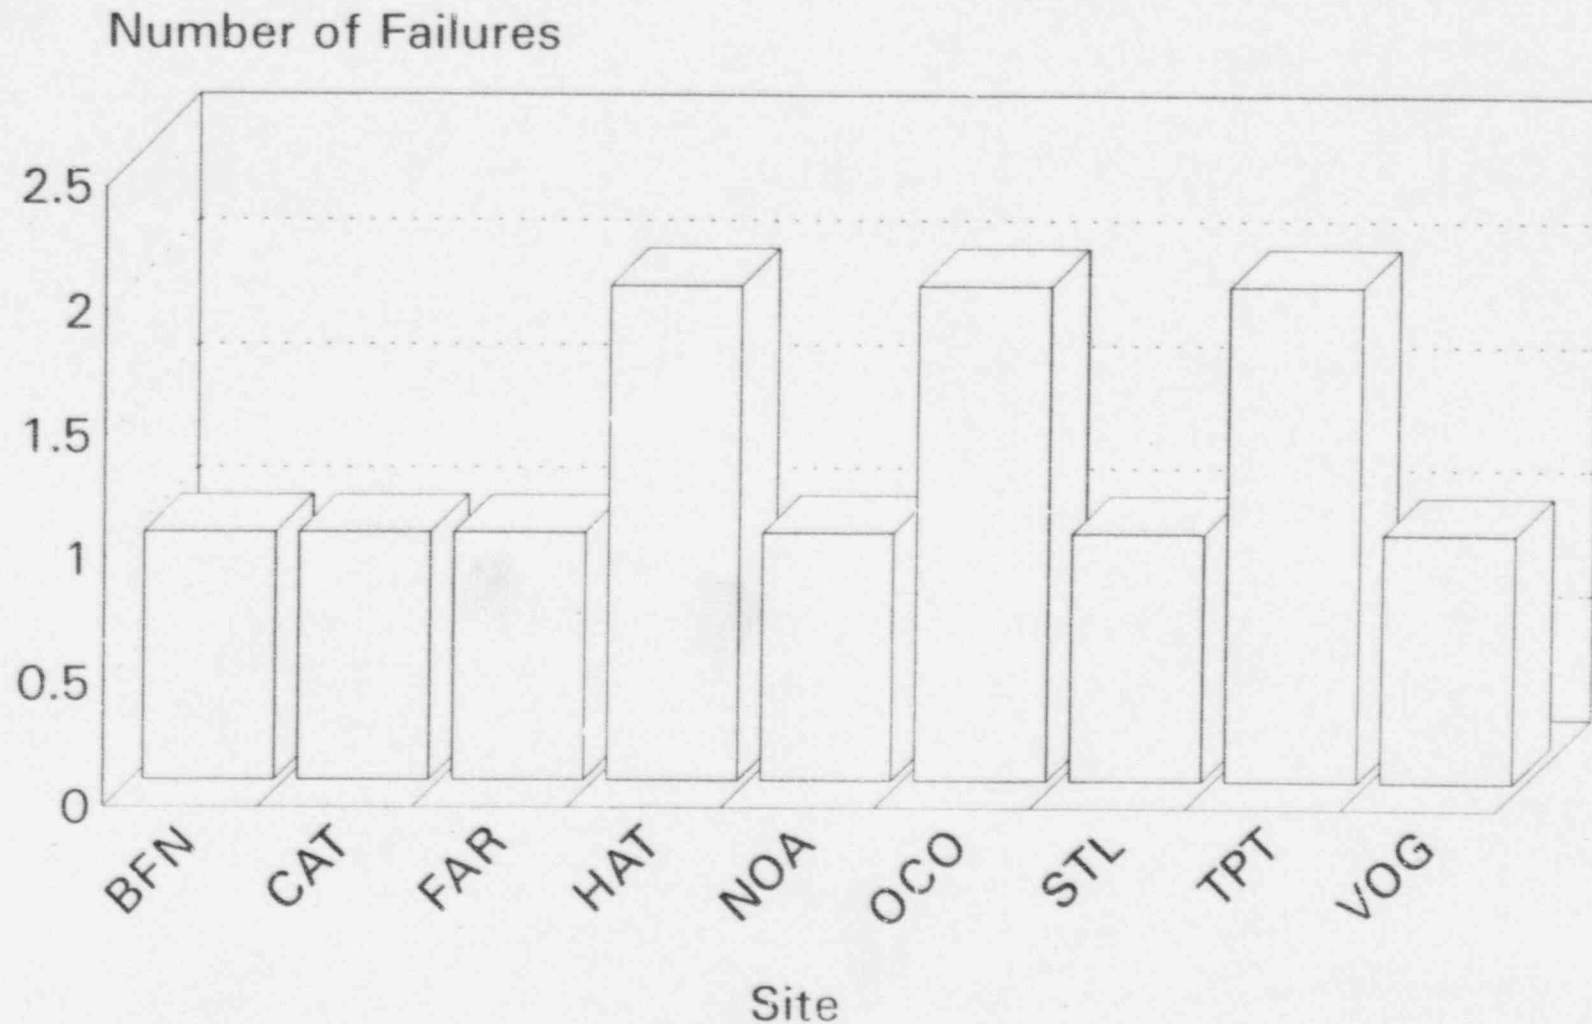
SIGNIFICANT SENSOR/LOOP/MODULE FAILURES

1994 - 1995

Based on Site Issues Matrix/LERs
