UNITED STATES
NUCLEAR REGULATORY COMMISSION
REGION II
101 MARIETTA STREET, N.W., SUITE 2900
ATLANTA, GEORGIA 30323-0199

SUBJECT: FEBRUARY 9, 1994 ST. LUCIE NUCLEAR STATION EXERCISE

This memo transmits the Exercise Scenario Package (Exercise Objectives, Narrative Summary, and Scenario Timeline) and provides work assignments and planning guidance for the St. Lucie Nuclear Station emergency preparedness exercise on February 9, 1994. You are reminded that the Exercise Scenario Package contains confidential information and should be treated as such until after the exercise is terminated. The work assignments are provided as Enclosure 1 to this memo, along with the inspection requirements for your assigned emergency response facility as listed in Inspection Procedure 82301. These assignments are for reference in your planning. Last minute changes may necessitate some minor adjustments; however, the assignments should be consistent with your experience and interest.

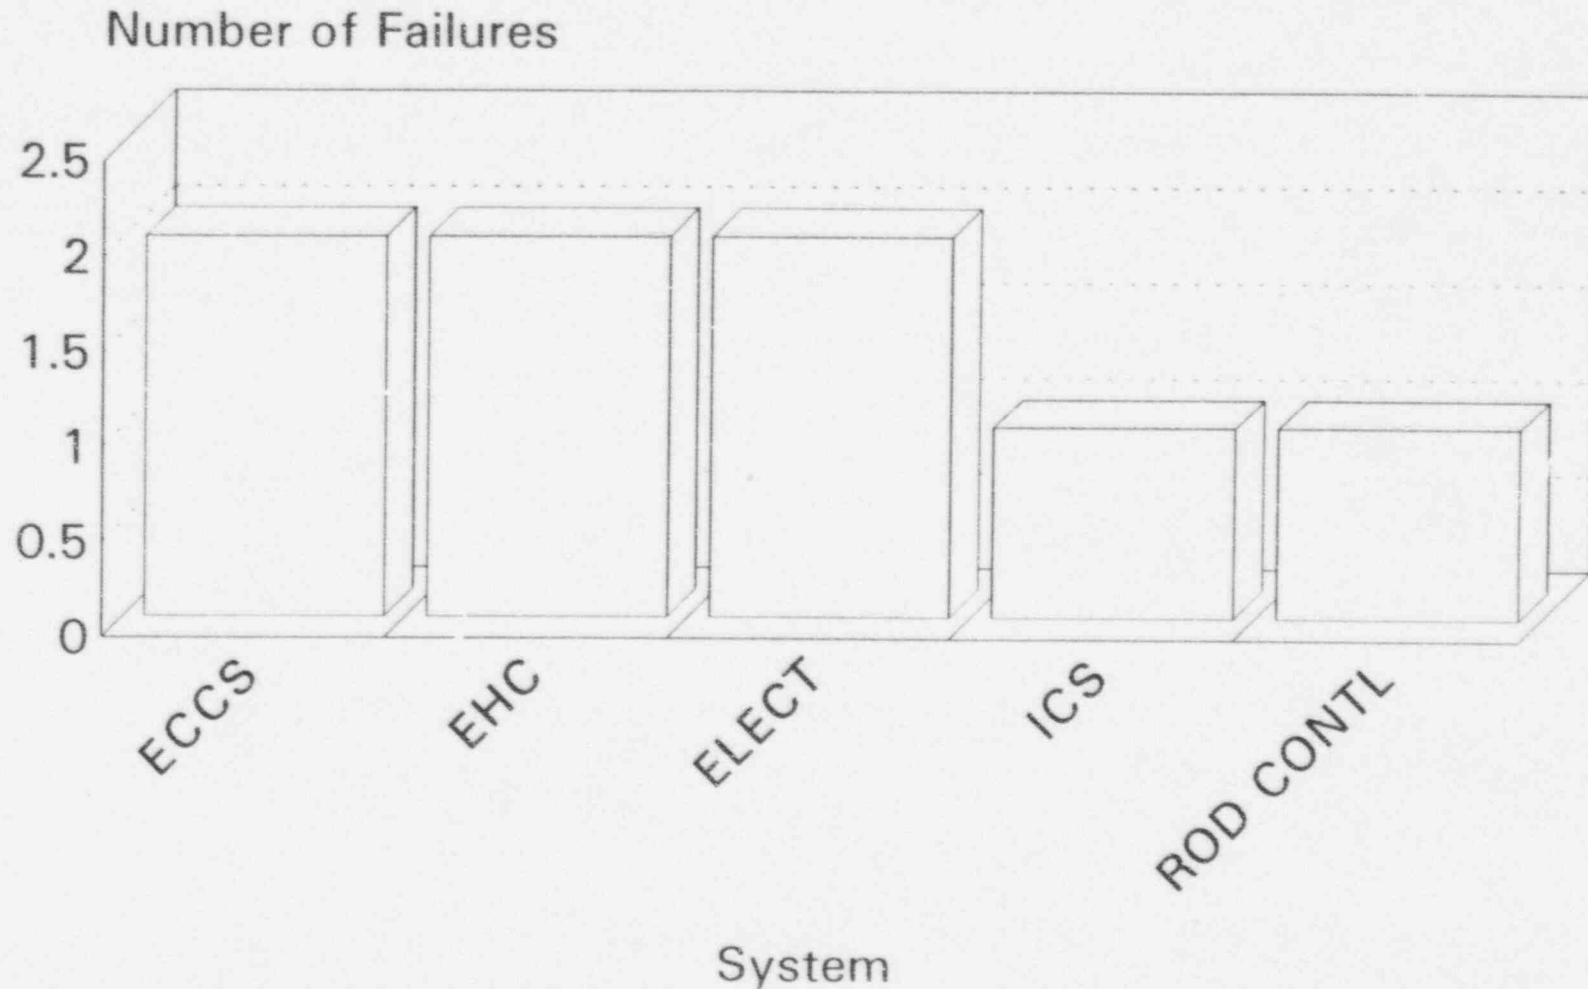
POWER SUPPLY FAILURES BY SYSTEM

1994 - 1995

Based on Site Issues Matrix/LERs

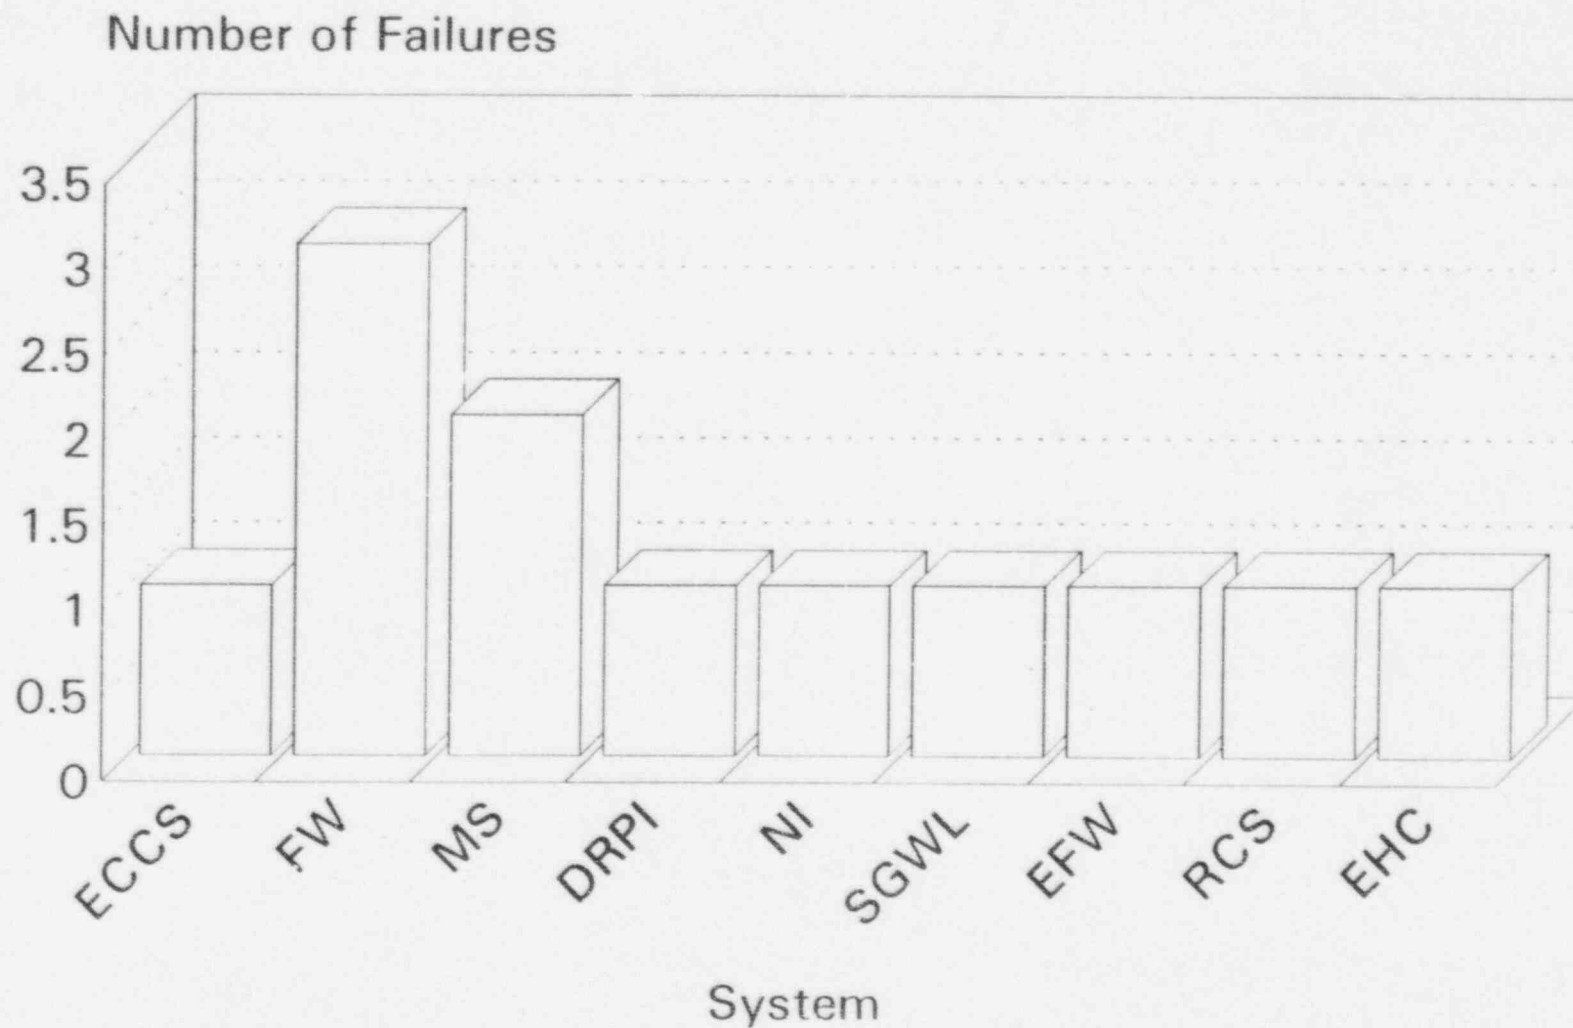
SENSOR/LOOP/MODULE FAILURES BY SYSTEM

1994 - 1995

Based on Site Issues Matrix/LERs

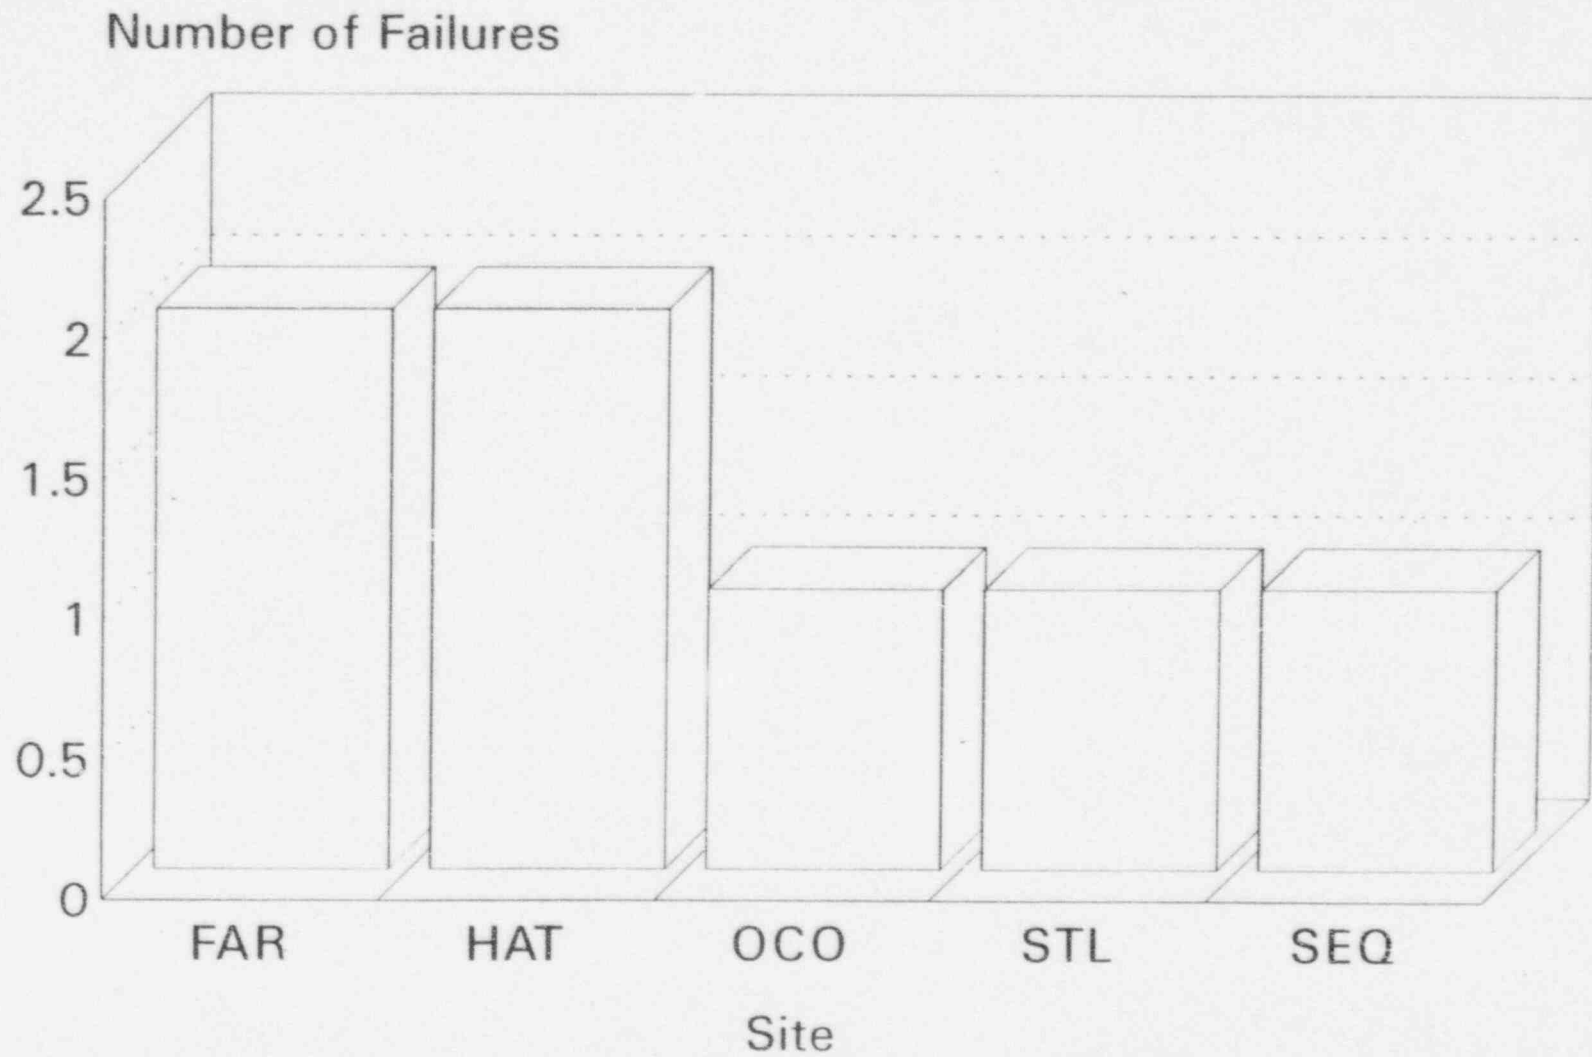
SIGNIFICANT SETPOINT AND INSTRUMENT INACCURACIES

1994 - 1995

Based on Site Issues Matrix/LERs

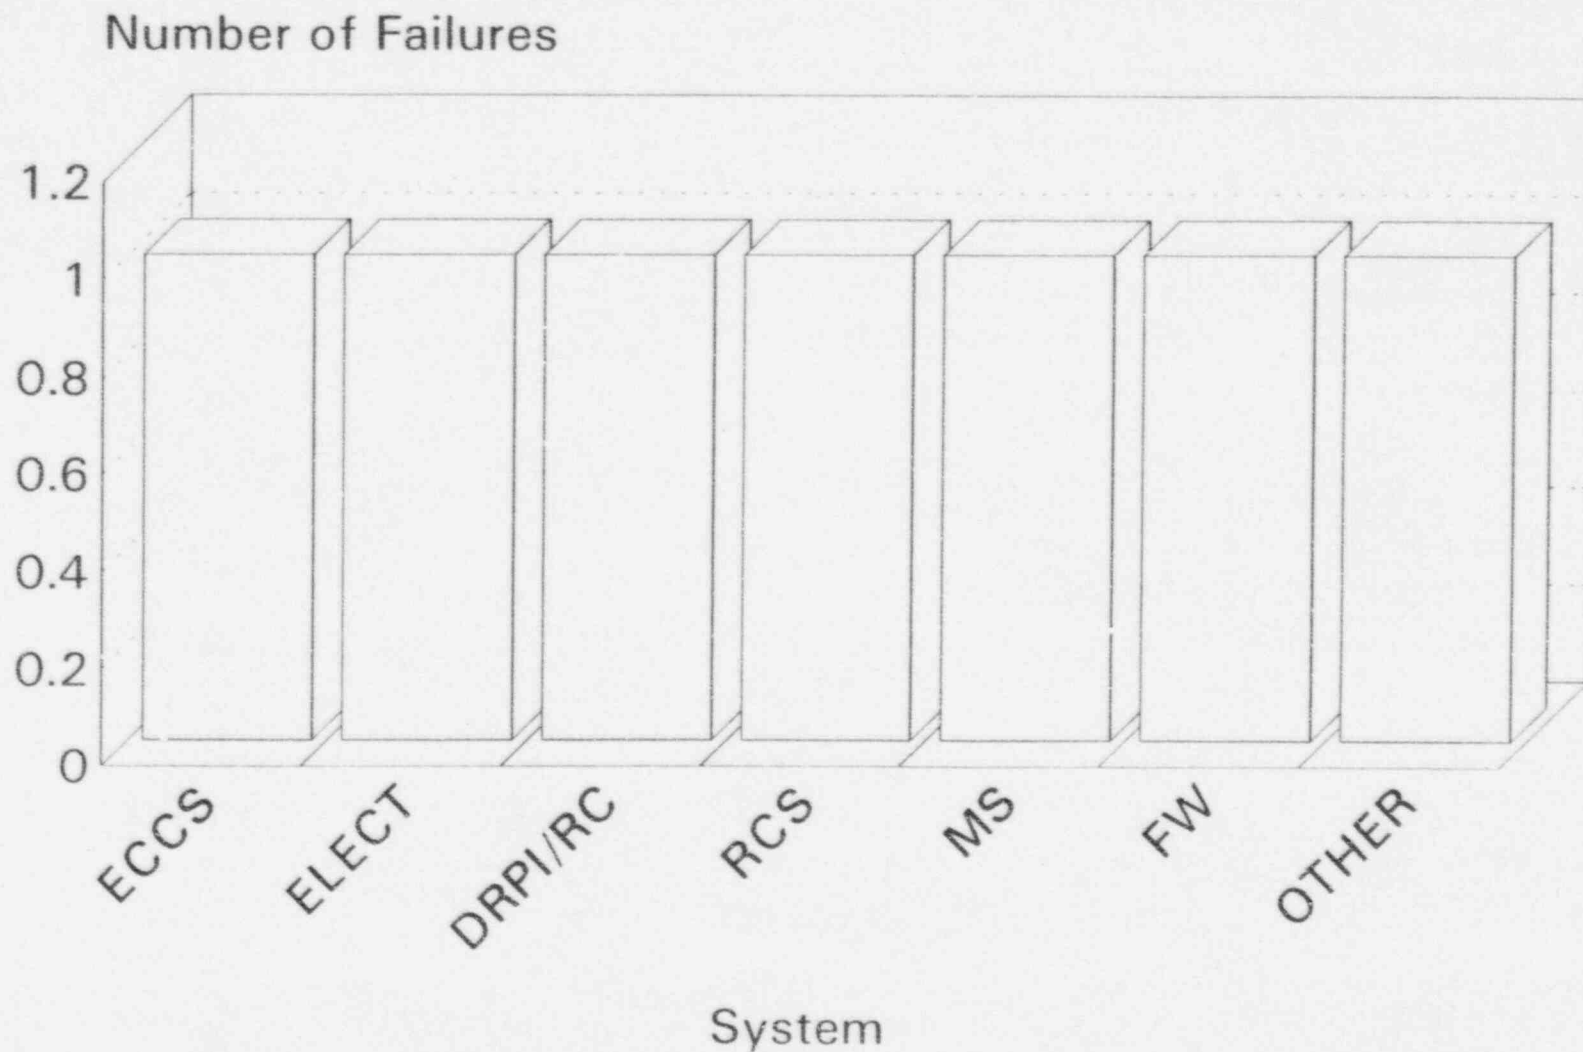
SETPOINT DRIFT/INSTRUMENT INACCURACIES BY SYSTEM

1994 - 1995

Based on Site Issues Matrix/LERs

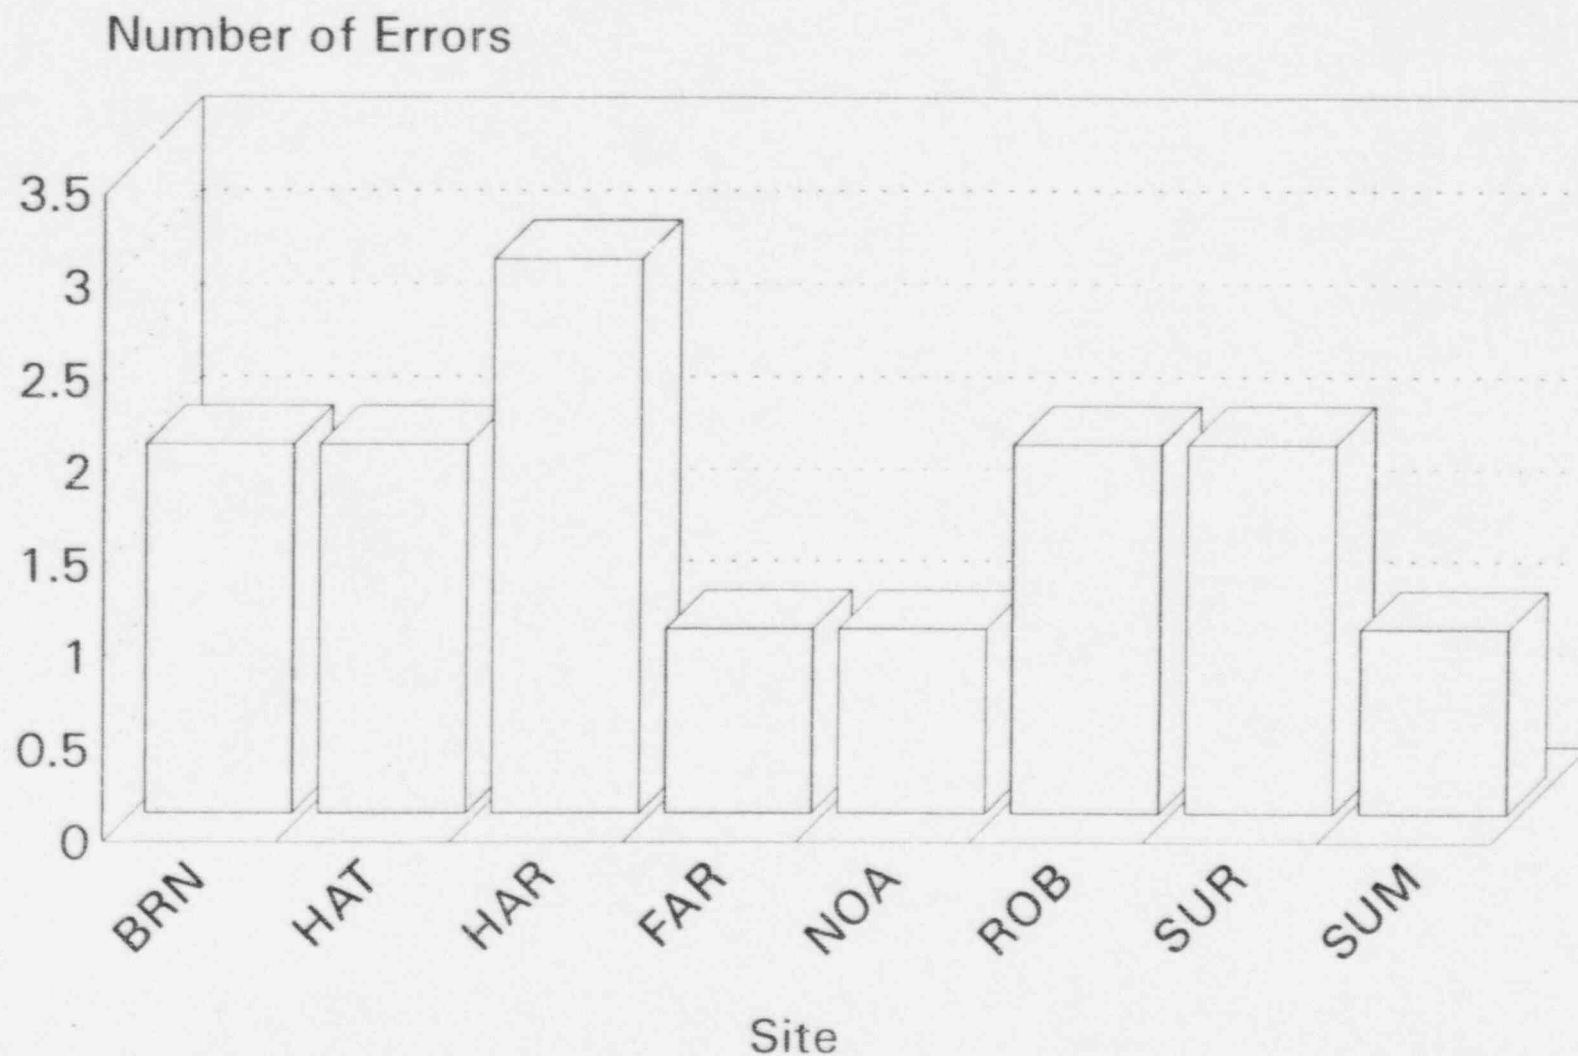
SIGNIFICANT PERSONNEL ERRORS - INSTRUMENT CALIBRATION

1994 - 1995

Based on Site Issues Matrix/LERs

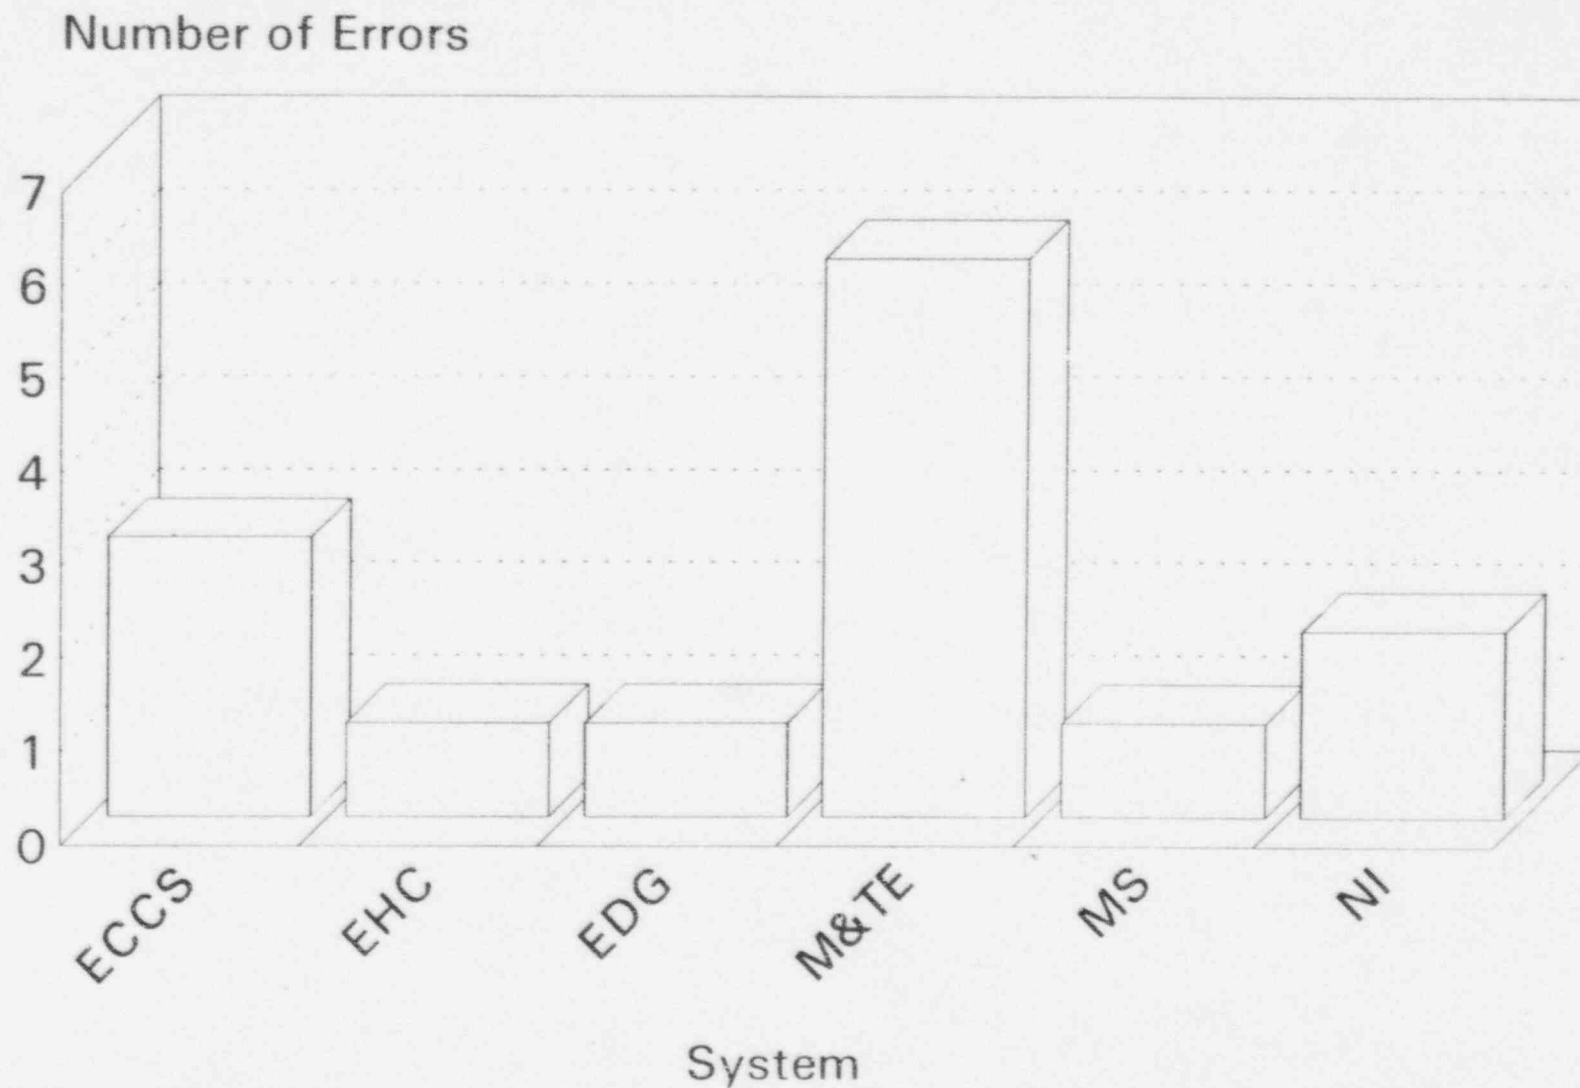
SIGNIFICANT PERSONNEL ERRORS - INSTRUMENT CALIBRATION - BY SYSTEM

1994 - 1995

Based on Site Issues Matrix/LERs

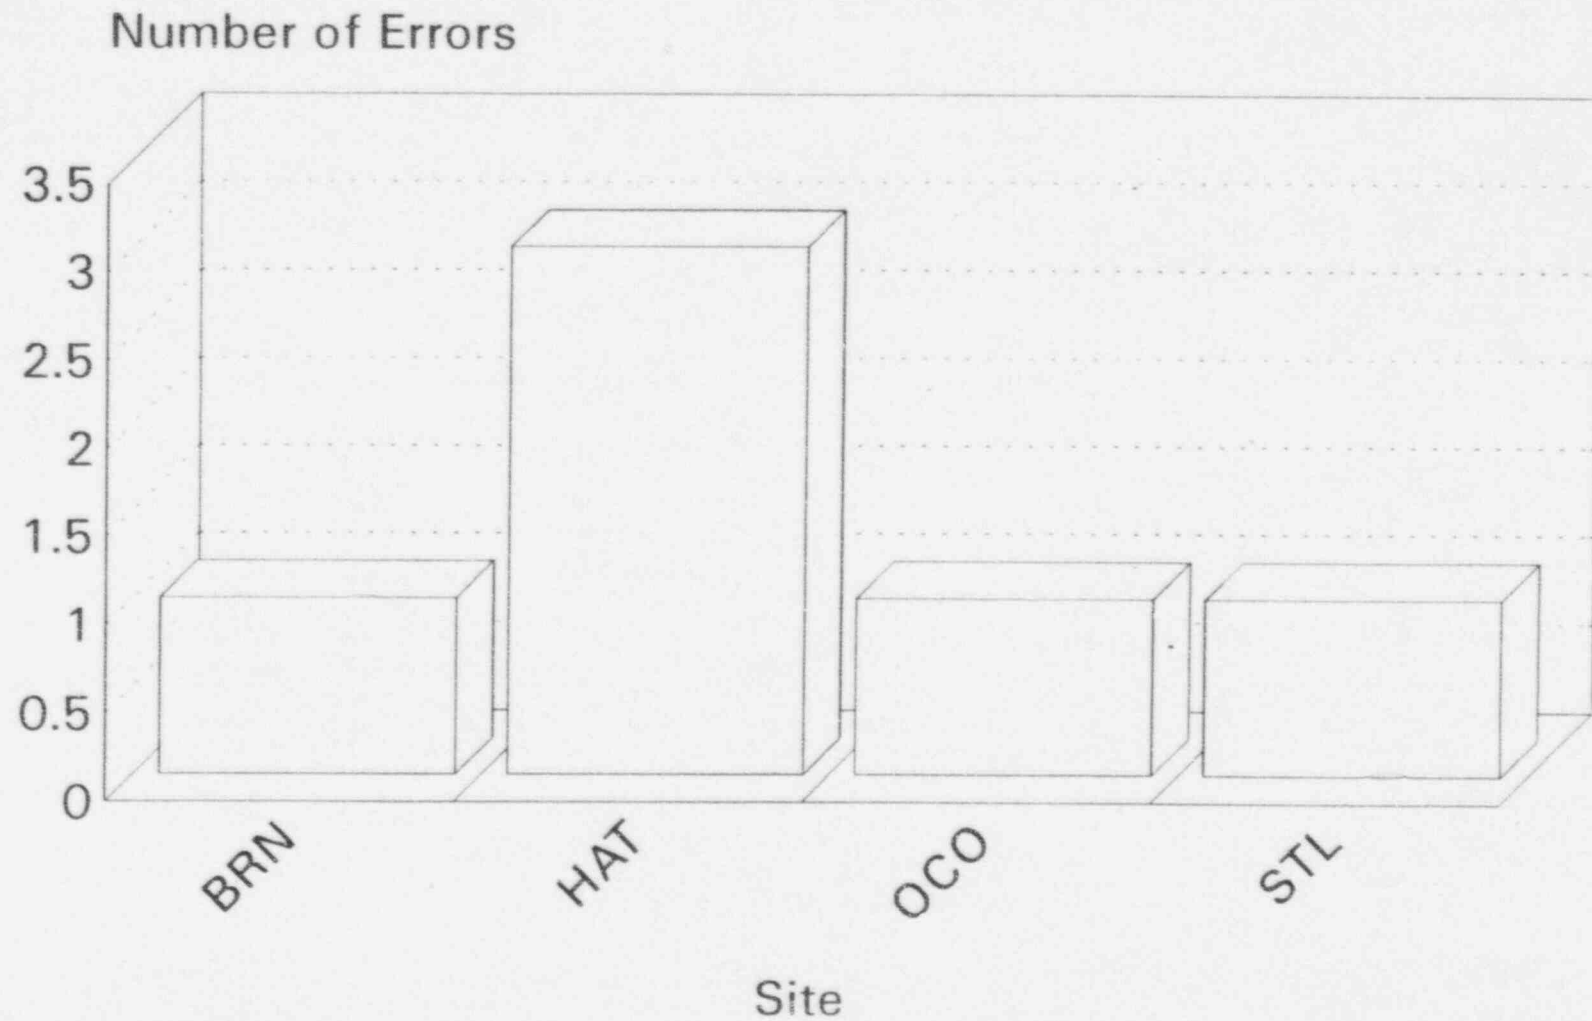
SIGNIFICANT PERSONNEL ERRORS - ELECTRICAL SYSTEMS

CAUSING TRIPS/RUNBACKS

1994 - 1995

Based on Site Issues Matrix/LEAs

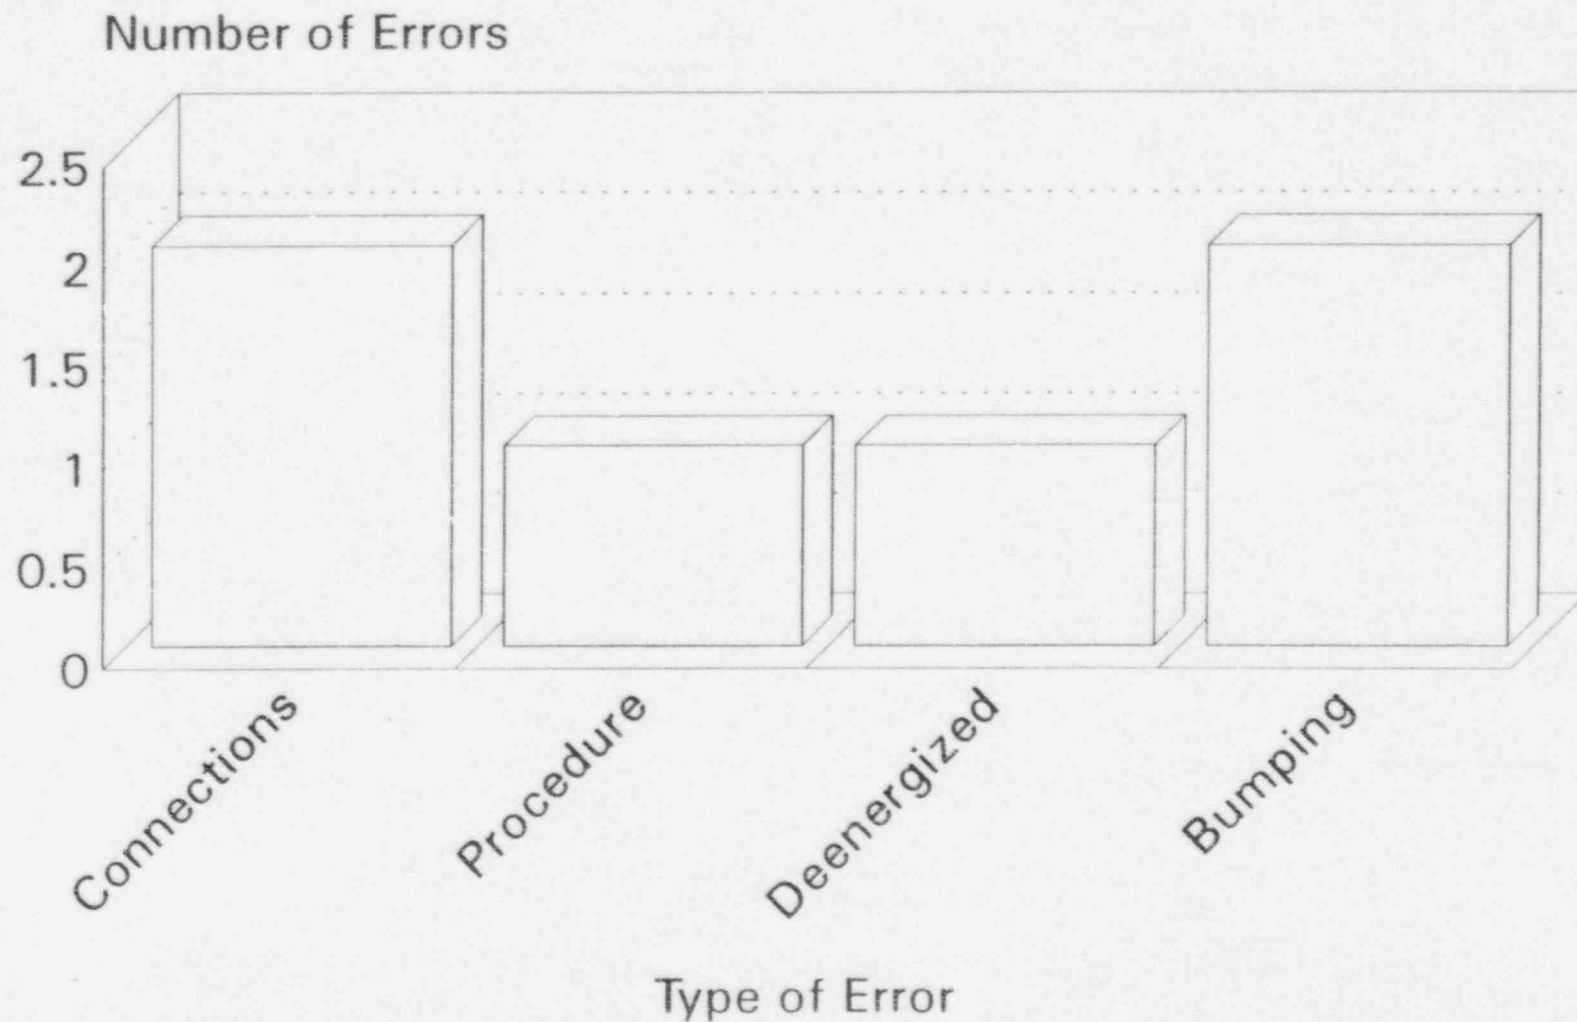
SIGNIFICANT PERSONNEL ERRORS - ELECTRICAL SYSTEMS

CAUSING TRIPS/RUNBACKS - BY SYSTEM

1994 - 1995

Based on Site Issues Matrix/LERs

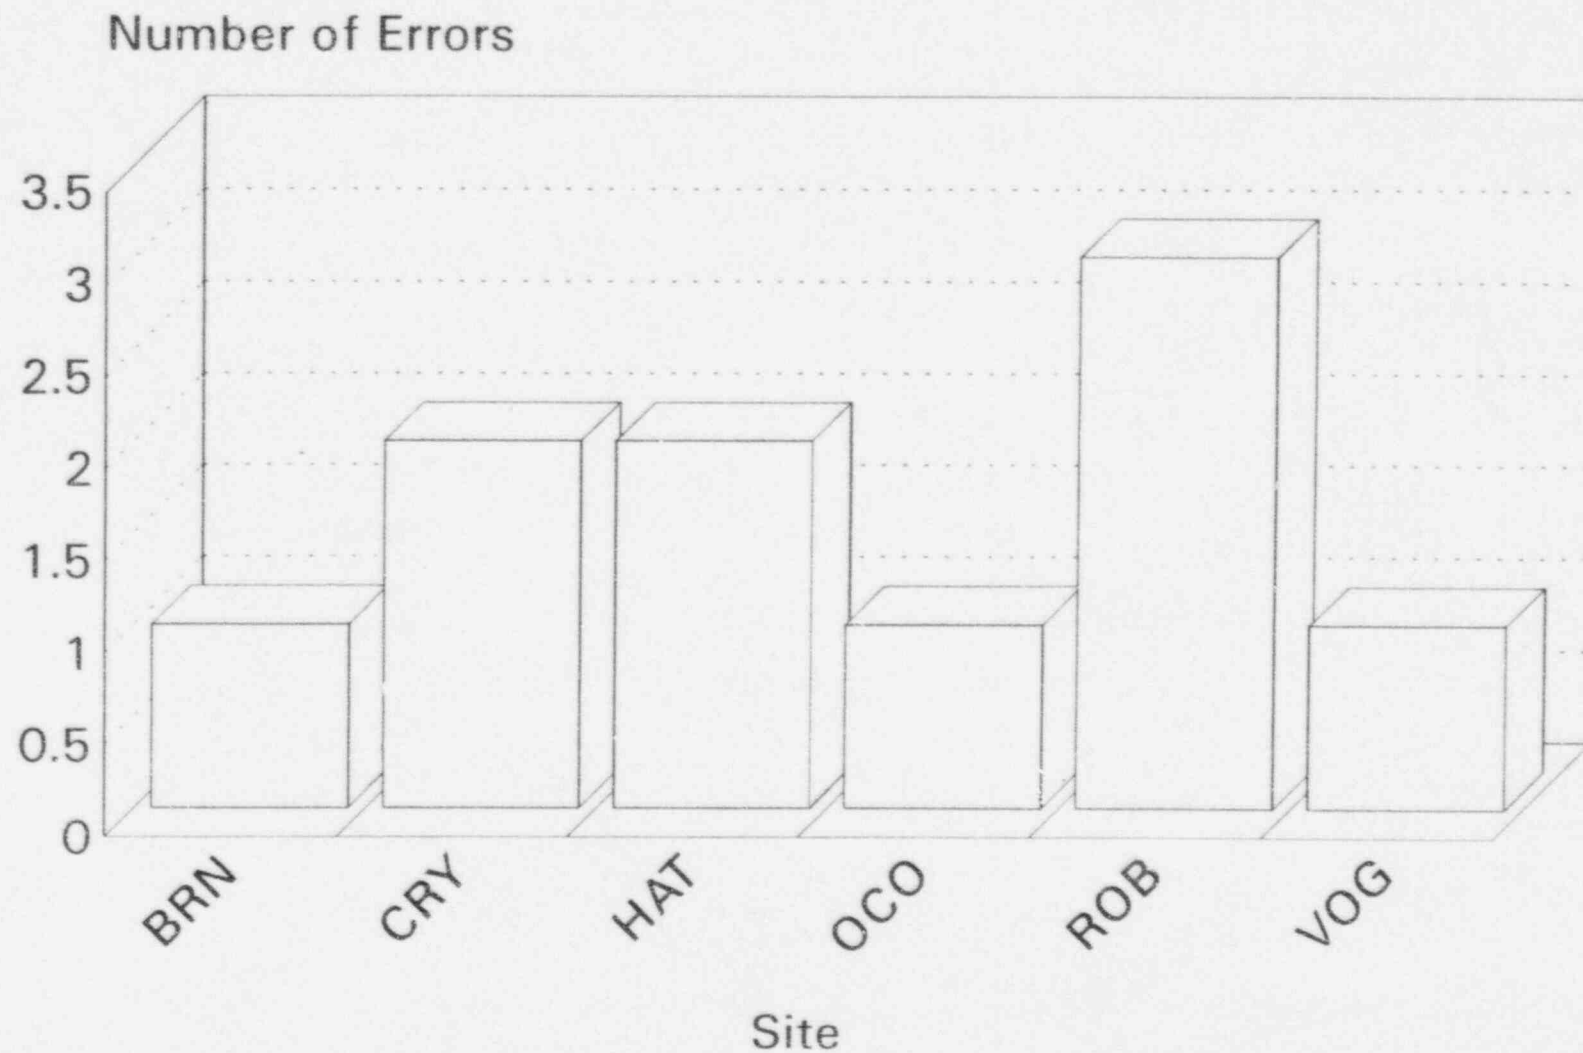
SIGNIFICANT ERRORS IN CONTROL OF SETPOINTS AND LIMITS

1994 - 1995

Based on Site Issues Matrix/LERs

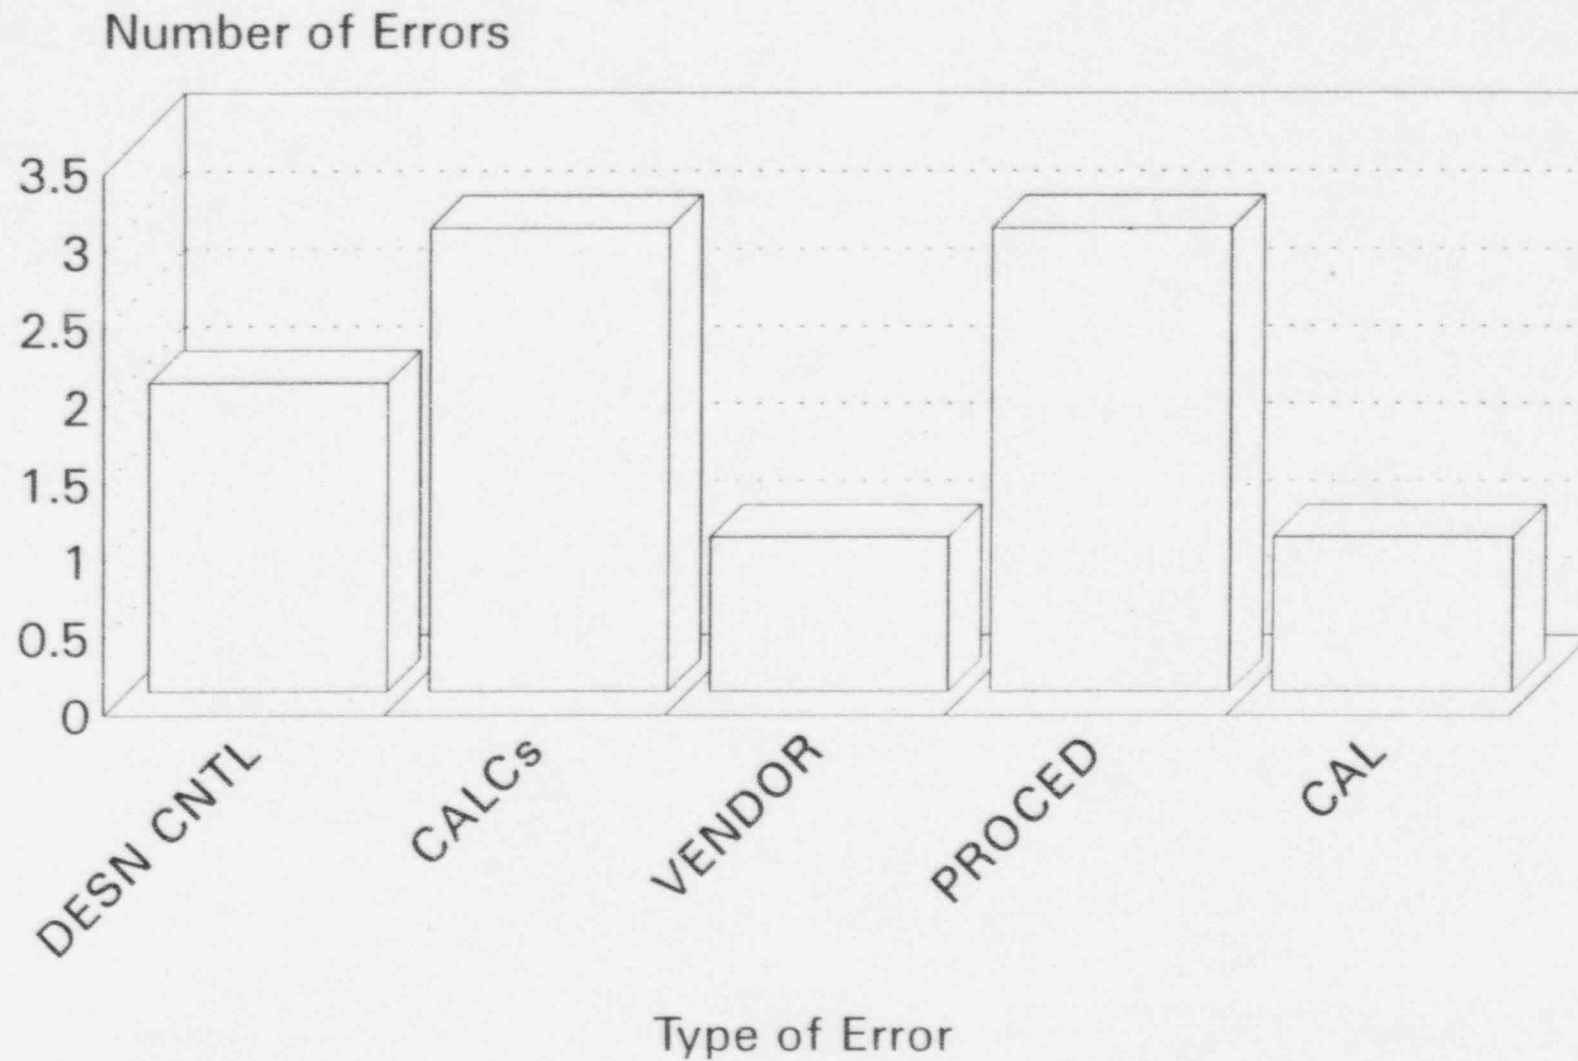
SIGNIFICANT ERRORS IN CONTROL OF SETPOINTS AND LIMITS

1994 - 1995

Based on Site Issues Matrix/LERs
