SUBJECT: INTEGRATED PLANT SAFETY ASSESSMENT REPORT SECTION 4.4,
WIND AND TORNADO LOADINGS, SECTION 4.7, TORNADO
MISSILES - MILLSTONE UNIT 1

Enclosed is the staff's Safety Evaluation Report for Sections 4.4 (Wind and Tornado Loadings) and 4.7 (Tornado Missiles) of the Integrated Plant Safety Assessment Report (IPSAR) for Millstone Unit 1 (NUREG-0824). Those sections of the IPSAR identified structures and components which were unable to adequately resist the effects of tornado winds and missiles.

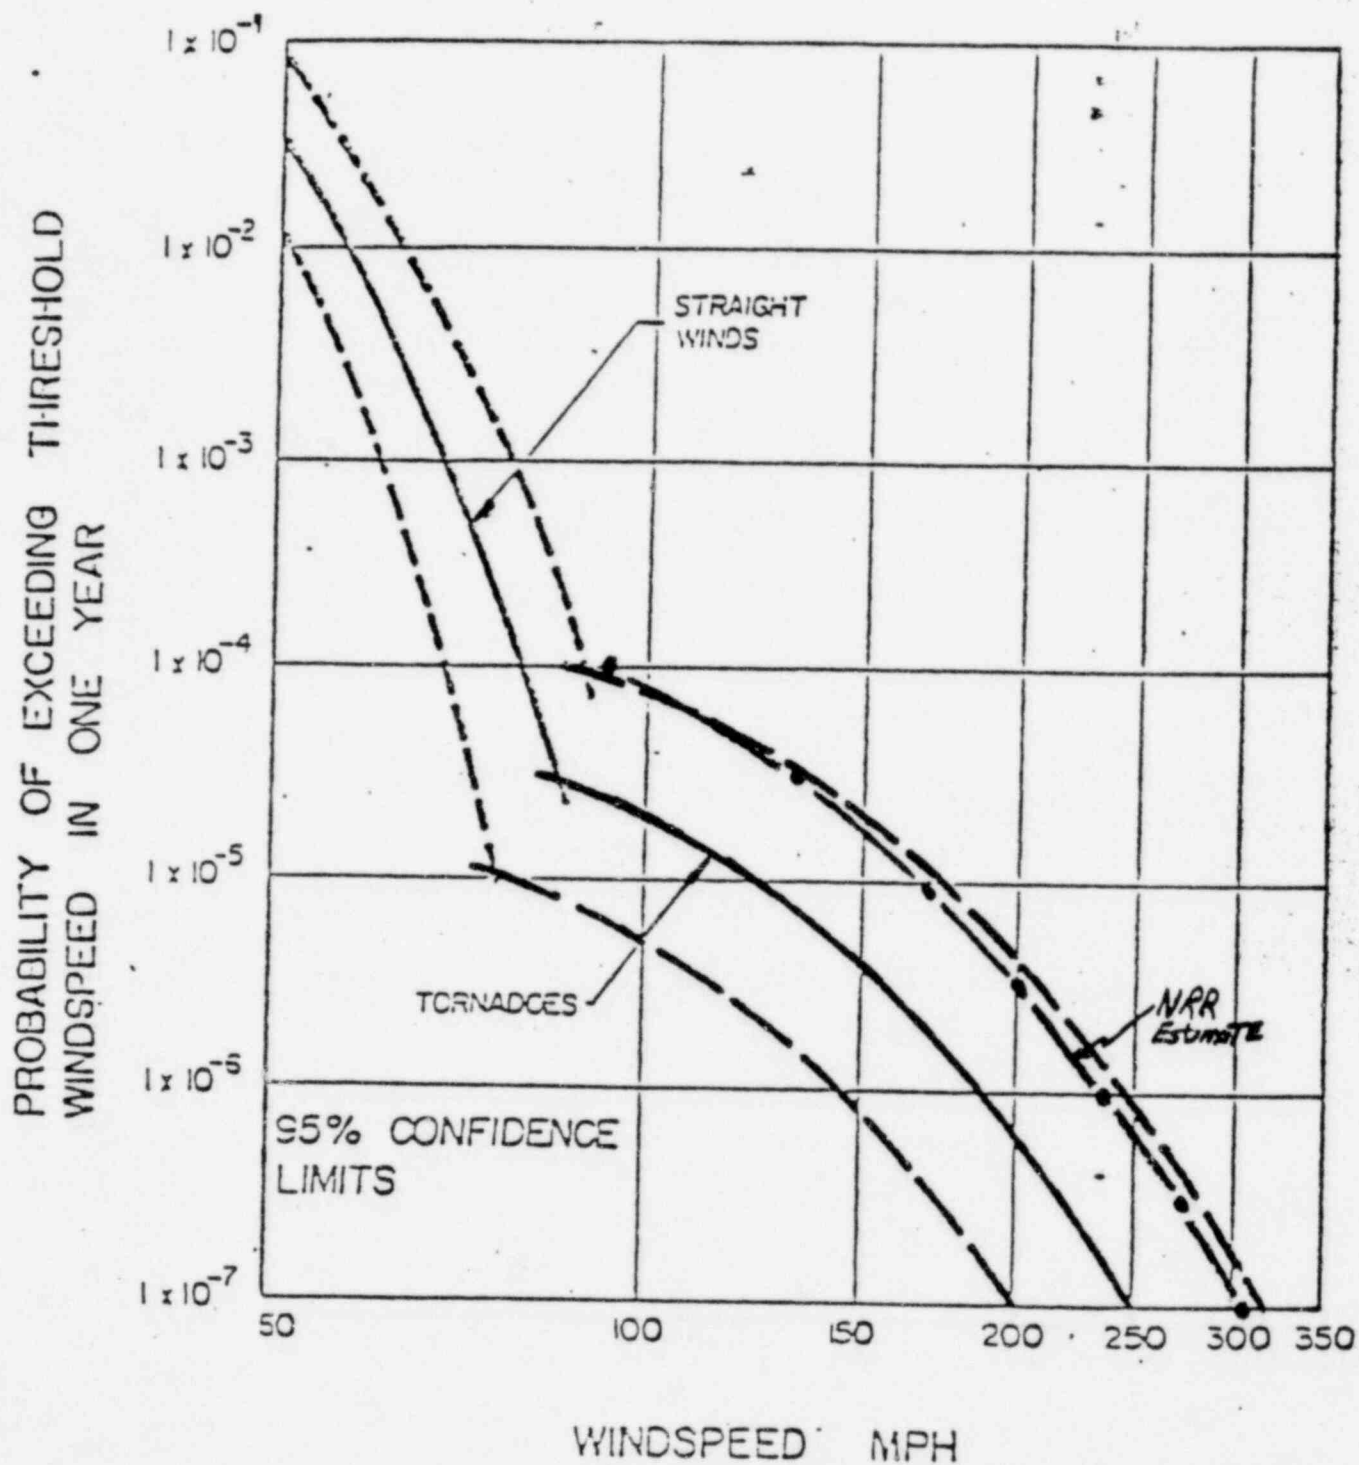
TORNADO AND STRAIGHT WIND HAZARD
PROBABILITY MODEL FOR HADDAM NECK - MILLSTONE
POWER REACTOR SITE, CONNECTICUT
