U.S. NUCLEAR REGULATORY COMMISSION
REGION I

Report No. 50-322/84-46

Facility Name: Shoreham Nuclear Power Station

Areas Inspected: Special, announced team inspection of emergency lighting and the safe shutdown capability of the plant in the event of a fire. The inspection involved 170 inspector hours on-site and 66 inspector hours in-office by the team consisting of 4 inspectors.

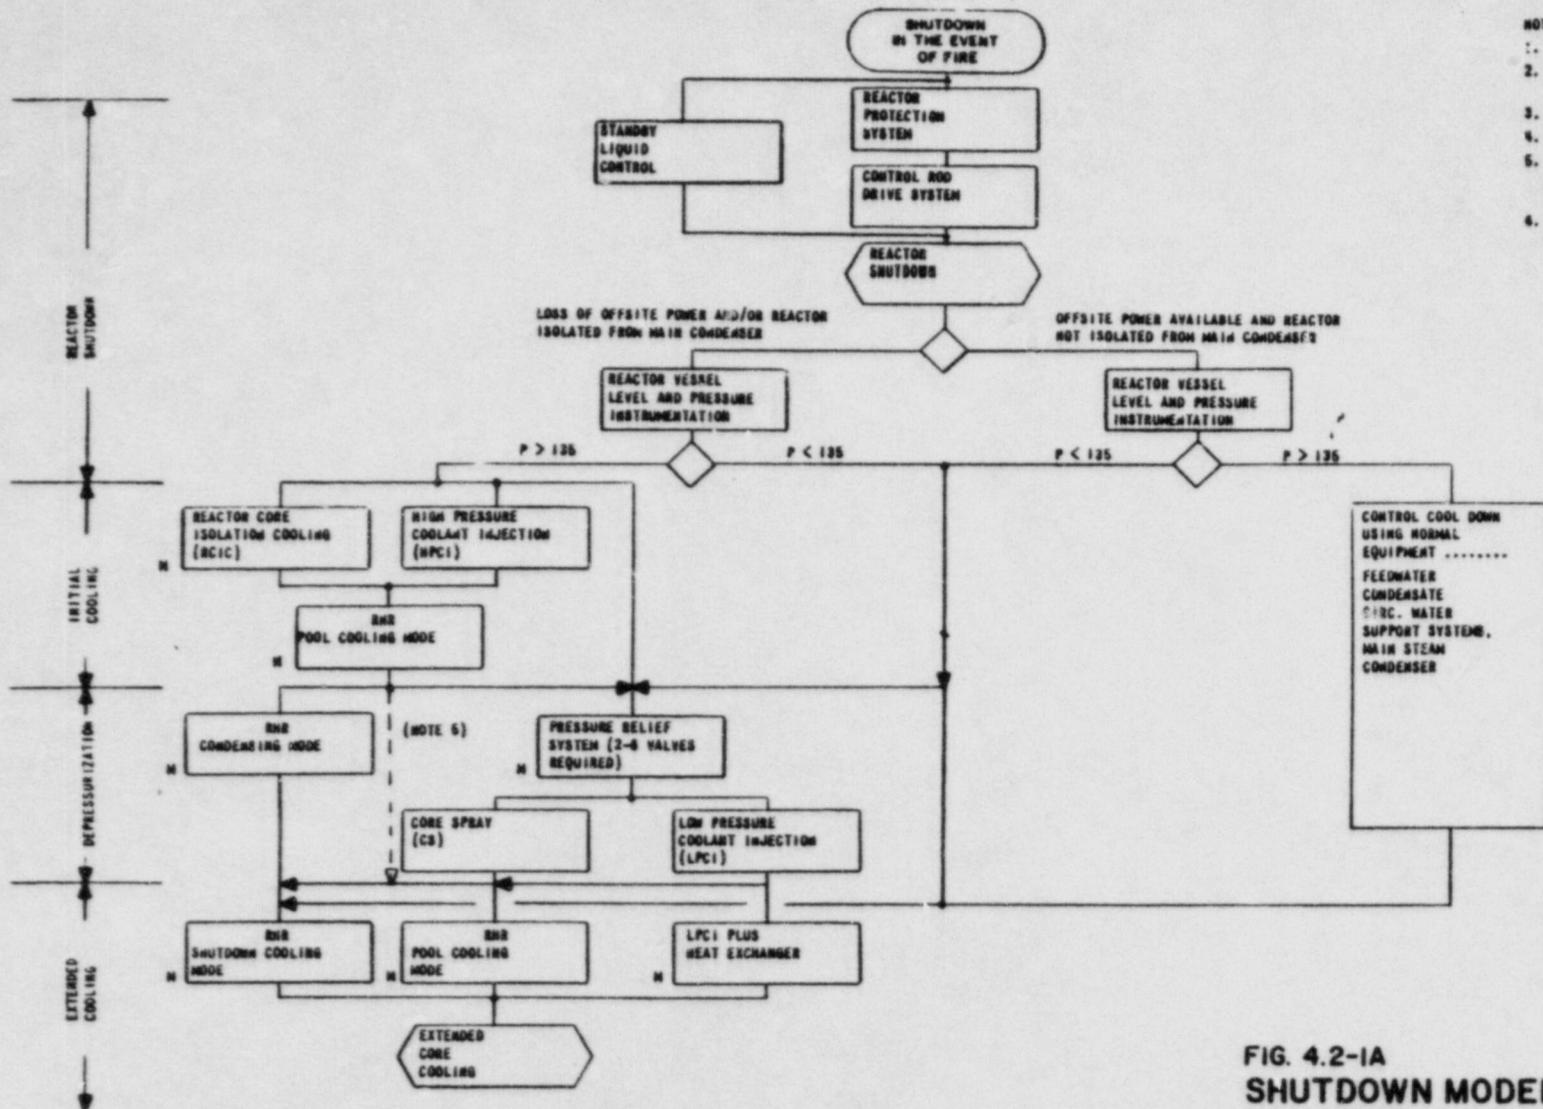
FIG. 4.2-1A
SHUTDOWN MODEL
PROTECTION SEQUENCE FOR SHUTDOWN
SHOREHAM NUCLEAR POWER STATION-UNIT 1
CABLE DEPARATION ANALYSIS REPORT

- NOTES:
1. RCIC IS AUTO START, MANUAL RESET.
 2. BWR CONDENSING MODE REQUIRES NON-SAFETY INSTRUMENT AIR.
 3. INSTRUMENTATION NOT SHOWN.
 4. M - MANUAL.
 5. NO FORCED COOLDOWN CAPABILITY THIS PATH HOWEVER PLANT REMAINS SAFE IN HOT SHUTDOWN CONDITION AND WILL EVENTUALLY DEPRESSURIZE.
 6. ADDITIONAL FLEXIBILITY EXISTS IN THAT PATHS OF MANY OPERATIONS MAY BE RETRACED.
