SUBJECT: REVISED SAFETY EVALUATION ON THE TENNESSEE VALLEY AUTHORITY (TVA)
SEQUOYAH NUCLEAR PERFORMANCE PLAN

As previously noted, the staff plans to issue this evaluation, in final form, as NUREG-1232, Volume 2, Part 1, with the evaluations of employee concern element reports as Part 2.

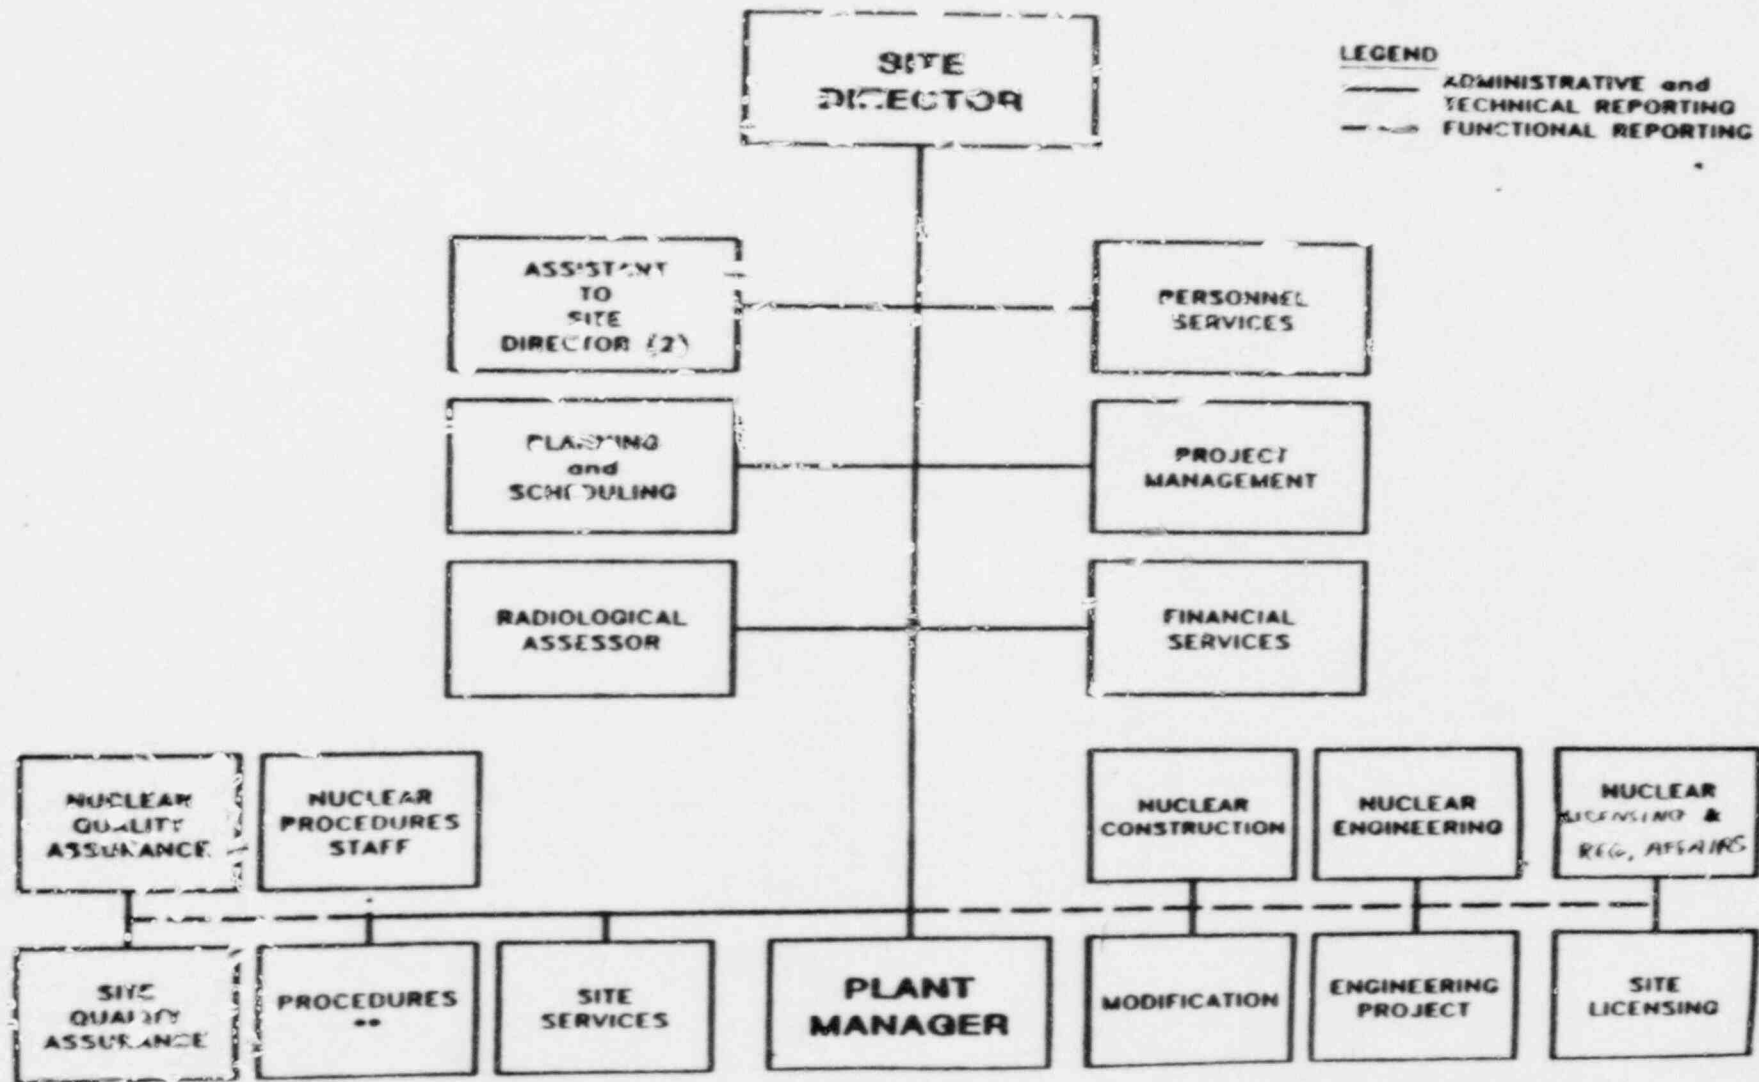
Figure 4.1 Sequoyah site organization

Sequoyah site organization is organized into functional departments that generally parallel the functional departments in TVA's headquarters Office of Nuclear Power. The functional alignment of the Office of Nuclear Power is discussed in the staff's SER of the Corporate Nuclear Performance Plan (NUREG-1232, Volume 1). In that SER, the staff stated that corporate functional area managers are responsible for the technical direction in each functional area at each of the nuclear sites. The Sequoyah site organization showing this functional alignment is presented in Figure 4.1. Each site functional department is responsible for a discrete type of function.

** Temporarily reports to Site Director;
Long-term function will report to
Site Services

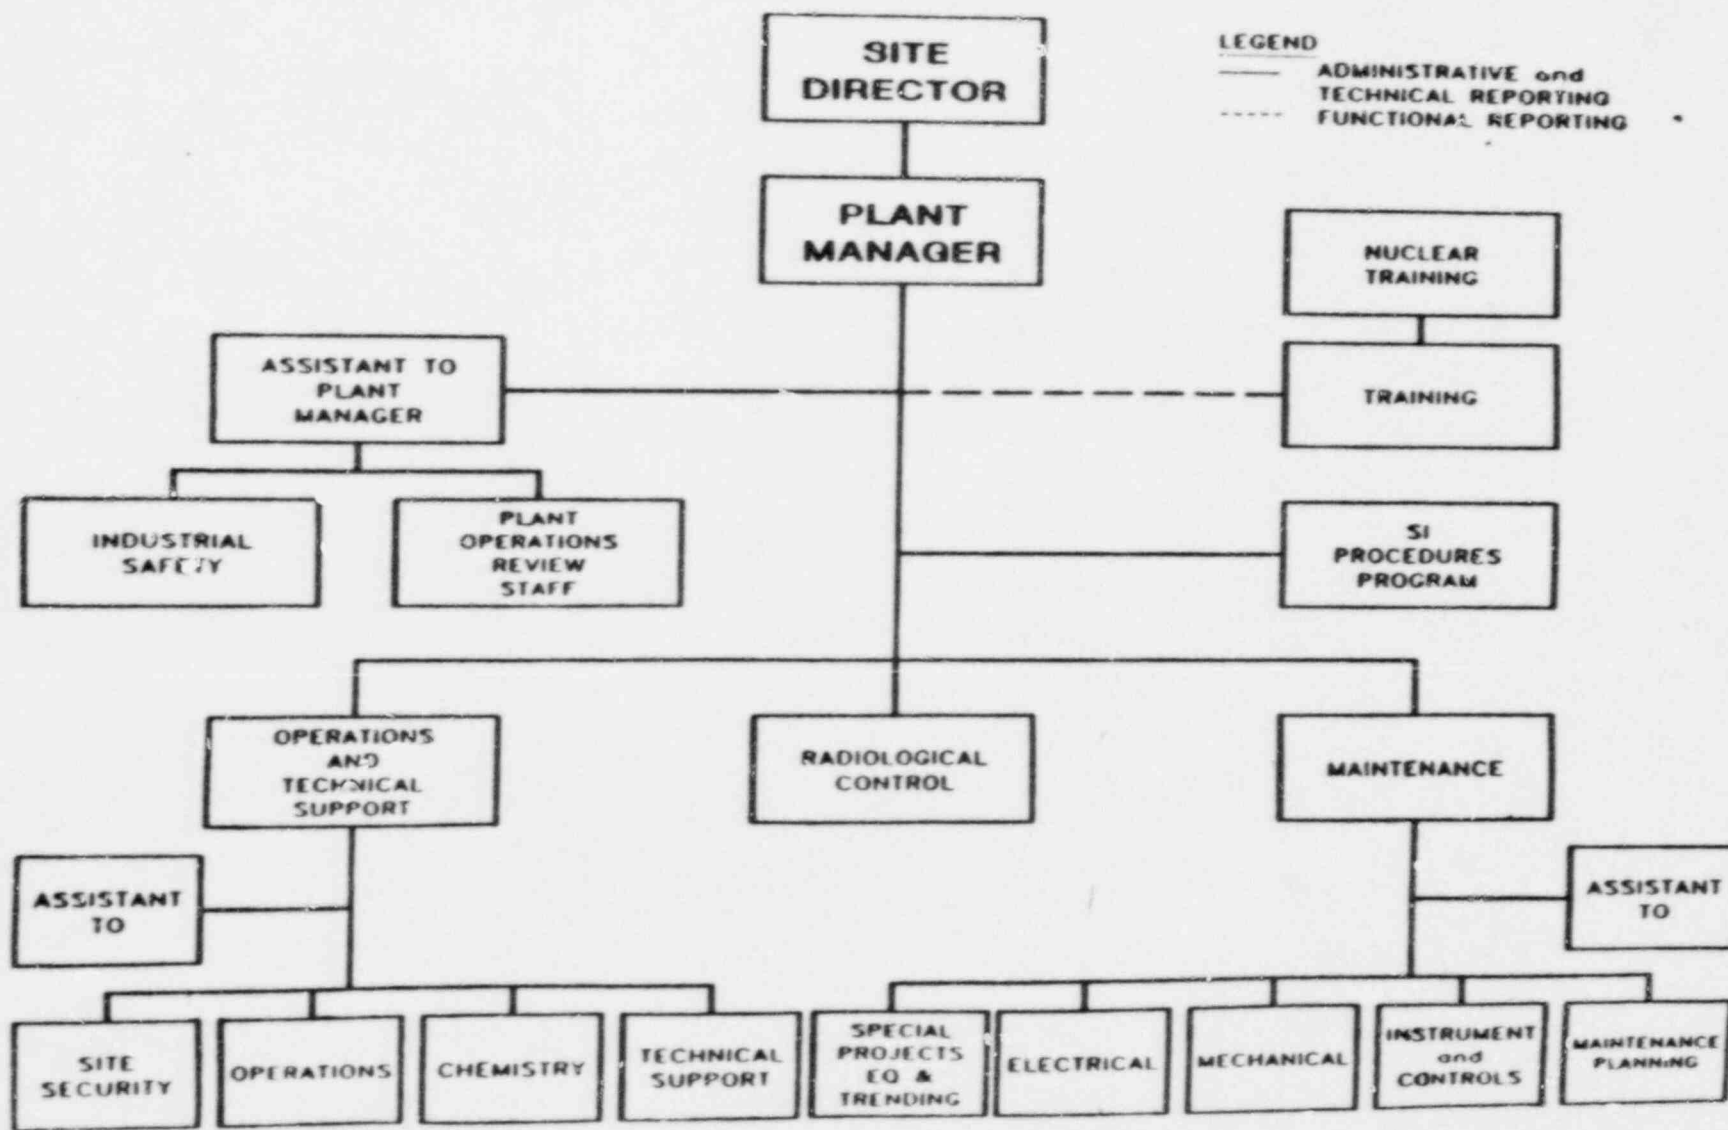
Figure 4.2 Sequoyah nuclear plant organization

The Sequoyah plant organization is shown in Figure 4.2. The Plant Manager is responsible for conducting the day-to-day plant operations in compliance with licensing regulatory requirements. A plant management organization has been implemented with a unit superintendent assigned to operations and a unit superintendent assigned to maintenance.

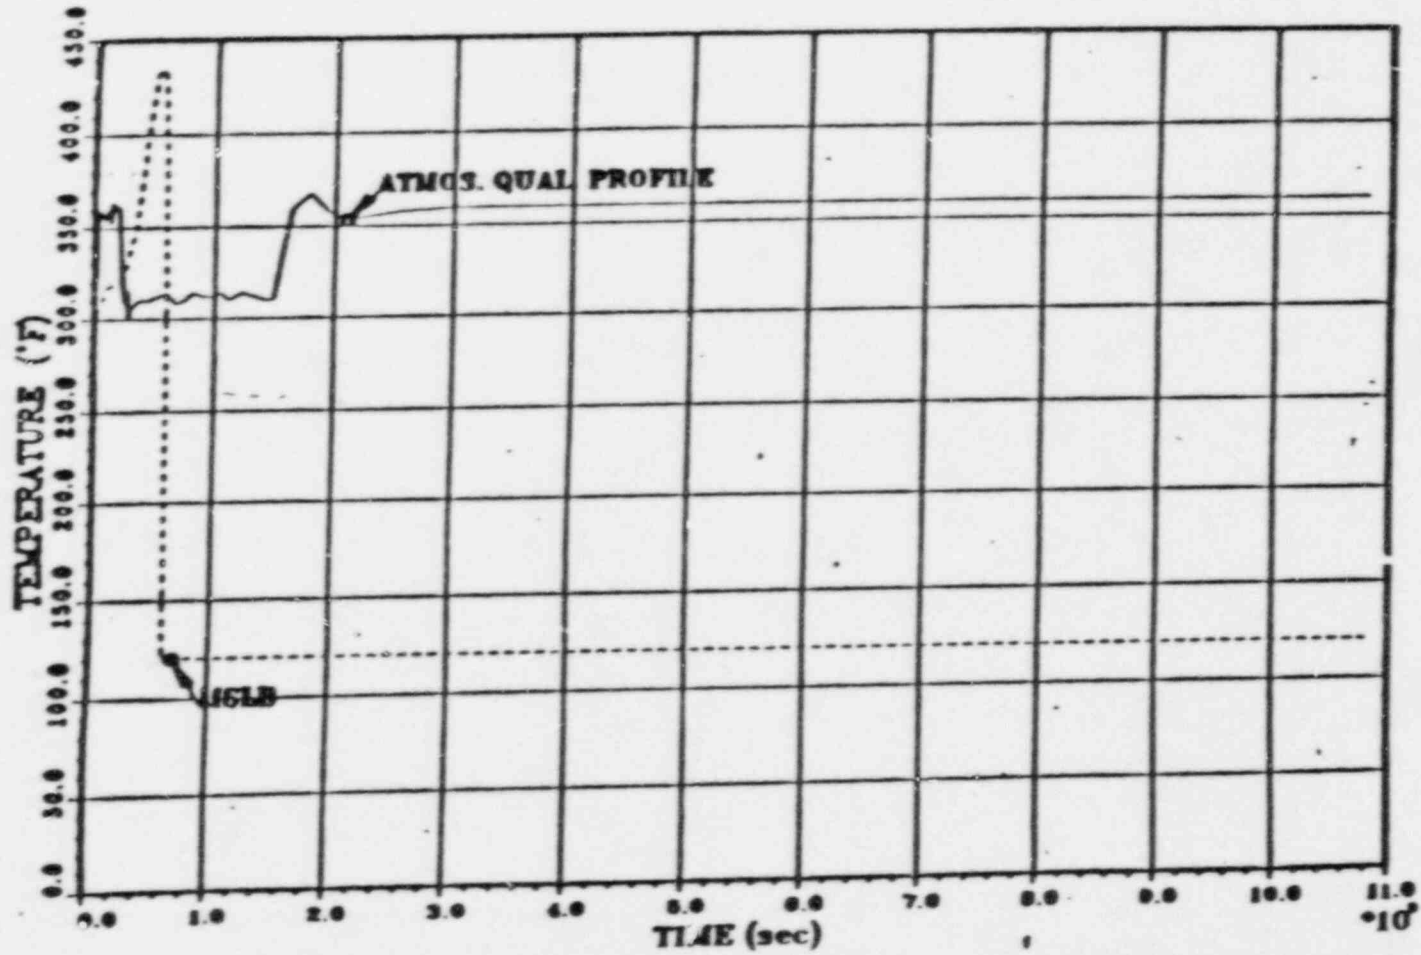
Figure 1. MSIV Solenoid EQ Test Chamber Temperature

FIGURE SUPPLIED
BY THE LICENSEE

MSIV SOLENOID EQ TEST CHAMBER TEMPERATURE

TVA also provided details of the guidelines used in constructing the heat transfer models. TVA's assumptions were made to conservatively increase the temperature predicted during a MSLB, while lowering the surface and internal temperatures resulting from analysis of EQ test chamber profiles. In this way, higher than expected surface and internal temperatures resulting from MSLBs are compared to lower than expected surface and internal temperatures derived from the qualification tests, thereby adding conservatism. The values of heat transfer coefficients used for the MSLB analyses were provided along with schematics of the models used. The Licensee concluded that qualification of the MSIV devices was established for each component by comparison of the calculated thermal response during a MSLB to the calculated response during qualification testing. The qualification for steam and moisture exposure is based wholly upon the existing qualification test results. The review of the existing qualification test results was not within the scope of this evaluation. The results of the existing qualification tests have been assumed to be acceptable during this evaluation. A sample of Licensee-supplied temperature profiles is included as Figures 1 through 3. Figure 1 represents the EQ temperature profile of a MSIV solenoid versus the MSLB temperature profile. Figure 2 is a plot of the calculated MSIV solenoid surface temperature during the MSLB. Figure 3 represents the calculated internal coil temperature during a MSLB as compared to the EQ test temperature.
