Report Nos.: 50-348/87-30 and 50-364/87-30

Facility Name: Farley Nuclear Plant, Units 1 and 2

Inspection Conducted: November 2-6, 1987, and November 16-20, 1987

Scope: This special, announced inspection was in the area of Environmental Qualification (EQ) of Electrical Equipment and included a review of Alabama Power Company's (APCO) implementation of the requirements of 10 CFR 50.49; plant walkdown inspections of electrical equipment within the scope of 10 CFR 50.49; a review of the licensee's corrective actions for previously identified EQ deficiencies; and a review of their evaluations of these findings on how they effect restart of Unit 2 and continued operation of Unit 1.

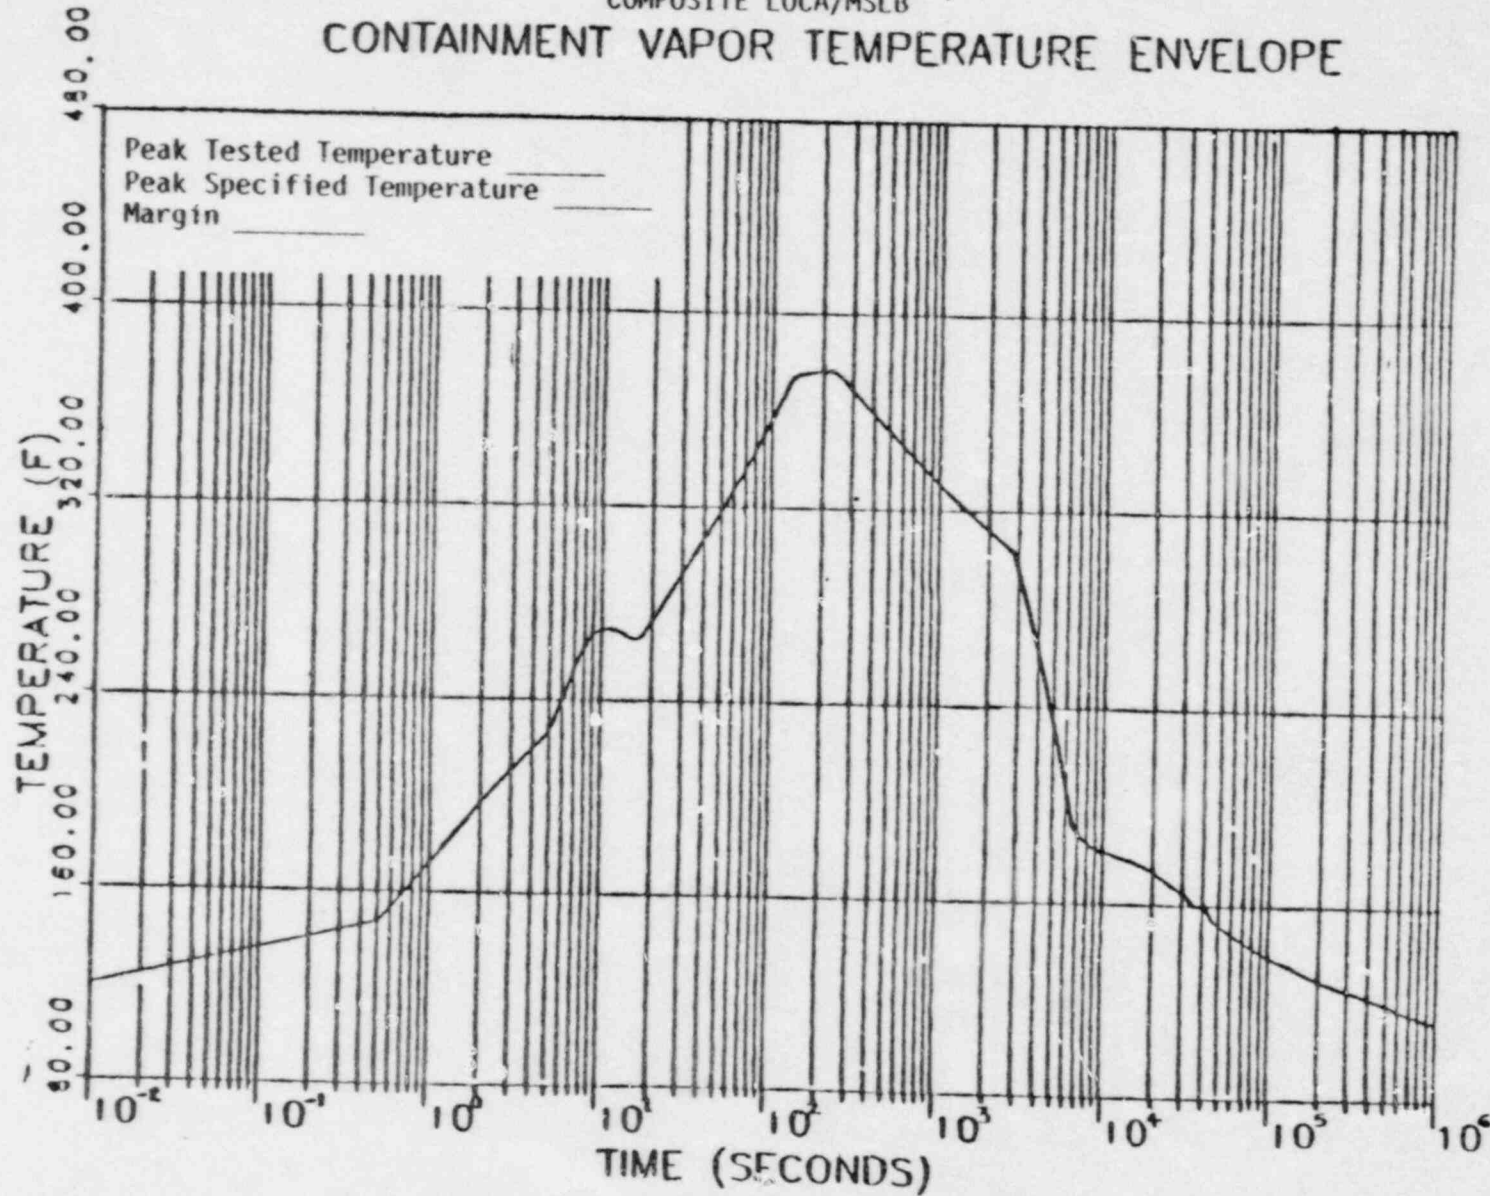
FIGURE 3.0-1

This curve is based on FSAR
Curves Figures 6.2-11, 6.2-13,
and 6.2-40.

COMPOSITE LOCA/MSLB
CONTAINMENT VAPOR TEMPERATURE ENVELOPE
