Docket Nos. 50-327/328

SUBJECT: REVISED SAFETY EVALUATION ON THE TENNESSEE VALLEY AUTHORITY (TVA)
SEQUOYAH NUCLEAR PERFORMANCE PLAN

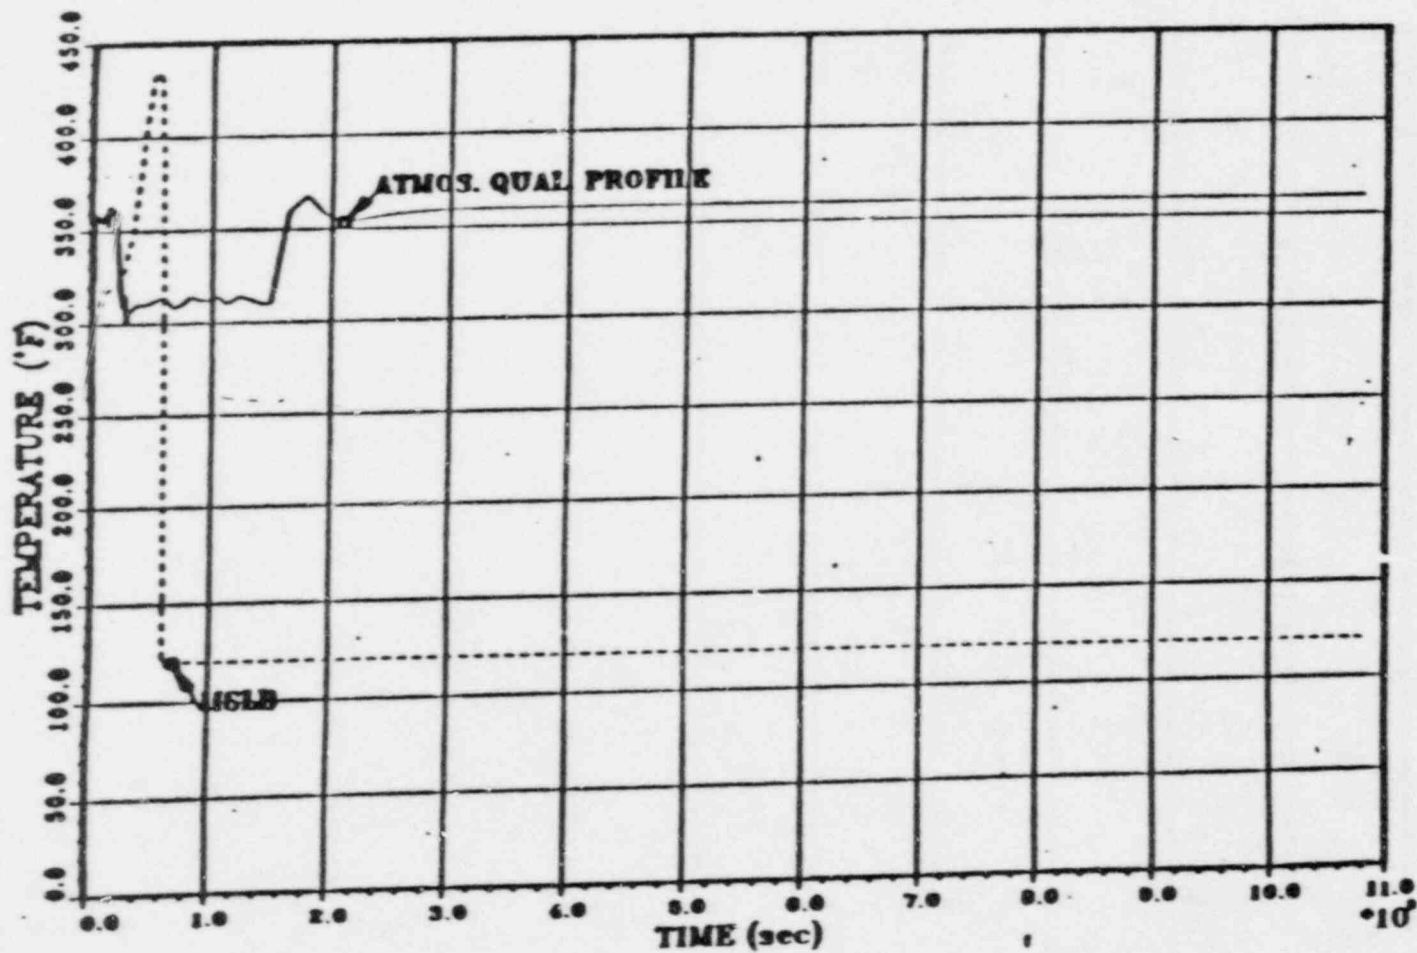
Figure 1. MSIV Solenoid EQ Test Chamber Temperature

FIGURE SUPPLIED
BY THE LICENSEE

MSIV SOLENOID EQ TEST CHAMBER TEMPERATURE

TVA also provided details of the guidelines used in constructing the heat transfer models. TVA's assumptions were made to conservatively increase the temperature predicted during a MSLB, while lowering the surface and internal temperatures resulting from analysis of EQ test chamber profiles. In this way, higher than expected surface and internal temperatures resulting from MSLBs are compared to lower than expected surface and internal temperatures derived from the qualification tests, thereby adding conservatism. The values of heat transfer coefficients used for the MSLB analyses were provided along with schematics of the models used. The Licensee concluded that qualification of the MSIV devices was established for each component by comparison of the calculated thermal response during a MSLB to the calculated response during qualification testing. The qualification for steam and moisture exposure is based wholly upon the existing qualification test results. The review of the existing qualification test results was not within the scope of this evaluation. The results of the existing qualification tests have been assumed to be acceptable during this evaluation. A sample of Licensee-supplied temperature profiles is included as Figures 1 through 3. Figure 1 represents the EQ temperature profile of a MSIV solenoid versus the MSLB temperature profile. Figure 2 is a plot of the calculated MSIV solenoid surface temperature during the MSLB. Figure 3 represents the calculated internal coil temperature during a MSLB as compared to the EQ test temperature.
