U.S. NUCLEAR REGULATORY COMMISSION
REGION I

Report No. 50-271/88-04

Facility Name: Vermont Yankee

Inspection Summary: Inspection on February 8-11, 1988 (Report No. 50-271/88-04)

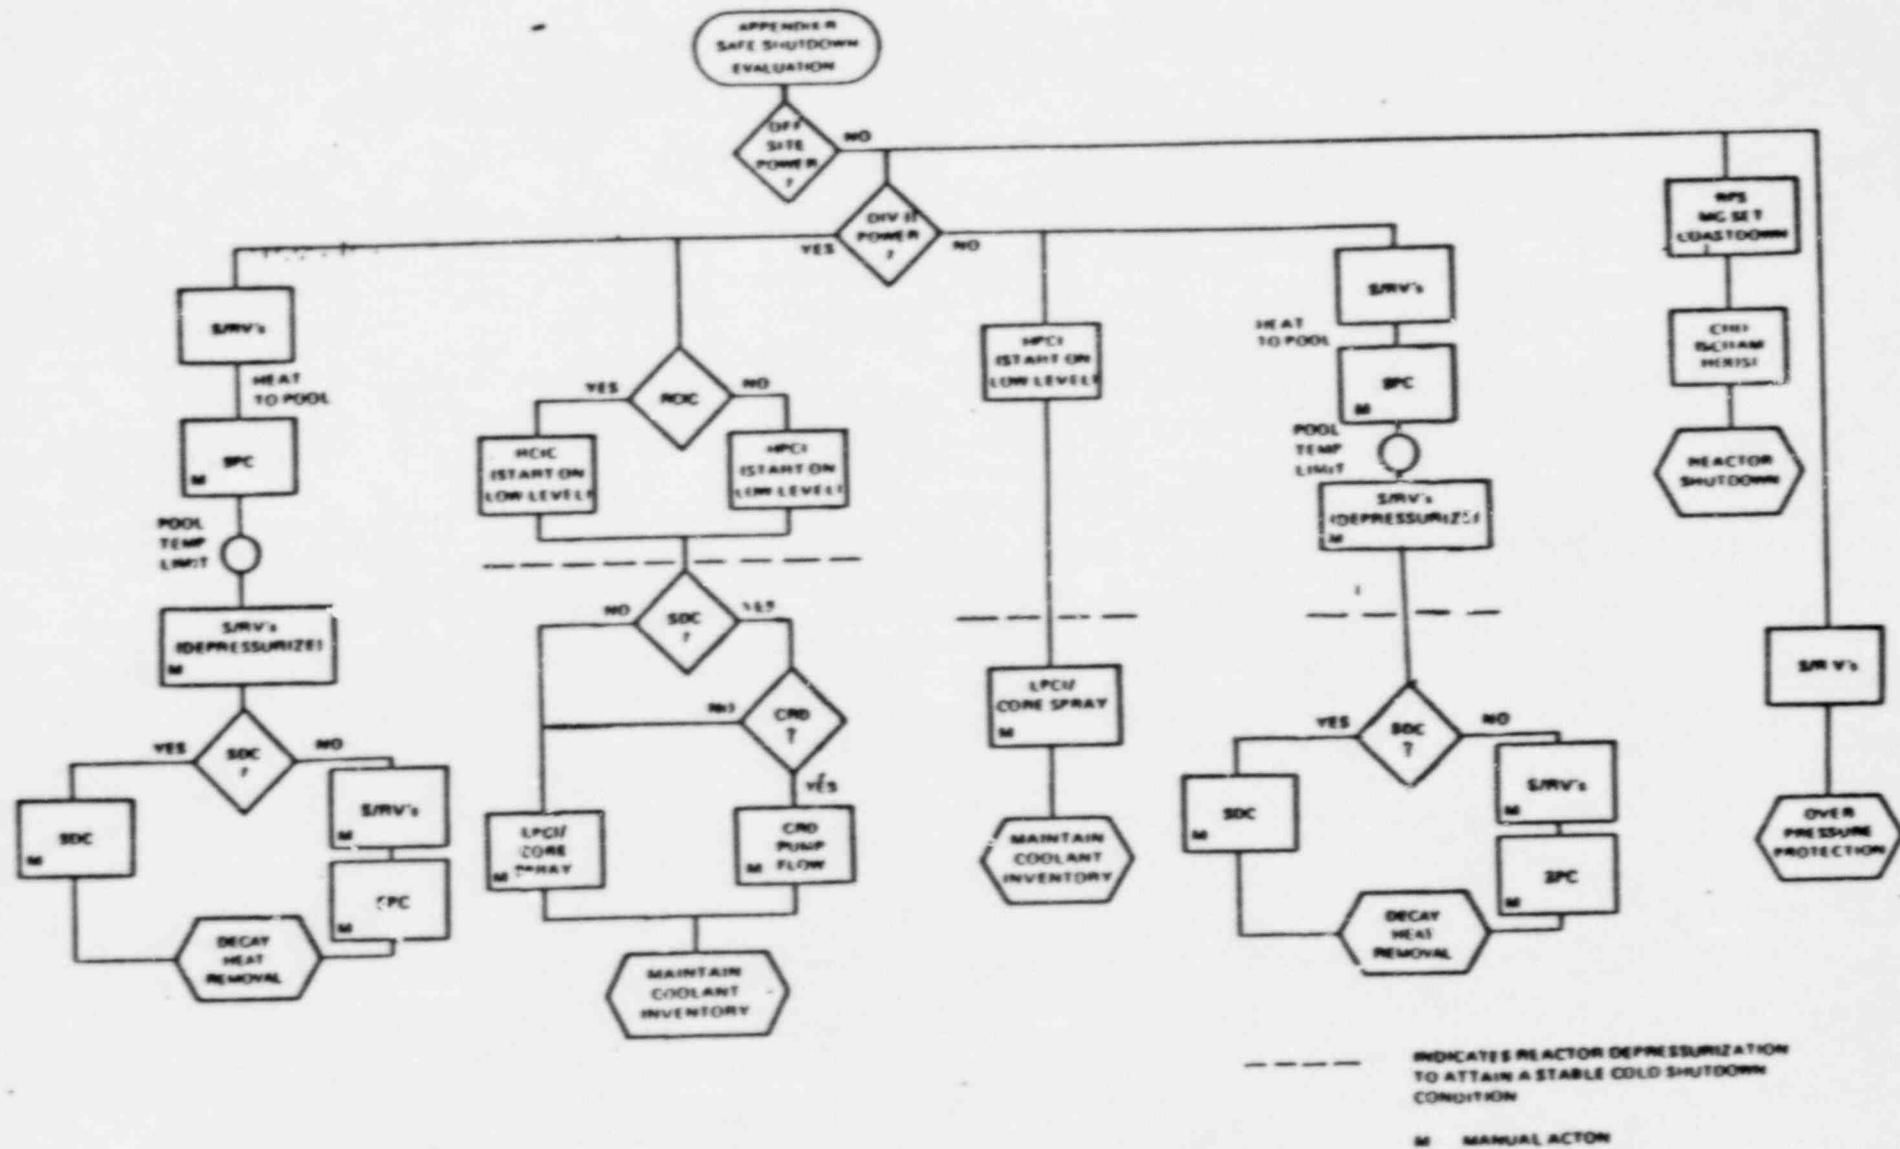
FIGURE 2-1

SAFE SHUTDOWN SEQUENCE FOR APPENDIX R SECTION III G EVALUATION —
 VERMONT YANKEE NUCLEAR POWER PLANT
 OFFSITE POWER NOT AVAILABLE
