**Florida
Power**
CORPORATION

Subject: Crystal River Unit 3
Docket No. 50-302
Operating License No. DPR-72
Emergency Feedwater

CONFIRMATION OF ACTION LETTER

SUMMARY OF JULY 8, 1988 PRESENTATION

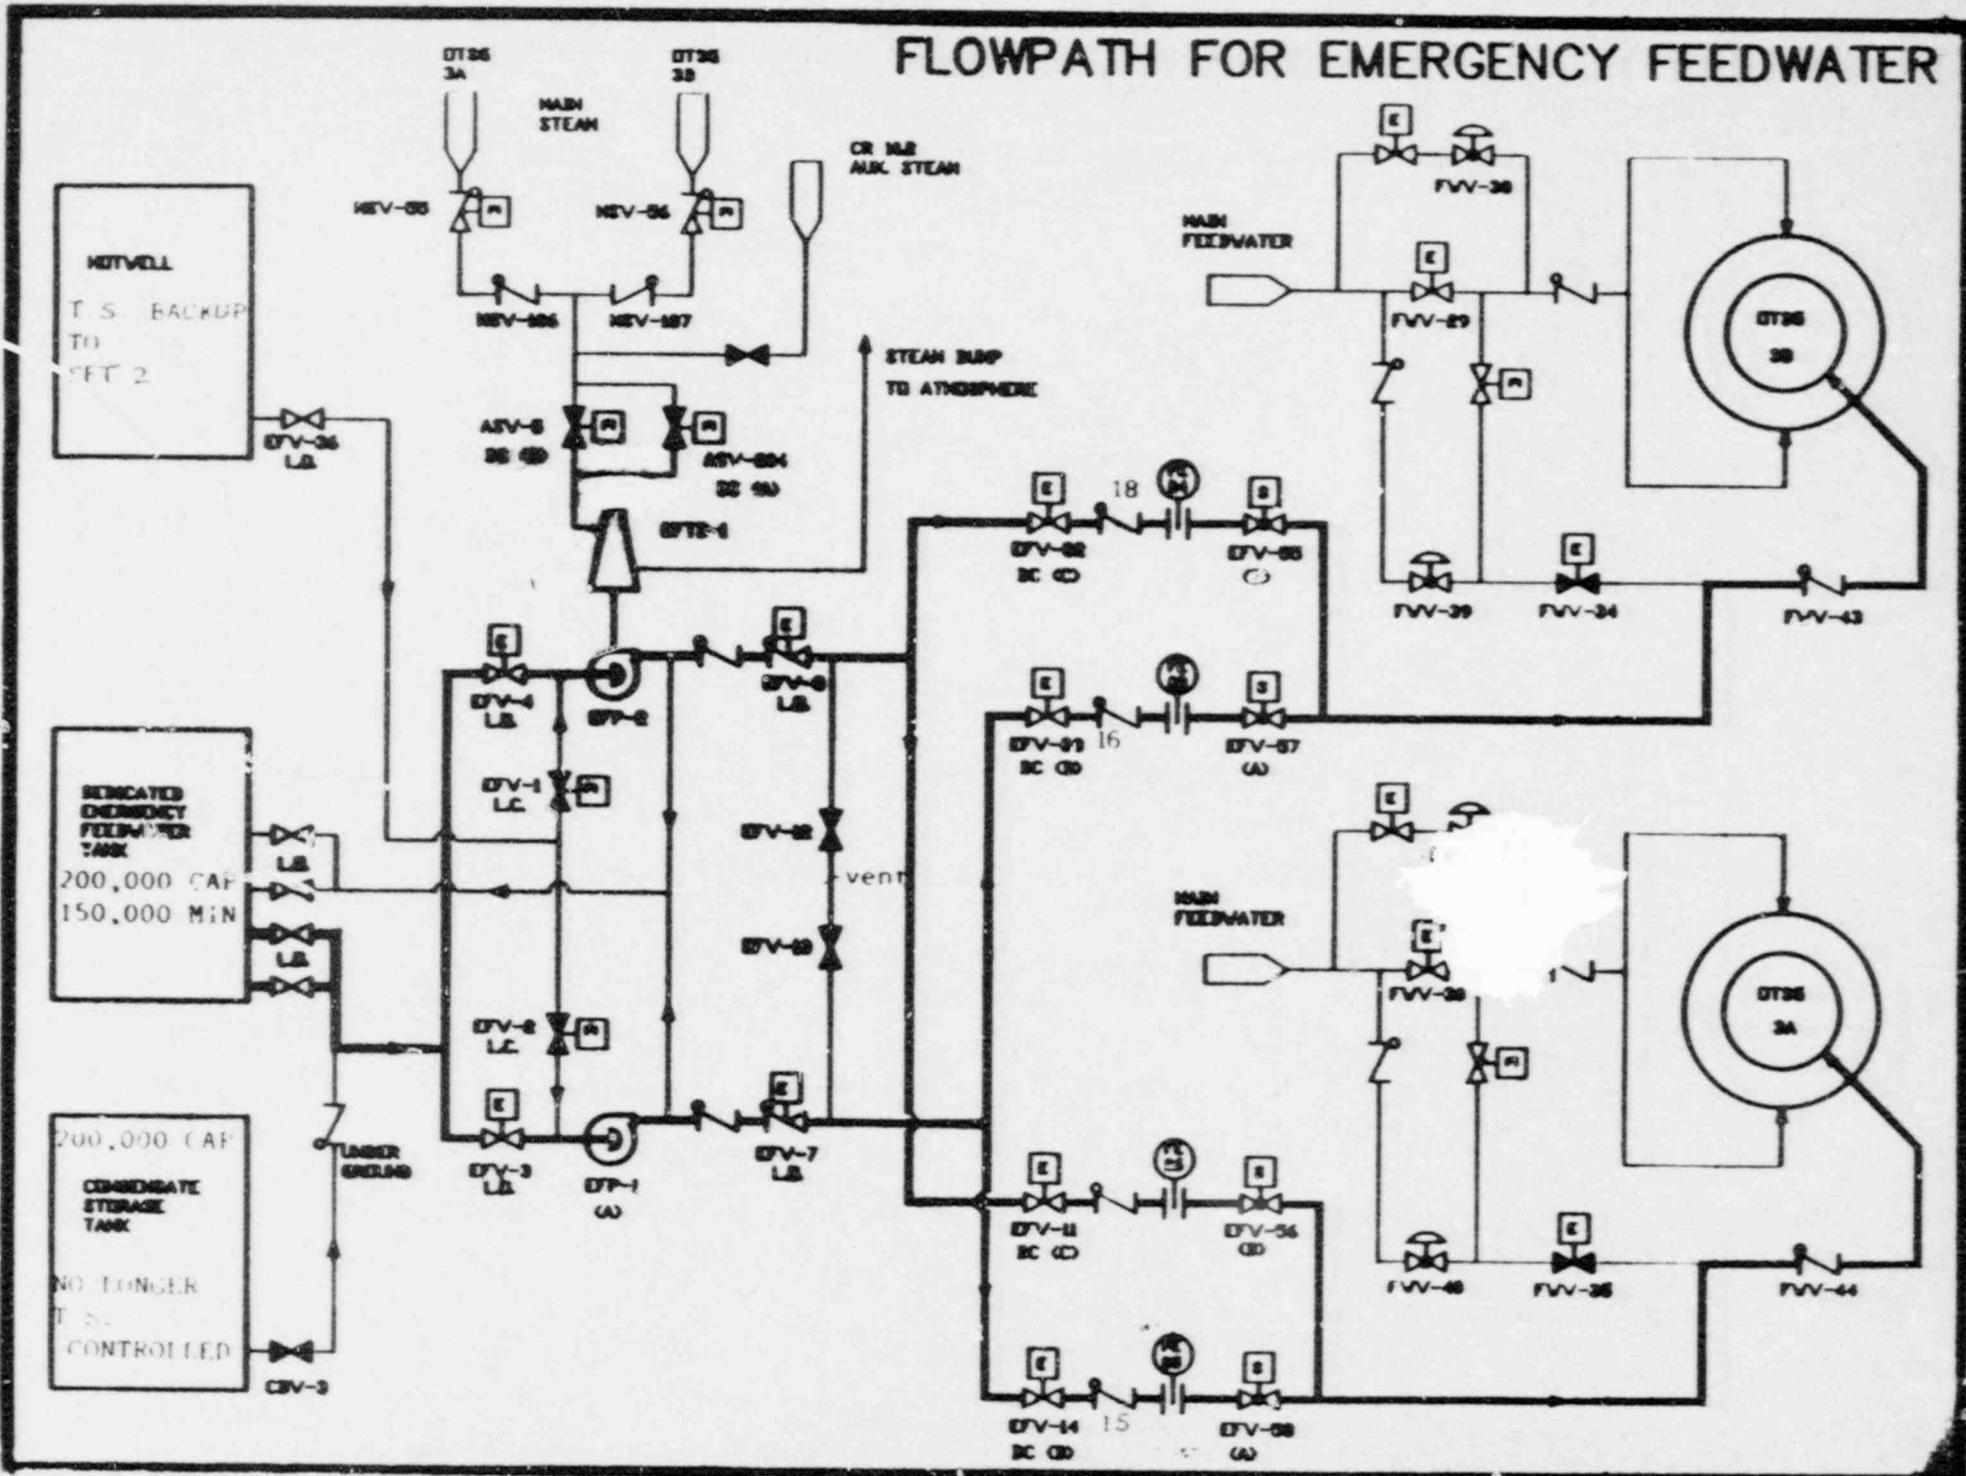
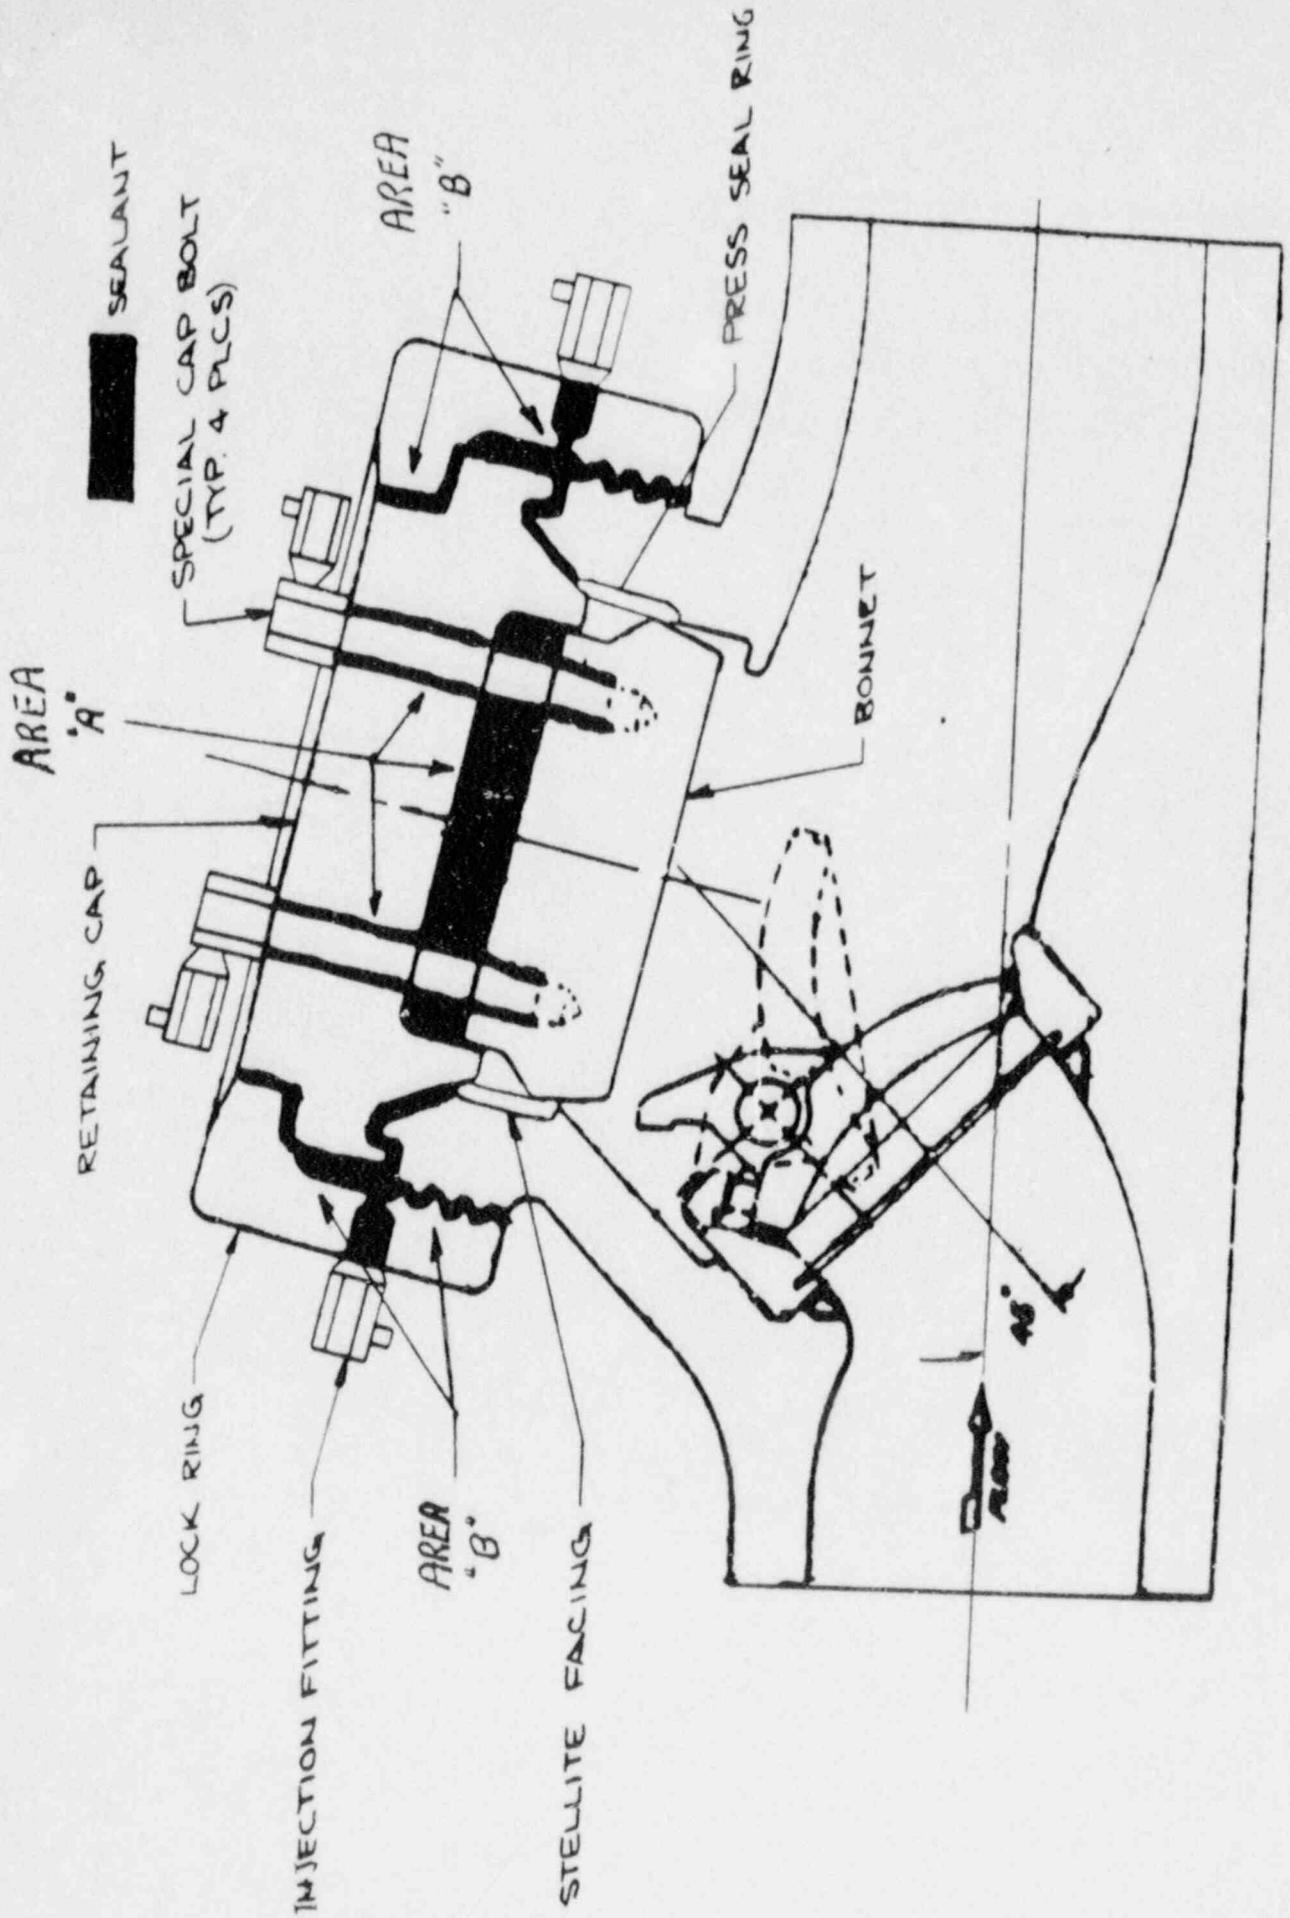
FLOWPATH FOR EMERGENCY FEEDWATER

During Refuel VI, several emergency feedwater (EFW) system valves underwent refurbishing. These efforts included the repair of EFV-33 and the inspection of EFV's 15, 16, 17, and 18 (see Attachment 1 flow schematic). Two (2) of these valves, EFV-18 and EFV-33, were identified as having body to bonnet leaks during Refuel VI startup activities on January 7, 1988. Efforts to secure the leaks were unsuccessful. The unit was returned to service on January 10, 1988.
