Florida Power

CORPORATION
Crystal River Unit 3
Docket No. 50-302

Subject: Crystal River 3 - Request For Additional Information on the Resolution of
Unresolved Safety Issue (USI) A-46 (Generic Letter 87-02)

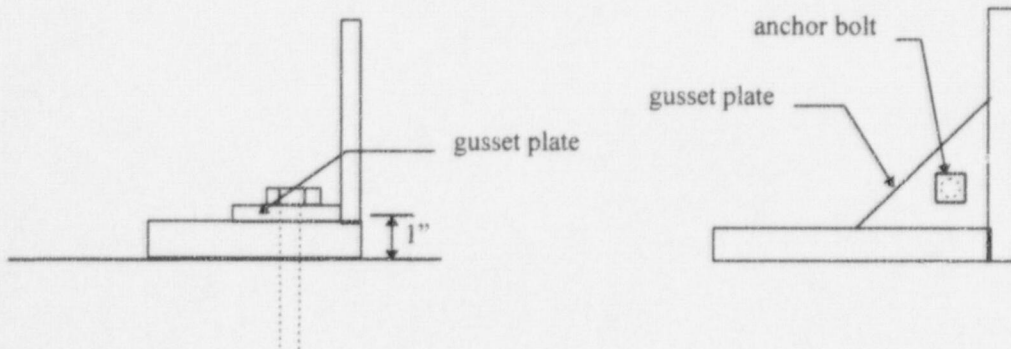
Checking for gap in accordance with Check 6 of the GIP was performed for all equipment with threaded anchors in the accessible areas around the equipment. This was performed in accordance with the PSP Section 4.4 which states: "SCEs should consider the anchorage attributes in Section 4.4.1 of the GIP (Reference 36), as they judge appropriate, in their evaluation of the specific anchorage, support, or load path." The result of this check is that a gap of 1 inch was found in seven distribution panels (Class 14). This gap is a standard detail for these distribution panels as the anchorage is through a triangular gusset plate 1 inch up from the bottom of the base.

Elevation View of Anchorage Load Path

Plan View of Anchorage Load Path
