Closeout of IE Bulletin 81-03: Flow Blockage of Cooling Water to Safety System Components by *Corbicula* sp. (Asiatic Clam) and *Mytilus* sp. (Mussel)

Prepared by J. H. Rains, W. J. Foley, A. Hennick

PARAMETER, Inc.

Prepared for
U.S. Nuclear Regulatory
Commission

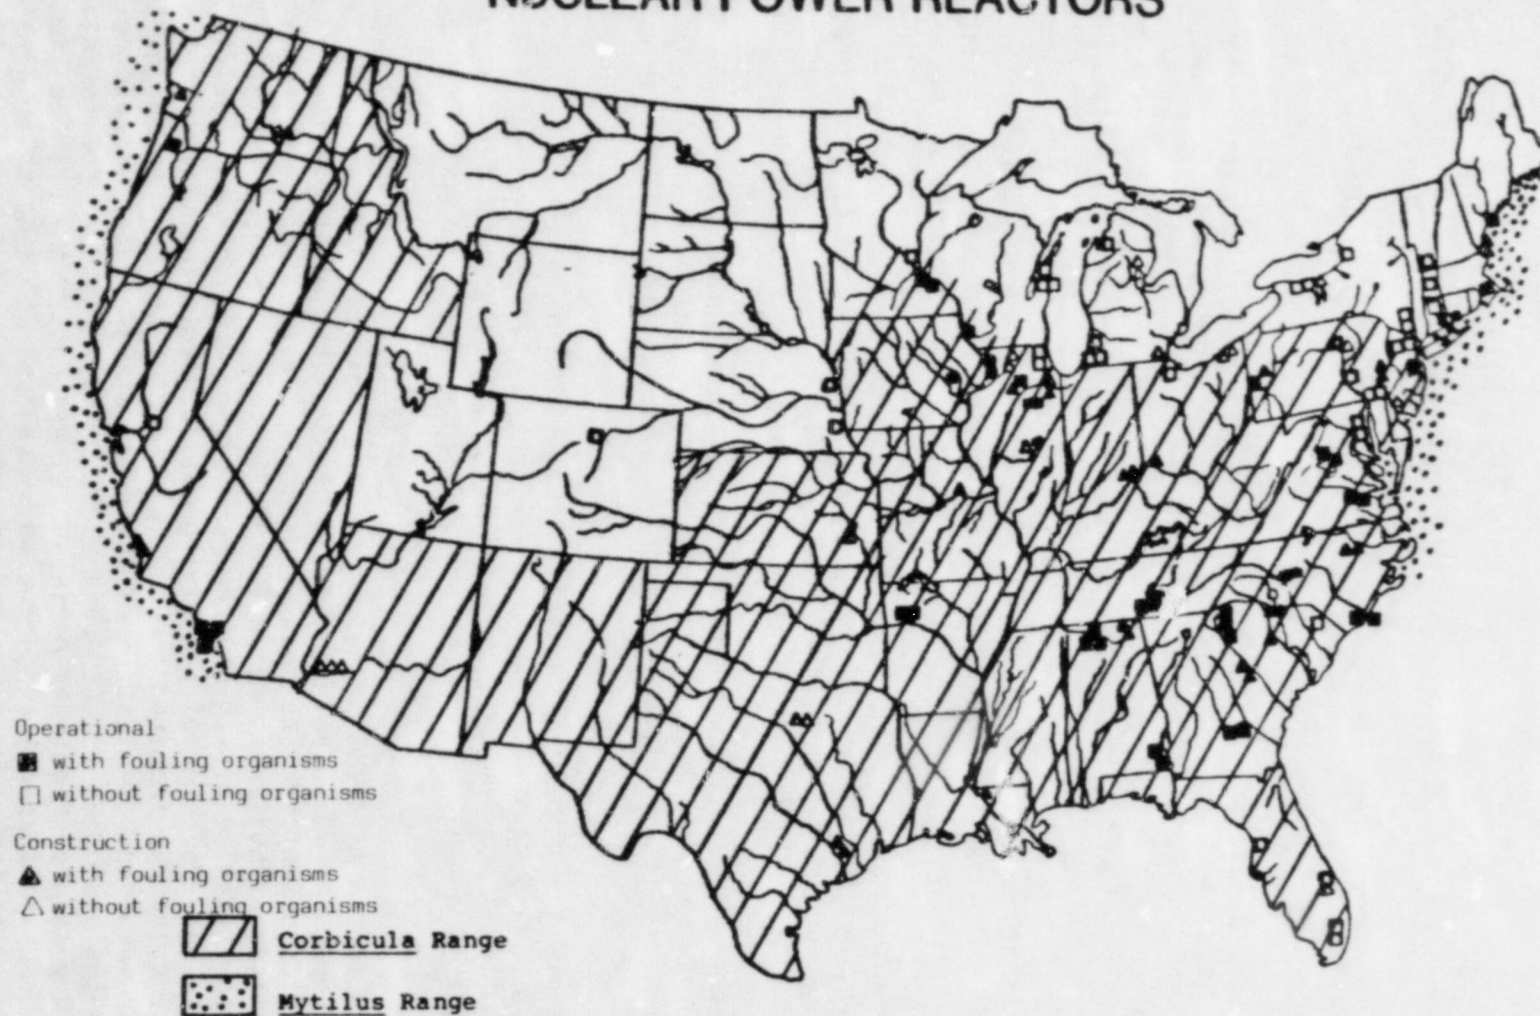
Figure A-1. *Corbicula* and *Mytilus* ranges and their relationship to nuclear power reactors in the United States 1983. Only facilities actively operating or under construction are shown.
