FAILURE MODE, EFFECTS, AND CRITICALITY ANALYSIS (FMECA)  
OF THE WEST VALLEY NUCLEAR SERVICES  
SUPERNATANT TREATMENT SYSTEM AND  
THE CEMENT SOLIDIFICATION SYSTEM

DECEMBER 1987

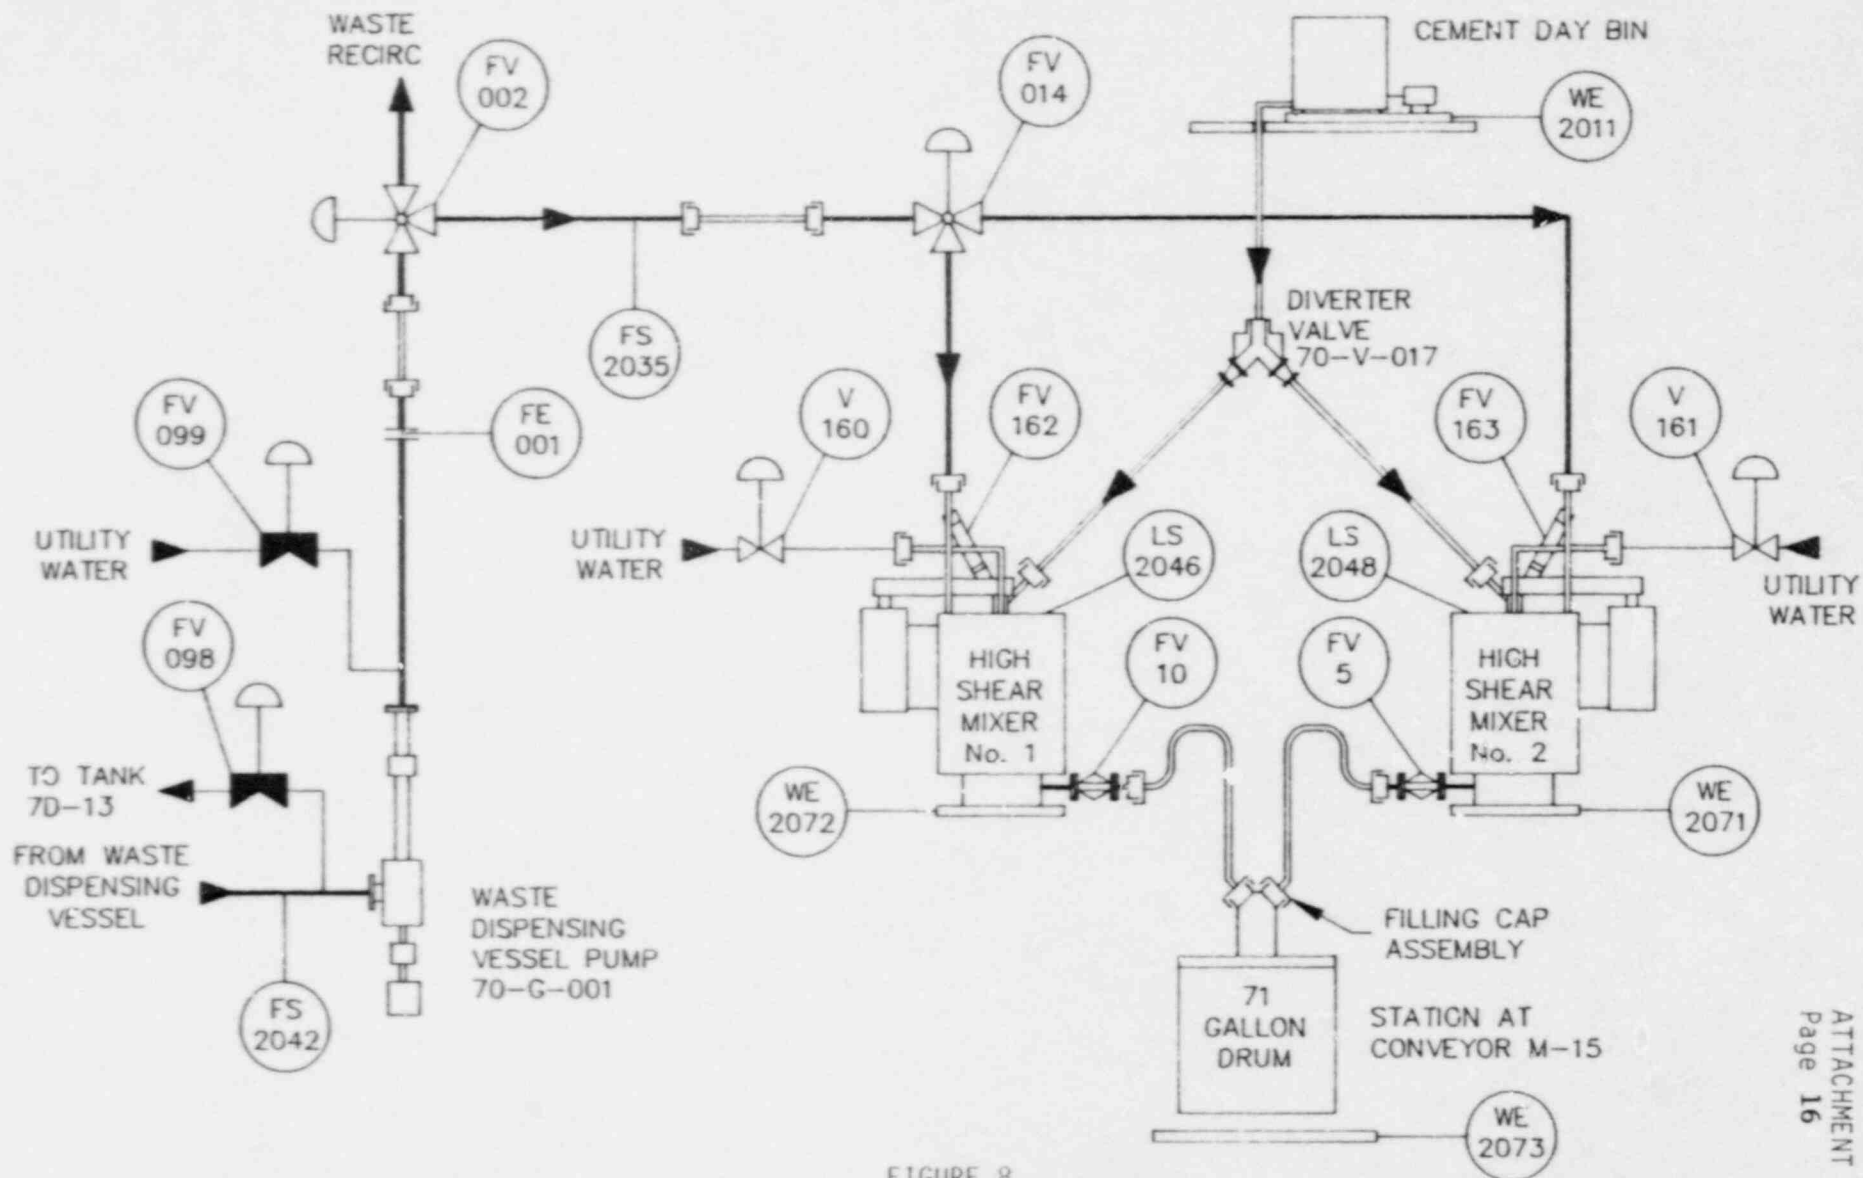
FIGURE 8

# CSS CEMENT SOLIDIFICATION SYSTEM

Figure 8 shows how the waste and cement is added to the mixers. The Cement Metering Subsystem consists of a cement day bin and feeder which dispenses metered amounts of dry cement into the High Shear Mixers via a diverter valve. The discharge rate is controlled based on the cement loss from the bin; as the cement feeds down into the mixer, the resulting decrease in weight is monitored by the control system.

The Cement Feed Diverter Valve alternately directs the cement into the two High Shear Mixers. The mixers provide the mechanical action to ensure adequate mixing of the waste slurry and cement. Additives can be introduced to adjust mixture setting time or the chemistry of the liquid wastes upstream of the mixers. Using the discharge head developed by a rotating blade in the mixer, the mixture batch (containing approximately 22 gallons of waste) is discharged through a special fill head and into a drum. Two mixer batches are placed into each drum. The fill head is designed to descend into the drum and seal the opening to prevent spillage of radioactive material. The fill head includes an internal vent that is normally vented to the process room. After each mixer completes its fill cycle, flush water is introduced into the mixer through spray nozzles which flush the top and side walls of the mixer to remove any residual material. This flush water becomes a part of the recipe for the next cycle and the process is repeated until the Waste Dispensing Vessel is emptied.

Figures 7 and 8 show the major CSS components addressed in the FMECA. The figures show all the equipment, valves, instruments and support systems evaluated. Section 7.1.2.1 is a discussion of the failure modes that resulted in Class 1 failures (major severity combined with a high relative probability of failure). Section 7.1.2.2 is a discussion of the failure modes that resulted in Class 2 failures. All failure modes are discussed in the
