Fermi 2

Annual Operating Report

March 20 - December 31, 1985

Detroit Edison Company

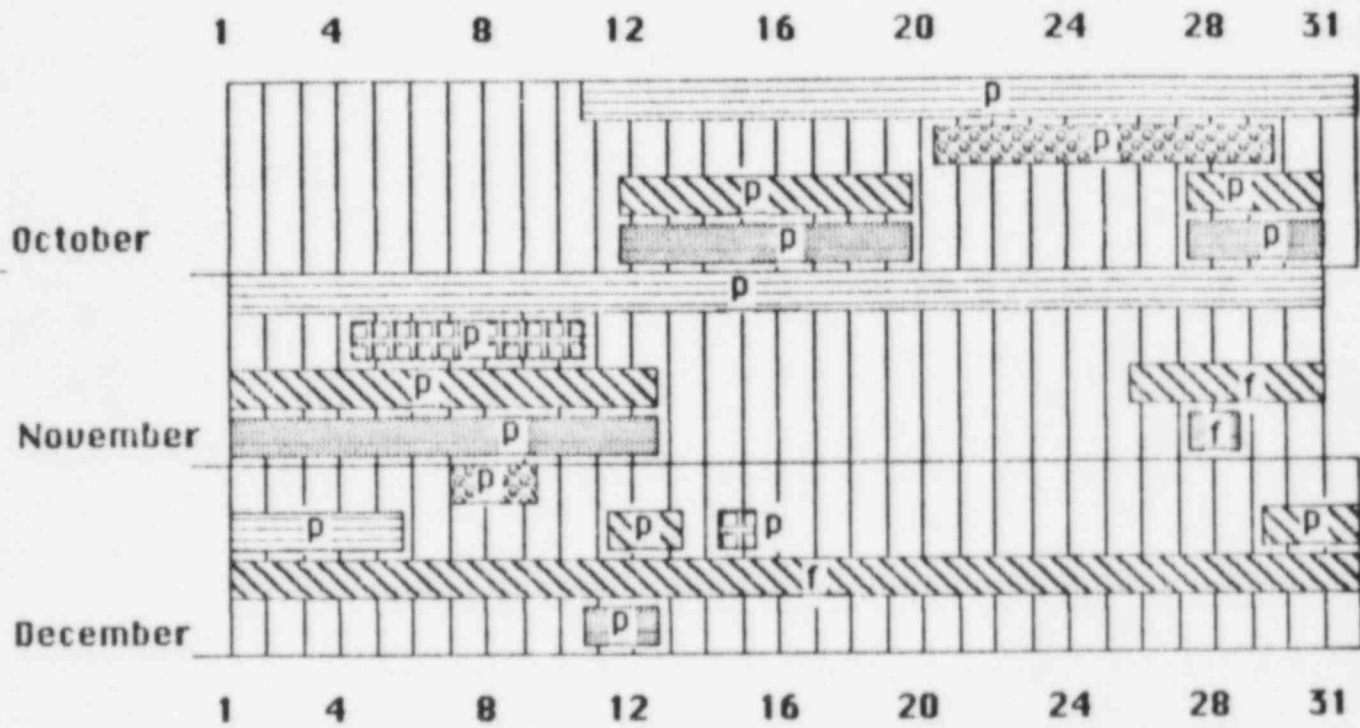
Fig. 2.7 - 1

### ECCS Outages

As shown in Figure 2.7-1, equipment failures which would have forced a system outage but were discovered during a planned outage have been reported as separate outages.
