NUREG-1232
Vol. 2

Safety Evaluation Report

on Tennessee Valley Authority:
Sequoyah Nuclear Performance Plan

**U.S. Nuclear Regulatory
Commission**

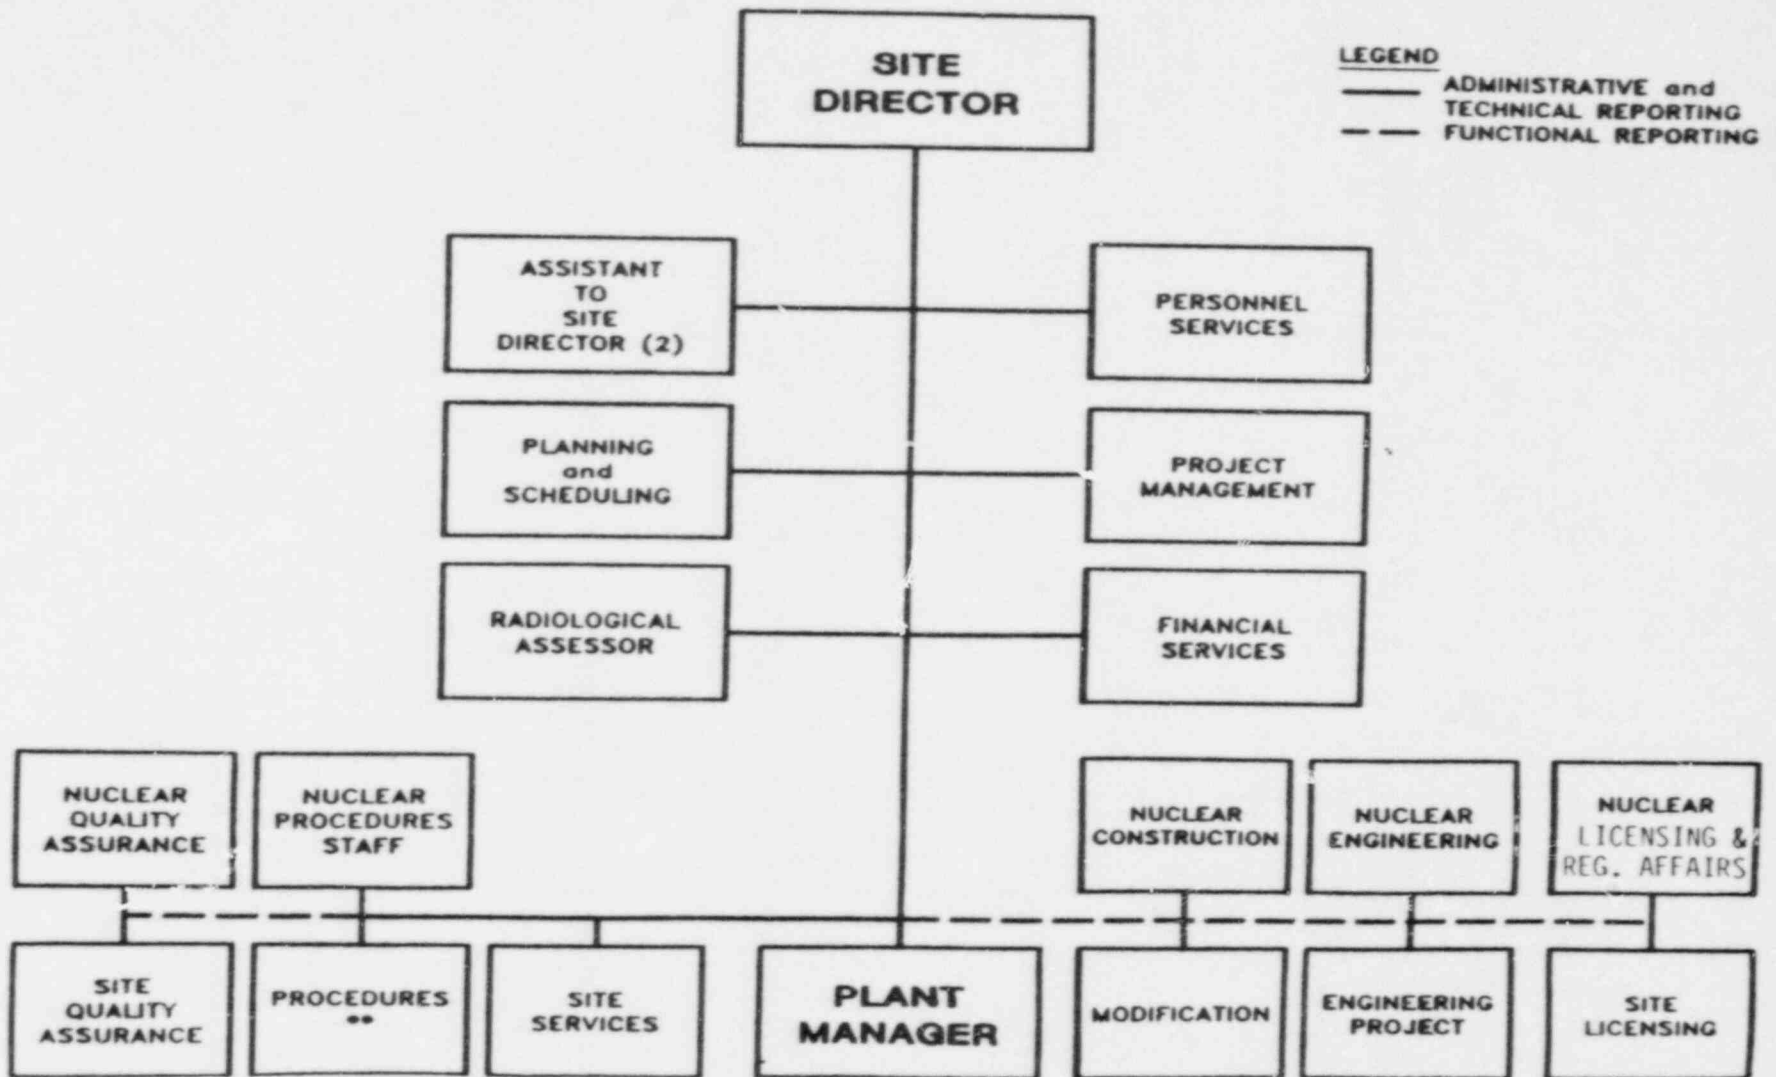
Figure 4.1 Sequoyah site organization

** Temporarily reports to Site Director; Long-term function will report to Site Services.

Sequoyah site organization is organized into functional departments that generally parallel the functional departments in TVA's headquarters Office of Nuclear Power. The functional alignment of the Office of Nuclear Power is discussed in the staff's SER of the Corporate Nuclear Performance Plan (NUREG-1232, Volume 1). In that SER, the staff stated that corporate functional area managers are responsible for the technical direction in each functional area at each of the nuclear sites. The Sequoyah site organization showing this functional alignment is presented in Figure 4.1. Each site functional department is responsible for a discrete type of function.

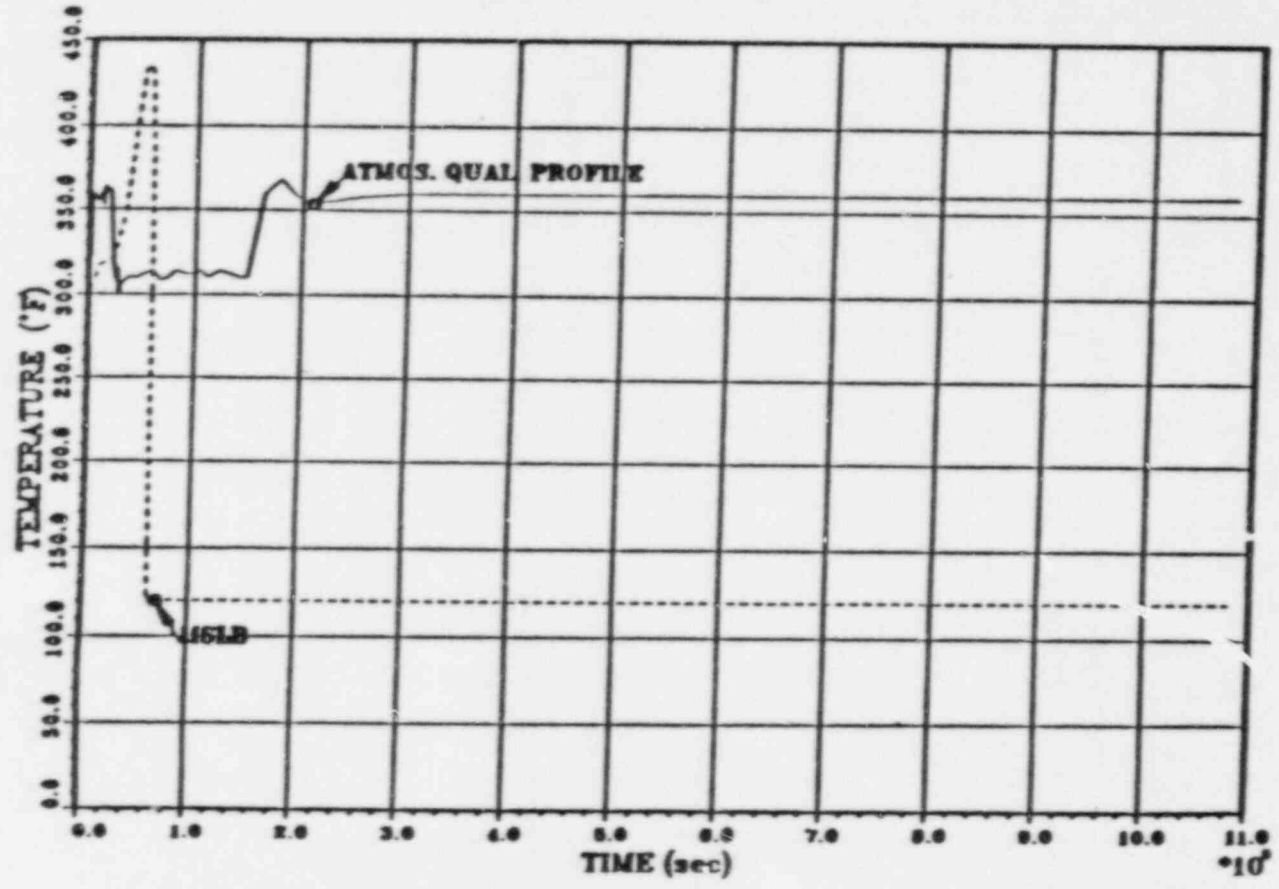
Figure 1. MSIV Solenoid EQ Test Chamber Temperature

MSIV SOLENOID EQ TEST CHAMBER TEMPERATURE

TVA also provided details of the guidelines used in constructing the heat transfer models. TVA's assumptions were made to conservatively increase the temperature predicted during a MSLB, while lowering the surface and internal temperatures resulting from analysis of EQ test chamber profiles. In this way, higher than expected surface and internal temperatures resulting from MSLBs are compared to lower than expected surface and internal temperatures derived from the qualification tests, thereby adding conservatism. The values of heat transfer coefficients used for the MSLB analyses were provided along with schematics of the models used. The Licensee concluded that qualification of the MSIV devices was established for each component by comparison of the calculated thermal response during a MSLB to the calculated response during qualification testing. The qualification for steam and moisture exposure is based wholly upon the existing qualification test results. The review of the existing qualification test results was not within the scope of this evaluation. The results of the existing qualification tests have been assumed to be acceptable during this evaluation. A sample of Licensee-supplied temperature profiles is included as Figures 1 through 3. Figure 1 represents the EQ temperature profile of a MSIV solenoid versus the MSLB temperature profile. Figure 2 is a plot of the calculated MSIV solenoid surface temperature during the MSLB. Figure 3 represents the calculated internal coil temperature during a MSLB as compared to the EQ test temperature.
