RELATED CORRESPONDENCE

Re: In the Matter of Commonwealth Edison Company
(Braidwood Station, Units 1 and 2)
Docket Numbers 50-456 and 50-457 *OC*

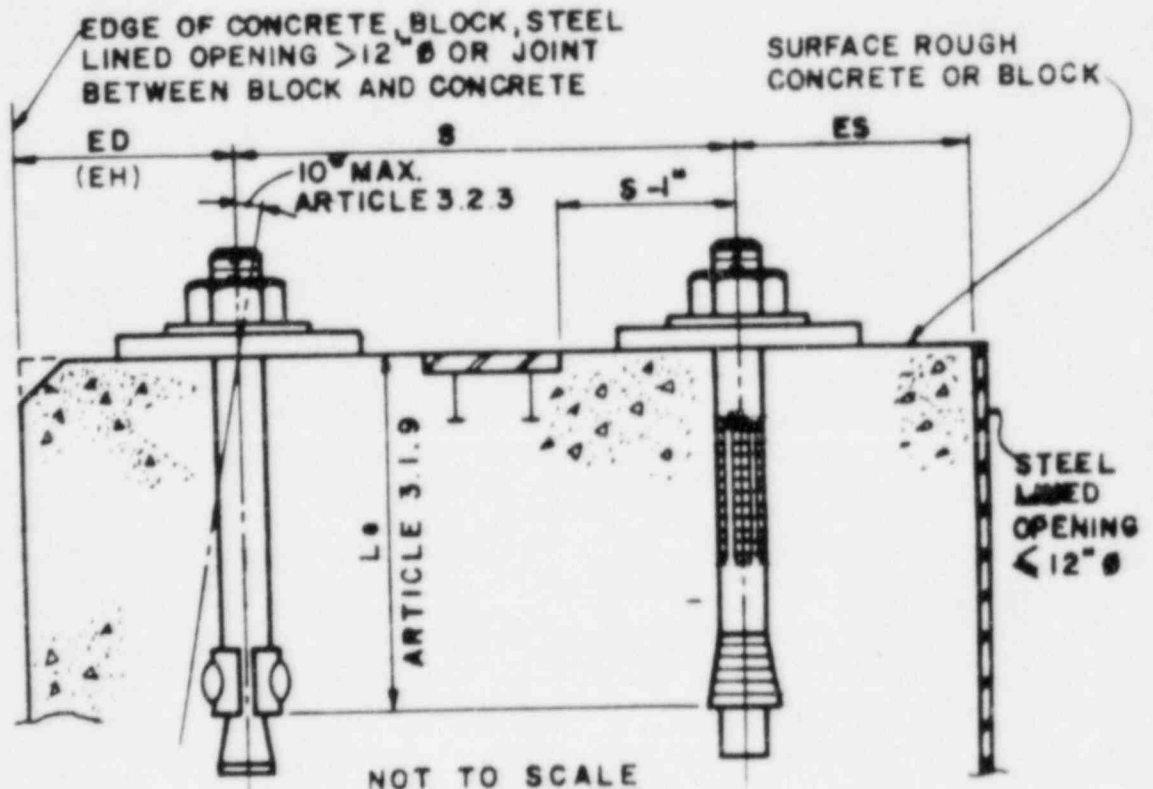
Figure 38-6

Nominal Bolt Diameter (inch)	Minimum Embedded Length* (inches) (L _e)	Minimum Spacing (inches) (S)	Minimum Edge Distance (inches)	
			(ED)	(ES)
1/4	5/8	2.5	3.25	1.75
3/8	3	4.5	5	2.5
1/2	4	6	7	3.5
5/8	5	7.5	8.5	4.25
3/4	6	9	10	5
1	8	12	13	6.5

*Minus 1/16" tolerance is allowed.

The Standard Specification for Concrete Expansion Anchor Work, Form BY/BR/CEA, provides the installation and inspection requirements for concrete expansion anchors. Within this document is Figure 38-6, copy attached, which shows the embedded length (L_e) measured from the surface of the concrete to the bottom of the expansion ring. The qualification report for concrete expansion anchors is entitled, "Report on Static, Dynamic and Relaxation Testing of Expansion Anchors in Response to NRC IE Bulletin 79-02", dated July 20, 1981. We extracted two pages from Chapter III of this report, copy attached, which show the embedded length (l_{eb}) measured from the surface of the concrete to the bottom of the expansion ring. This consistently defines the embedded length.
