Subject: Summary of Meeting on Selected Potential Restart Impact Issues

A meeting was held in the Region I office at Philadelphia Electric Company's (PECo) request on September 7, 1988. The licensee presented information on selected potential restart impact engineering issues. Attachment 1 is the attendance list and the agenda is provided as Attachment 2.

<u>Attachment</u>	<u>Subject</u>
3	Introduction
4	Control Panel Mounting
5	Open Commitments and Findings
6	Limiterque Operation at Reduced Voltage
7	Hanger Walkdown
8	Splice Inspections
9	Diesel Generator Control Circuit Modification (Cardox Interface)

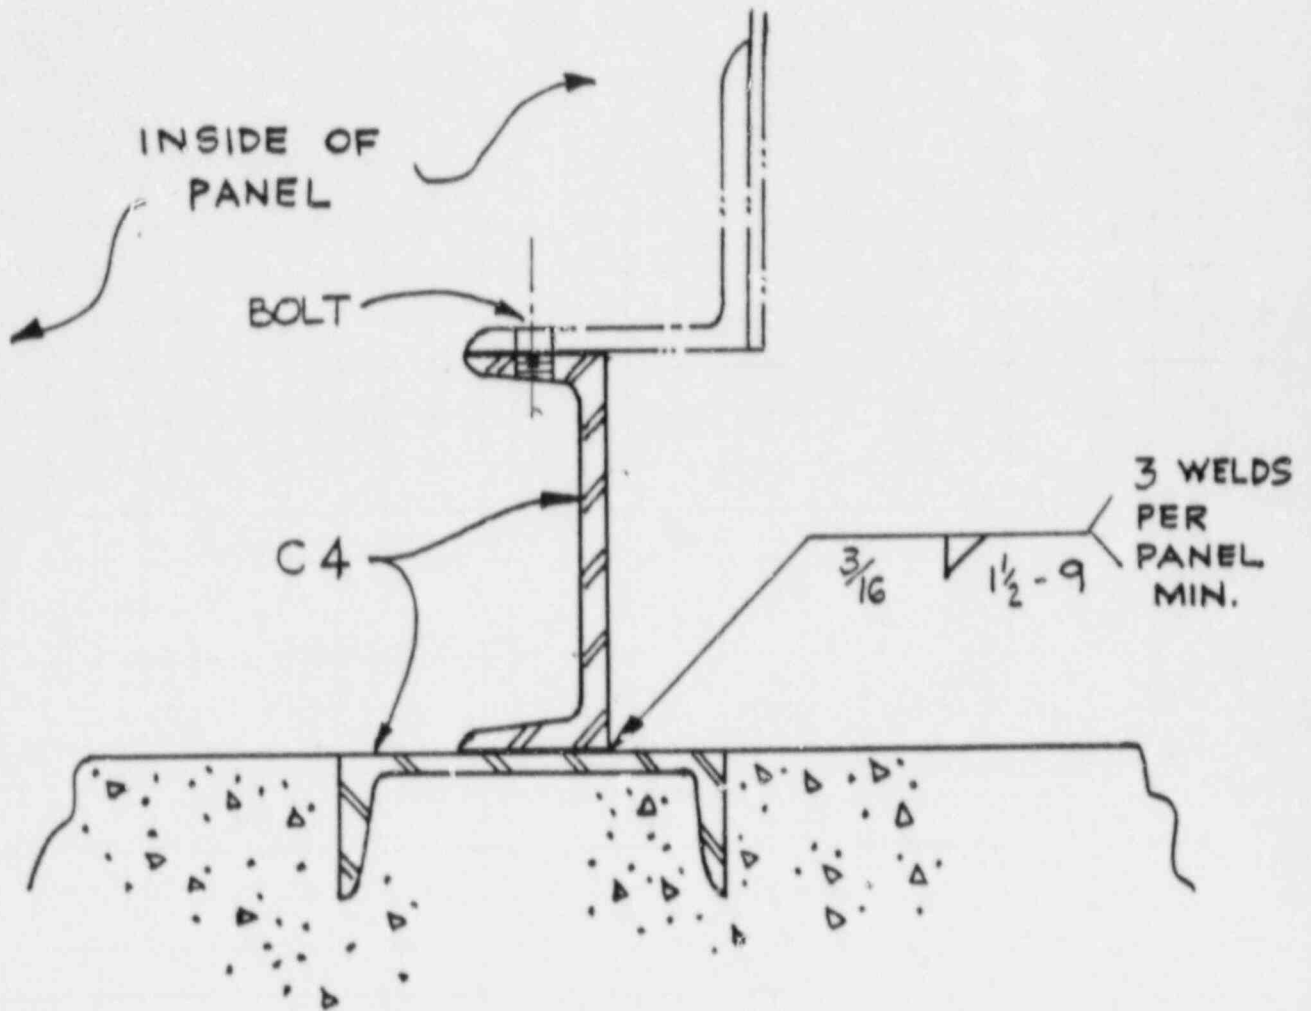
- INVESTIGATION & MODIFICATION
OF CONTROL PANEL ANCHORAGE

- ADDRESSED PANELS IN MAIN
CONTROL ROOM AND
OUTSIDE CONTROL ROOM

TYPICAL CONTROL PANEL
ANCHORAGE DETAIL

- ALL CONTROL PANELS IN THE CONTROL ROOM, CABLE SPREADING ROOM, AND S/R PANELS IN THE BALANCE OF THE PLANT HAVE BEEN EVALUATED & MODIFIED AS NECESSARY.
- WORK PERFORMED ON SCHEDULE WITH NO DEFECTS.
