WNP-2 ANNUAL OPERATING REPORT 1987

WASHINGTON PUBLIC POWER
SUPPLY SYSTEM

ANNUAL OPERATING REPORT
OF
WNP-2
FOR 1987

DOCKET NO. 50-397
FACILITY OPERATING LICENSE NO. NPF-21

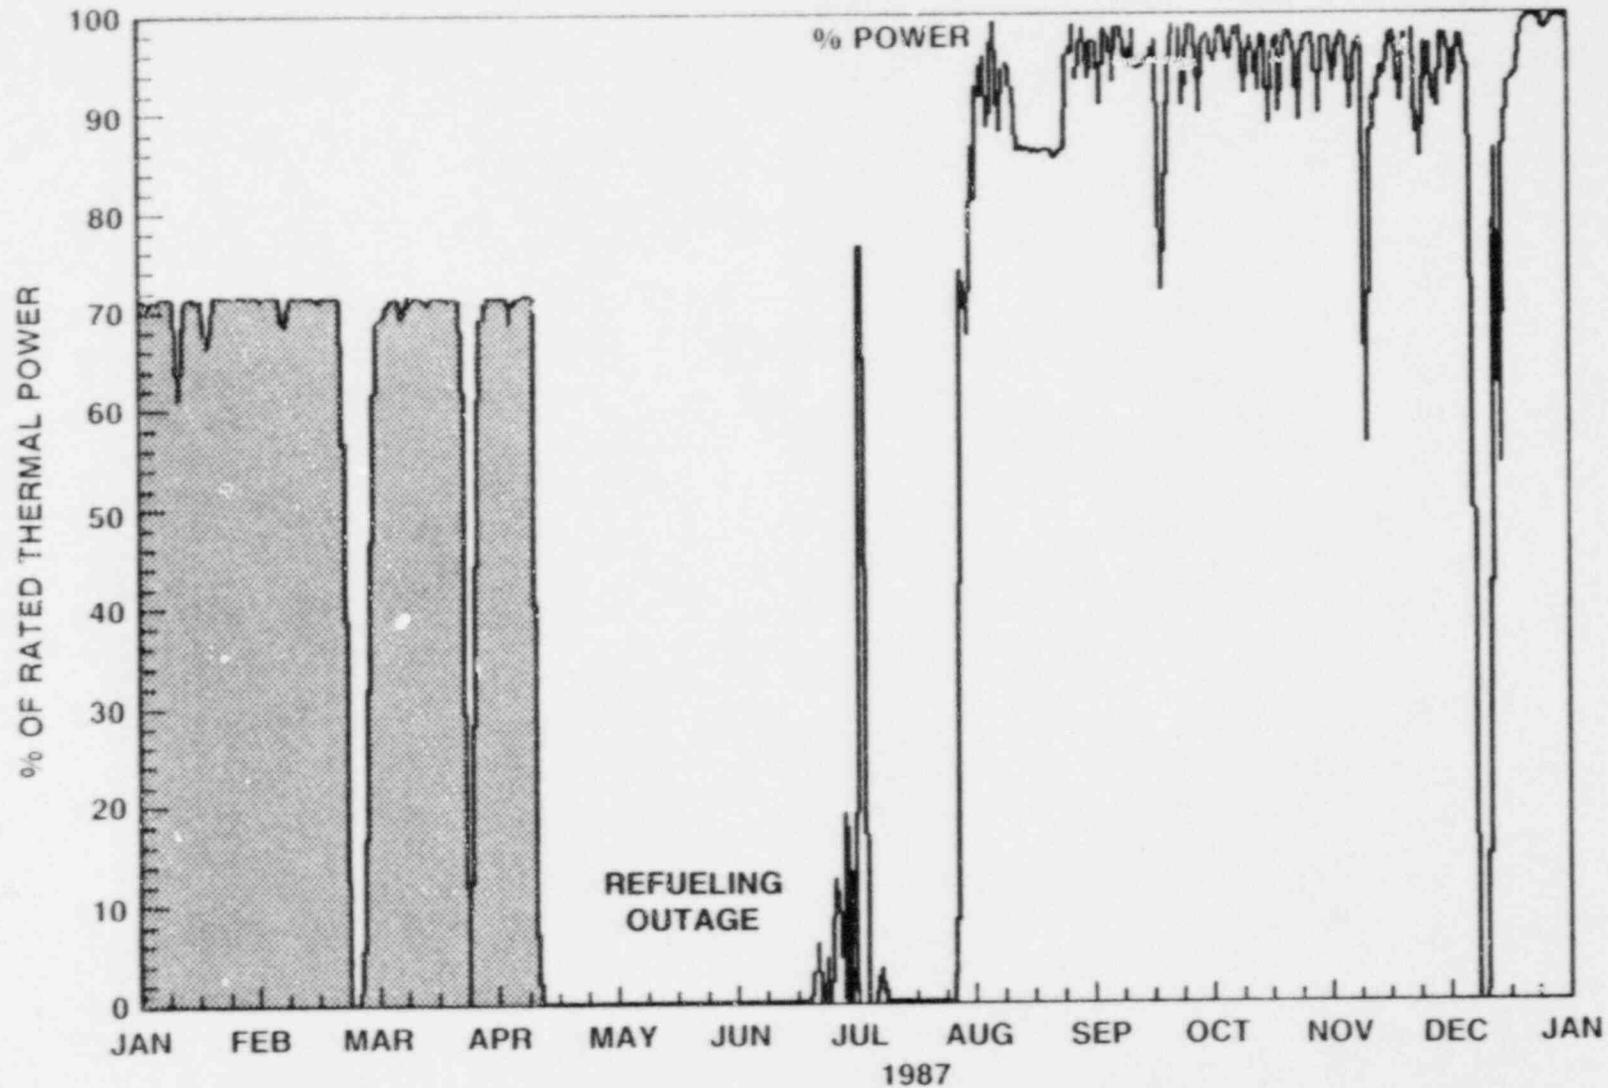
WNP-2 1987 POWER HISTORY

- * Started Maintenance/Refueling Outage
 ** Ended Maintenance/Refueling Outage
 *** Single Loop Operation

□ MAXIMUM POWER OUTPUT LIMITED TO APPROXIMATELY 72% BASED ON SINGLE LOOP OPERATION
DATA BASED ON AVERAGE POWER GENERATED PER DAY. THEREFORE, RECOVERY FROM A SCRAM
THAT OCCURRED WITHIN A 24 HOUR PERIOD WILL NOT INDICATE A ZERO PERCENT POWER LEVEL.

During the first part of 1987 (January-April), the plant continued single-loop operation due to the higher-than-acceptable vibrations experienced on Reactor Recirculation Pump "A". As a result of single-loop operations, power output was limited to 72 percent for that time frame.

On April 10, 1987, the plant was shut down for the annual maintenance and refueling outage. In late June-early July, after the outage, the plant experienced five unplanned automatic shutdowns (scrams) within a two-week period. As a result of those scrams, Supply System management directed that the plant remain shut down pending a thorough review of plant operations. It was concluded from the review that the five scrams were caused by a series of unrelated mechanical and electrical failures that, for the most part, could not have been anticipated.

On July 26, 1987, the plant was restarted and operated for a record 133 consecutive days until December 6, when it was shut down for a scheduled three-day maintenance outage to repair an inoperable flow control valve in the Condensate Filter/Demineralizer System. The inoperable valve had made it necessary to reduce power to 85 percent every four to five days to backwash and precoat the remaining filter demineralizers. Since starting up on July 26, until the planned shutdown on December 6, the plant operated at an average of 91 percent of its capacity. On December 10, the plant was restarted and ran at or near 100 percent capacity for the remainder of the year.

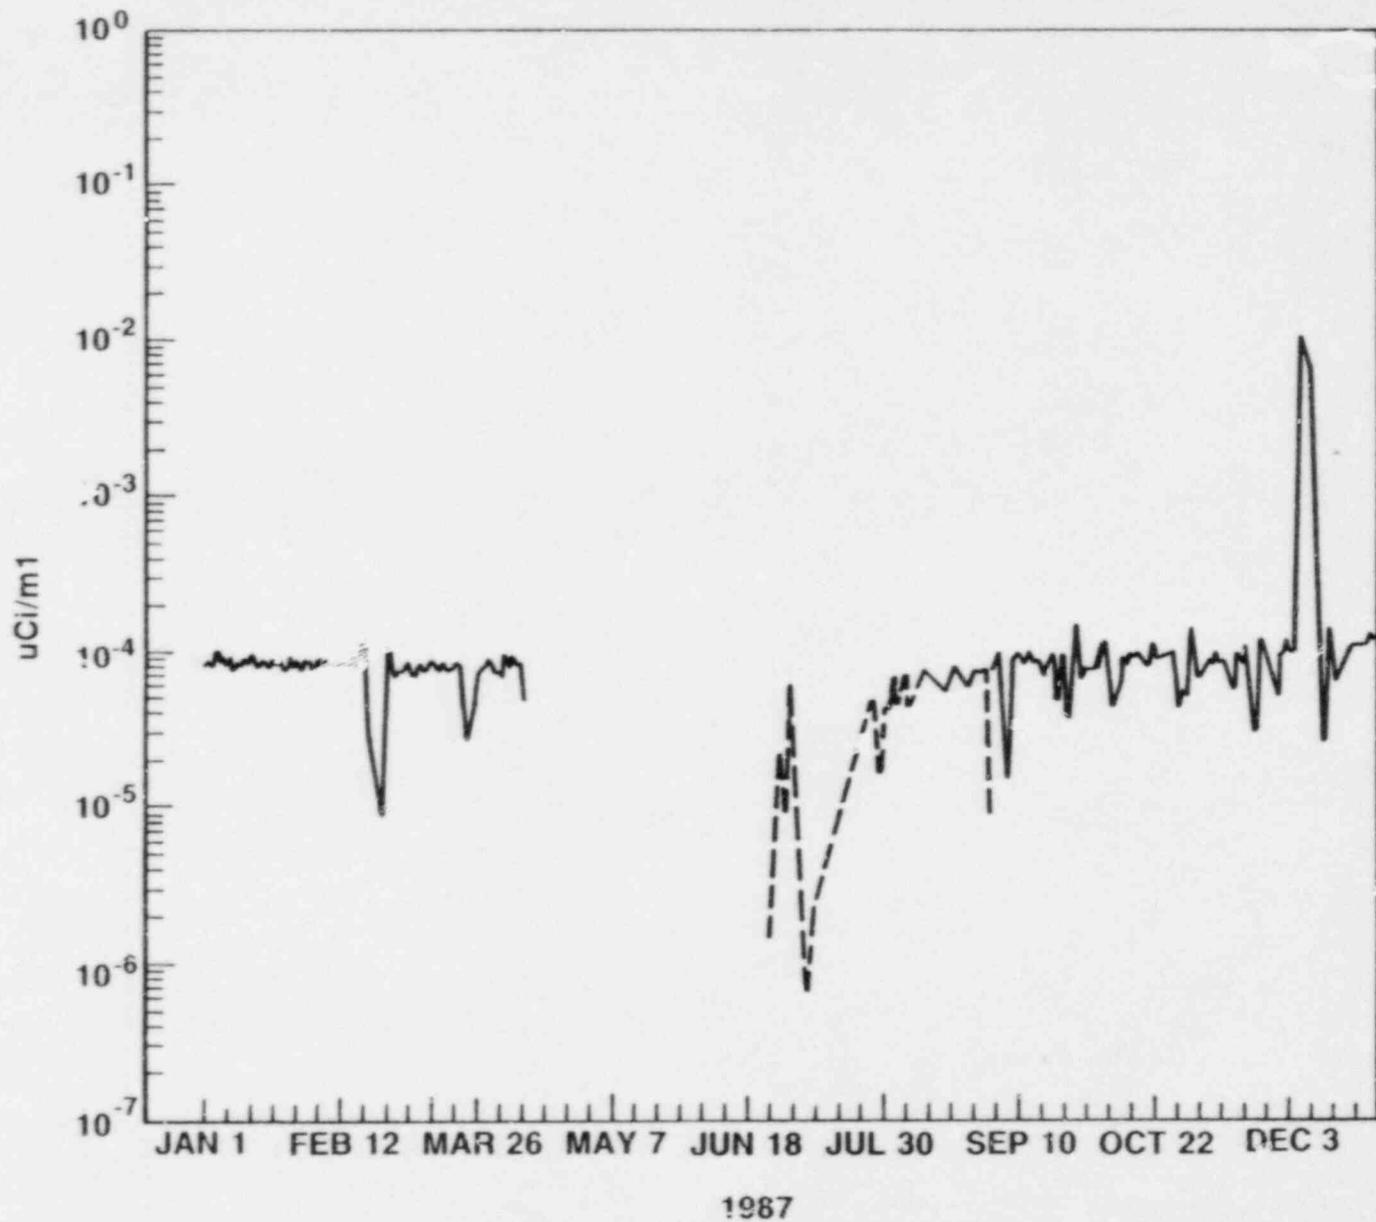
WNP-2 DOSE EQUIVALENT IODINE

A graph showing cumulative iodine dose equivalent for the calendar year 1987 is provided for reference and completeness. This information is provided in accordance with WNP-2 Technical Specifications.

— I2DEQ PRI 8
- - - I2DEQ PRI 1

In November, indications of a probable pinhole leak in a single fuel pin were noted. The indications were noted during cycle 3 operation, approximately three days following completion of a control rod sequence exchange, when Off-gas System post-treatment radiation monitor levels began rising. The increase was confirmed by chemical analysis. During a subsequent sequence exchange, selected rod movements were performed in conjunction with on-line pretreatment sample gamma spectroscopy analysis to attempt to isolate the location of the leak. Although initial results appear promising, further testing is planned in conjunction with the next sequence exchange (scheduled for mid-April, 1988) to further isolate/confirm the location of the leak. The current plan is to perform fuel sipping during the upcoming refueling outage (R-3) to identify the leaker and remove it from the core. It should be noted that, to date, no further increases which would indicate more leaking fuel pins have been noted.
