Crack Growth Rate and Fracture Toughness Tests on Irradiated Ex-Plant Materials

Nuclear Science and Engineering Division

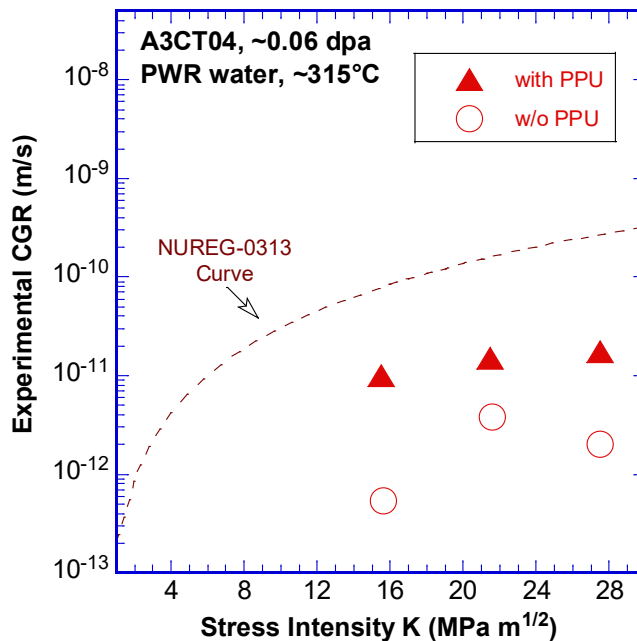
Figure 6 shows the SCC CGRs measured at three K levels with and without PPU. A disposition curve (NUREG-0313) previously developed with the data of unirradiated, sensitized SSs in high-DO environments is also included in the figure [16]. The sudden jumps in crack length are not accounted for in SCC CGRs since they are not a sustainable cracking behavior in this sample. The possible mechanisms for such a cracking instability will be discussed later. As shown in

Figure 6, all SCC CGRs are below the NUREG-0313 disposition curve, suggesting good SCC resistance for this sample in the test environment. The CGRs measured with PPU are higher than those measured without PPU. For the data with PPU, a weak K dependence can be seen between 16 and 21 MPa m^{1/2}. Without PPU, the CGRs are too low to be determined confidently. A much longer test time would be required for such slow CGRs in the test environment. Nonetheless, the good SCC property is evident for the decommissioned Zorita baffle plate material at this low dose level.

Figure 6. SCC CGRs of Specimen A3CT04 (~0.06 dpa) tested in PWR water

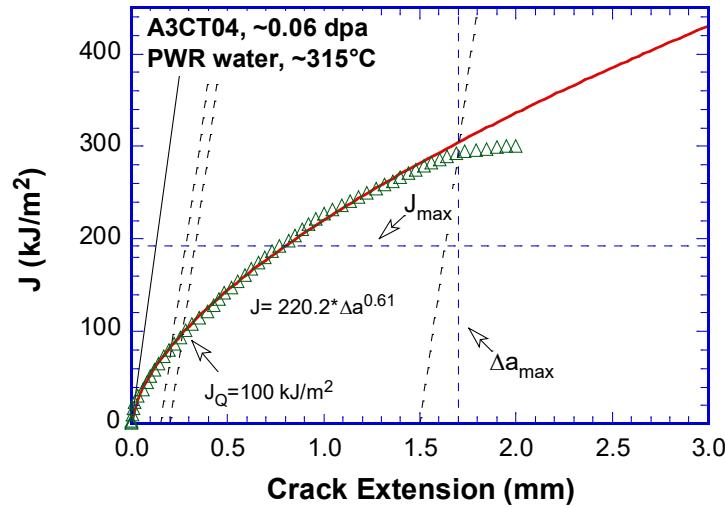
After the CGR test, a fracture toughness J-R curve test was performed on the sample in the test environment. The test was performed at $\sim 315^\circ\text{C}$ with a constant displacement rate about 0.08 mm/min. The ratio of a/W for the starter crack was about 0.57. Figure 7 shows the obtained J-R curve. The maximum J and Δa values can be determined with this sample are also included in the figure. A power law relationship $J = 220 \times \Delta a^{0.61}$ is obtained with the J-versus- Δa data, and the J_Q value at the 0.02-mm offset line is about 100 kJ/m², lower than those of typical unirradiated or low-dose SSs. Note that a flow stress of 375 MPa was assumed for this sample in the J-R curve analysis. This low flow stress leads to a low J_{\max} for such a small sample, and the data points above J_{\max} have to be included in the curve fitting. The curvature of the final crack front is also too high. Consequently, the J_Q value obtained from this sample cannot be validated for a J_{1C} per the ASTM E1820-15 [11]. Nonetheless, the obtained J-R curve has a high power exponent (~ 0.6), similar to those observed in unirradiated SSs.

Figure 7. J-R curve of Specimen A3CT04 (~ 0.06 dpa) tested at $\sim 315^\circ\text{C}$

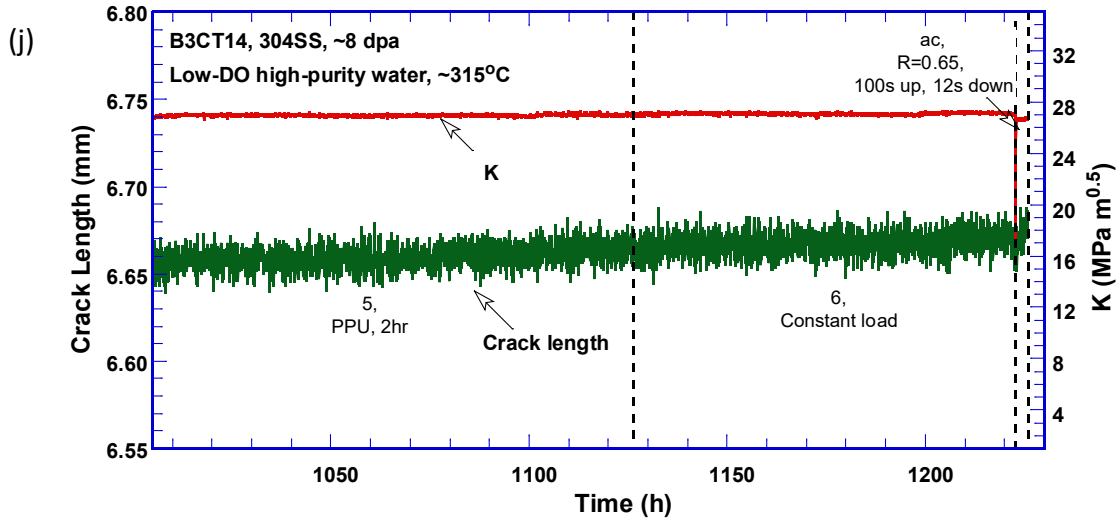
The test started with cyclic loading at a K_{\max} of ~12.7 MPa m^{1/2} and a load ratio of 0.32 and 0.5 Hz. Figure 13 shows the time history plots for the crack length and applied K for this test. No significant crack advance was observed in this sample until the K_{\max} increased to ~15.8 MPa m^{1/2}. A cyclic CGR comparable to that of fatigue growth rate in air was obtained after ~330 μm crack extension. As the rise time and load ratio increased, the measured CGRs declined as expected, but quickly fell below the fatigue line when the load ratio was close to 0.5. After the crack was re-activated with a K_{\max} of ~16.4 MPa m^{1/2}, environmentally enhanced cracking started to appear in this sample with a load ratio below 0.45. Figure 14 shows the cyclic CGRs as a function of fatigue growth rate in air under the same loading conditions. After the environmental enhancement was stabilized, the test was set to a constant K with PPU every 2 hours. A SCC CGR of 2.4×10^{-11} m/s was recorded over ~100 hours. After the PPU was removed, the measured CGR decreased to about 1.5×10^{-11} m/s.

Next, the crack was advanced under cyclic loading with a K_{\max} of ~21.3 MPa m^{1/2}. The degree of environmental enhancement remained the same as in Figure 14. After about 146 μm crack extension, the test was set again to a constant K with PPU every 2 hours. A SCC CGR of 2.9×10^{-11} m/s was obtained over ~110 hours. After the PPU was removed, the CGR decreased slightly to 1.9×10^{-11} m/s. Immediately after the constant-K test, a cyclic load test period was performed with a K_{\max} of ~21.5 MPa m^{1/2}. In contrast to the cracking instability in the 0.06-dpa sample, no jump in crack length was observed in this sample (see Figure 13h). This confirms that no unbroken ligament developed during the constant-K test period.

The crack was advanced once again with cyclic loading at a K_{\max} of ~26.5 MPa m^{1/2}. No stepwise increase in crack length was observed with the increase in K_{\max} . The environmentally enhanced cracking remained stable, and the degree of the enhancement was about the same as that observed at the lower K_{\max} levels (see Figure 14). After ~200 μm crack extension, the sample was once again set to a constant K with PPU. A SCC CGR of 1.7×10^{-11} m/s was measured over 120 hours. After the PPU was removed, the CGR dropped to 1.3×10^{-11} m/s. Before the CGR test was terminated, a brief cyclic test period was also conducted with a K_{\max} of ~26.7 MPa m^{1/2}. Again, no stepwise increase in crack length was observed (see Figure 13i). All test conditions and CGR results from this sample are summarized in Table 4.

Figure 13. Crack-length-vs.-time plot of Specimen B3CT14 (~8 dpa) tested in low-DO high-purity water: test periods (a) a–c, (b) d–f, (c) g–i, (d) k–n, (e) o–q, (f) 1–2, (g) r–v, (h) x–ab, and (i) 5–6

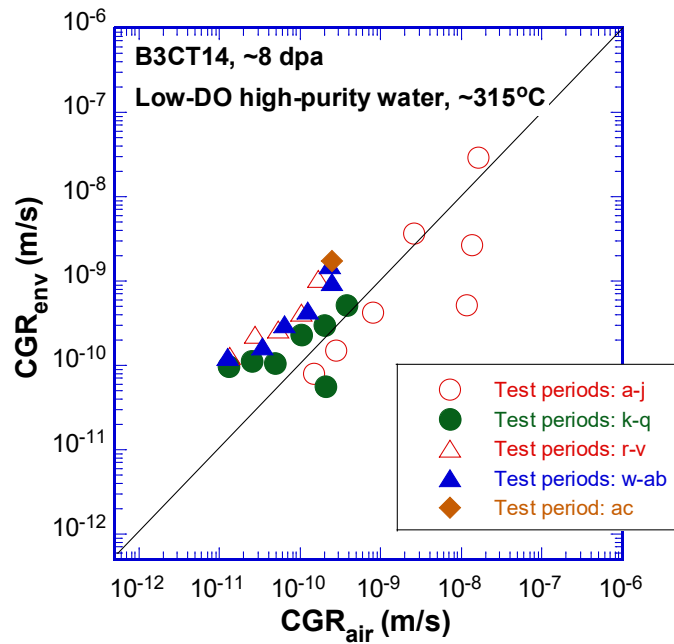
The cyclic CGRs are plotted in Figure 14 as a function of fatigue growth rate in air. Compared with the 0.06-dpa sample, the cracking seems more difficult to initiate in this 8-dpa specimen. The crack growth stalled several times during the cyclic test, resulting in several data points below the diagonal line in Figure 14. Environmental enhancement was also more difficult to establish in this sample. Once started, however, the degree of enhancement remained stable.

Figure 14. Cyclic CGRs of Specimen B3CT14 (~8 dpa) tested in low-DO, high-purity water

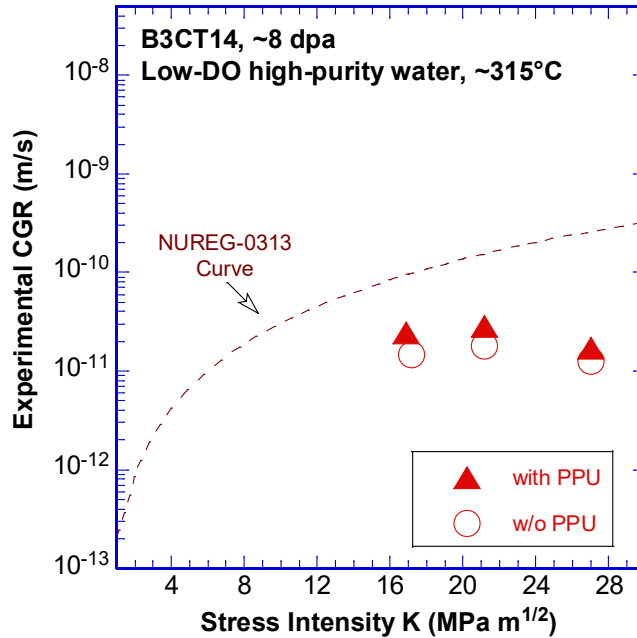
All SCC CGRs of this sample are below the NUREG-0313 curve, as shown in Figure 15. Although the CGRs with PPU are similar to those of the 0.06-dpa sample, the CGRs without PPU are slightly higher. No K dependence can be seen between 17 and 27 MPa m^{1/2} in this sample.

Figure 15. SCC CGRs of Specimen B3CT14 (~8 dpa) tested in low-DO, high-purity water

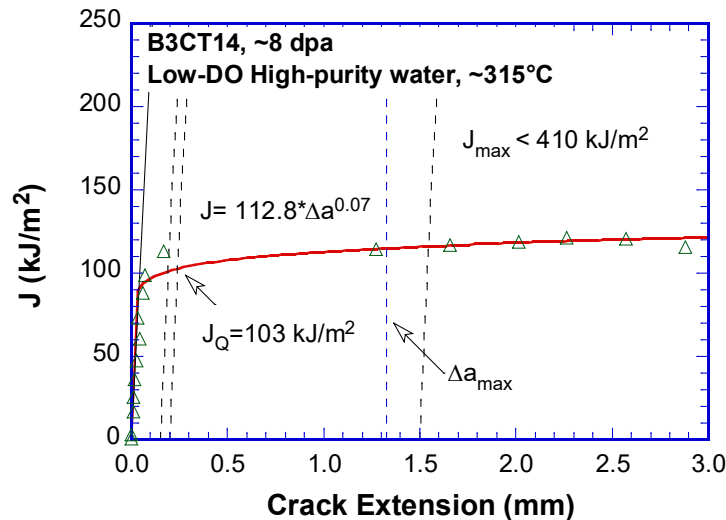
After the CGR test, a fracture toughness J-R curve test was conducted on the same sample in the test environment. The ratio of a/W for the starter crack was about 0.56. The obtained $J-\Delta a$ data are shown in Figure 16. The Δa_{\max} can be measured with this sample is also included in the figure. The J_{\max} value is more than 410 kJ/m^2 , significantly higher than the J-R curve shown in the figure. The obtained $J-\Delta a$ data are fitted to a power-law relationship, $J = 113 \times \Delta a^{0.07}$. Note that because only one data point is between the exclusion lines, data outside the validated crack extension region are included for the curve fitting. The J-R curve intercepts the 0.2-mm offset line at 103 kJ/m^2 , similar to that obtained at 0.06 dpa. However, the power exponent of the J-R curve of this sample is much lower, indicating severe embrittlement at this dose level.

Figure 16. J-R curve of Specimen B3CT14 (~8 dpa) tested at ~315°C
