SYSTEMATIC ASSESSMENT OF LICENSEE PERFORMANCE

INSPECTION REPORT NO. 50-317/84-99; 50-318/84-99

CALVERT CLIFFS NUCLEAR POWER PLANT

ASSESSMENT PERIOD: OCTOBER 1, 1984 - APRIL 30, 1986

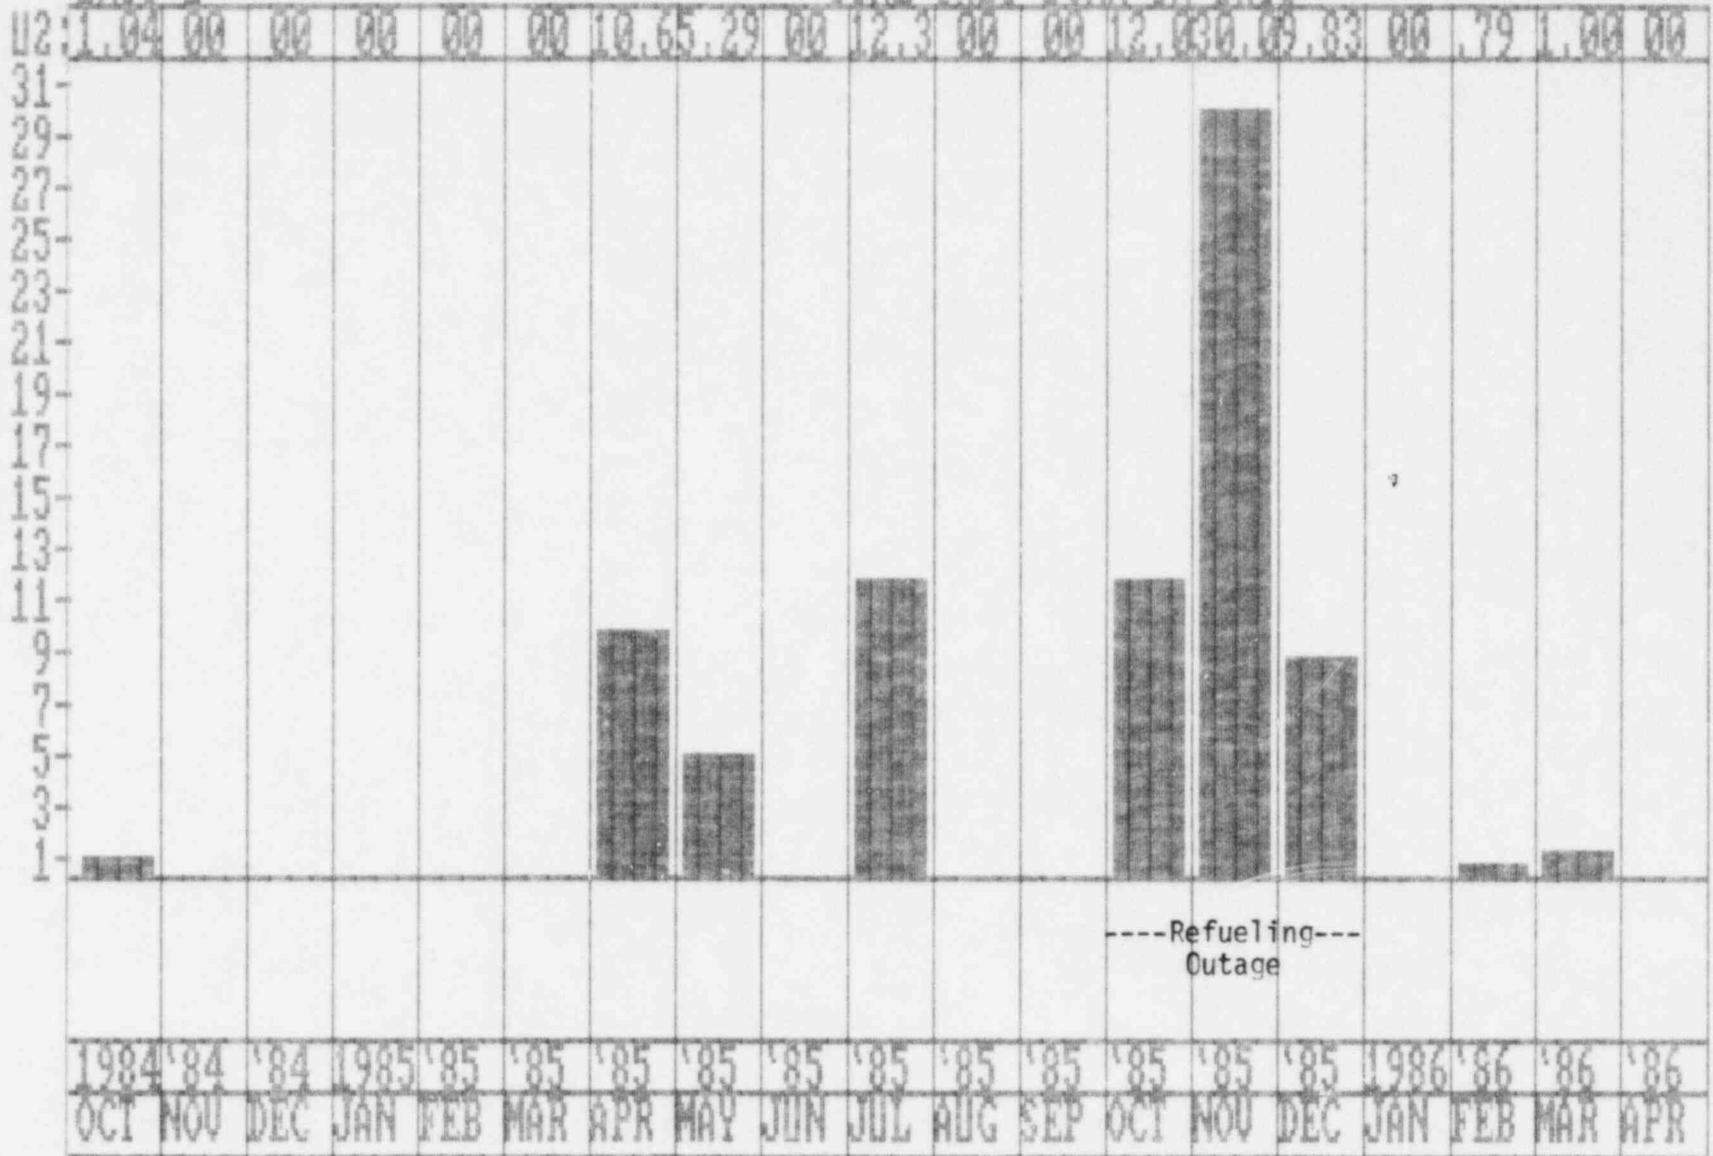
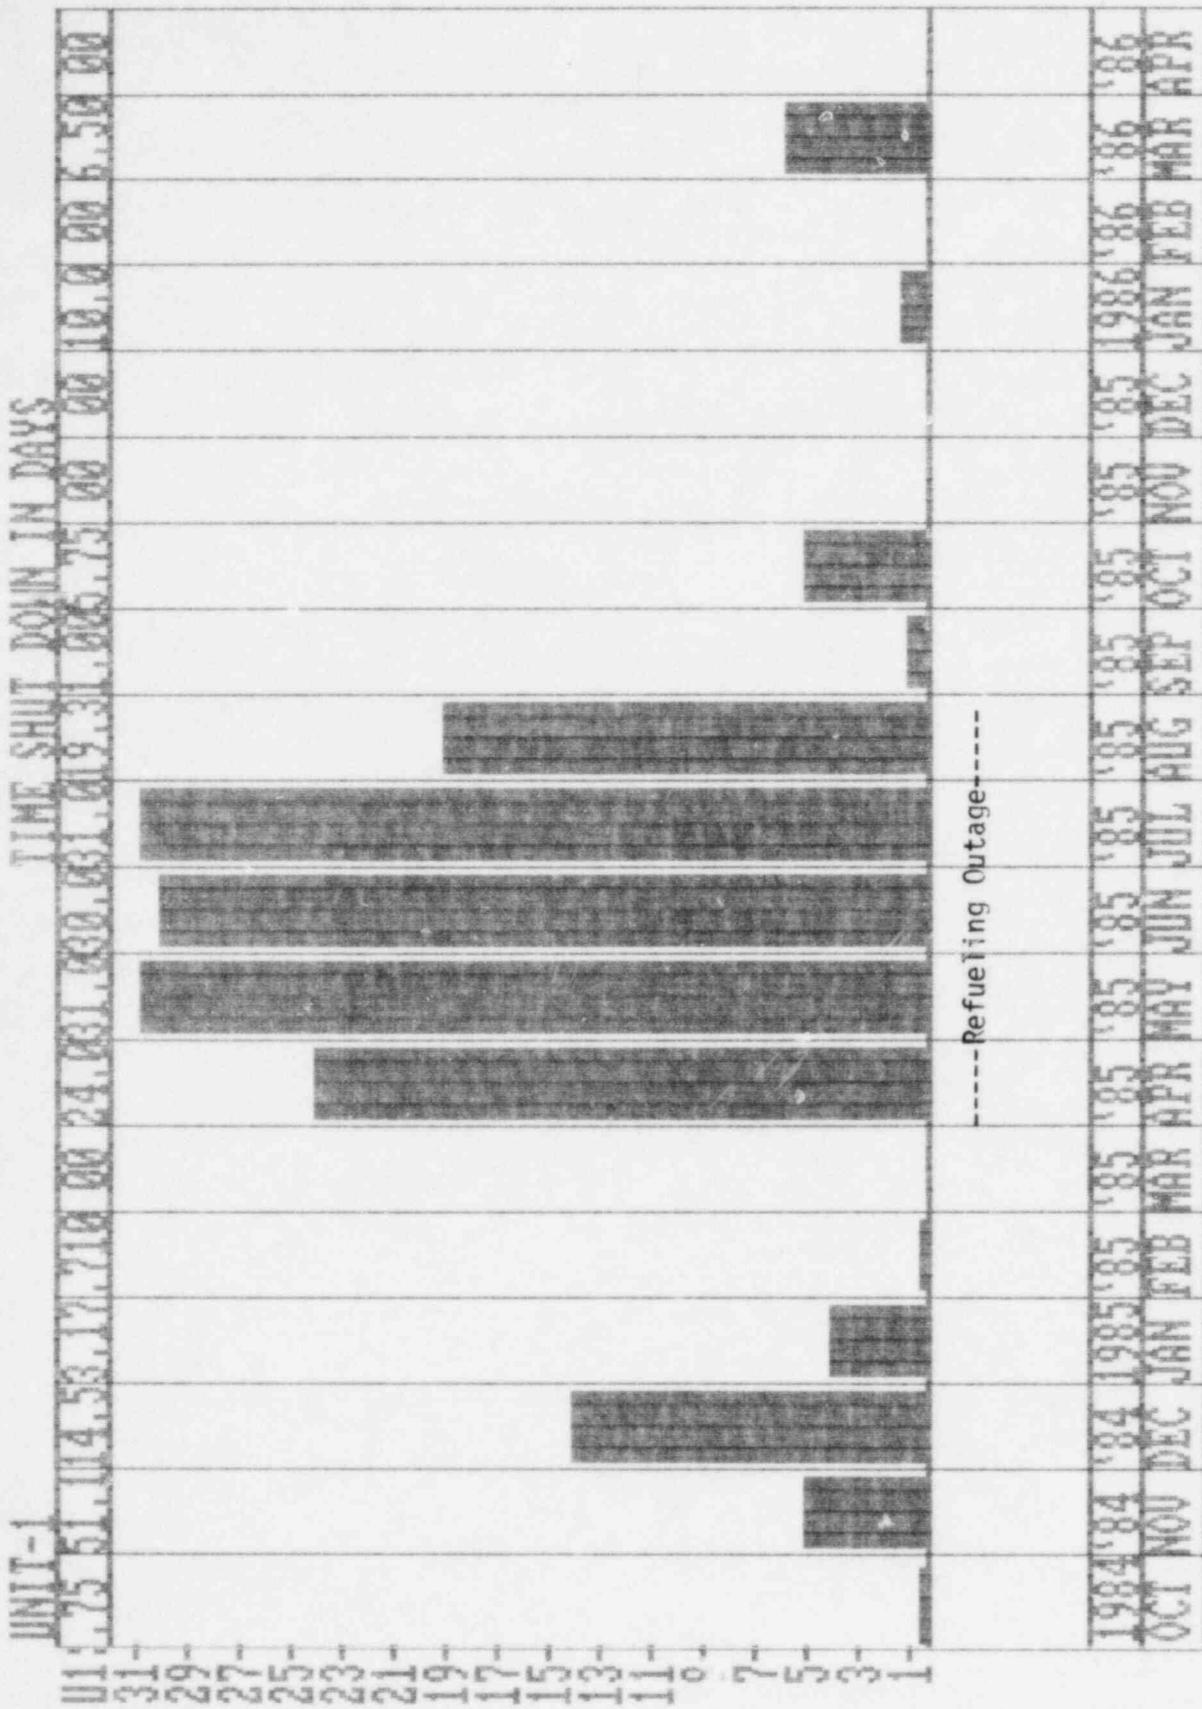
UNIT-2

TIME SHUT DOWN IN DAYS

ATTACHMENT 1 - TIME SHUT DOWN PER MONTH IN DAYS
ATTACHMENT 2 - TOTAL NUMBER OF SHUTDOWNS AND TRIPS PER YEAR SINCE STARTUP (UNITS 1 AND 2)

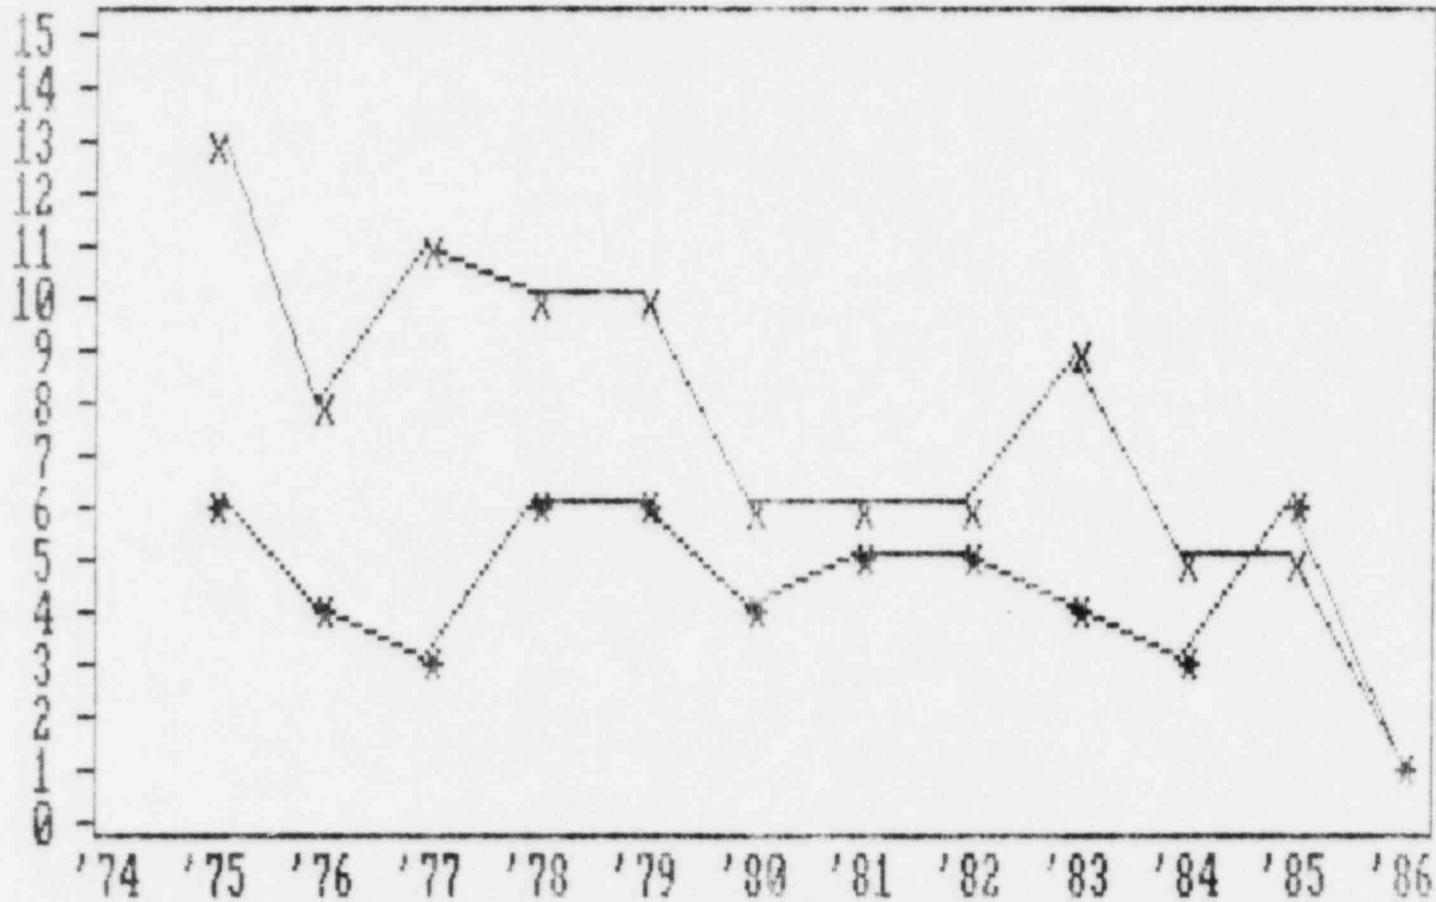
TOTAL NUMBER OF SHUTDOWNS & TRIPS PER YEAR
SINCE STARTUP

UNIT 1 UNIT 1
SHUTDOWNS TRIPS
---X--- ---X---

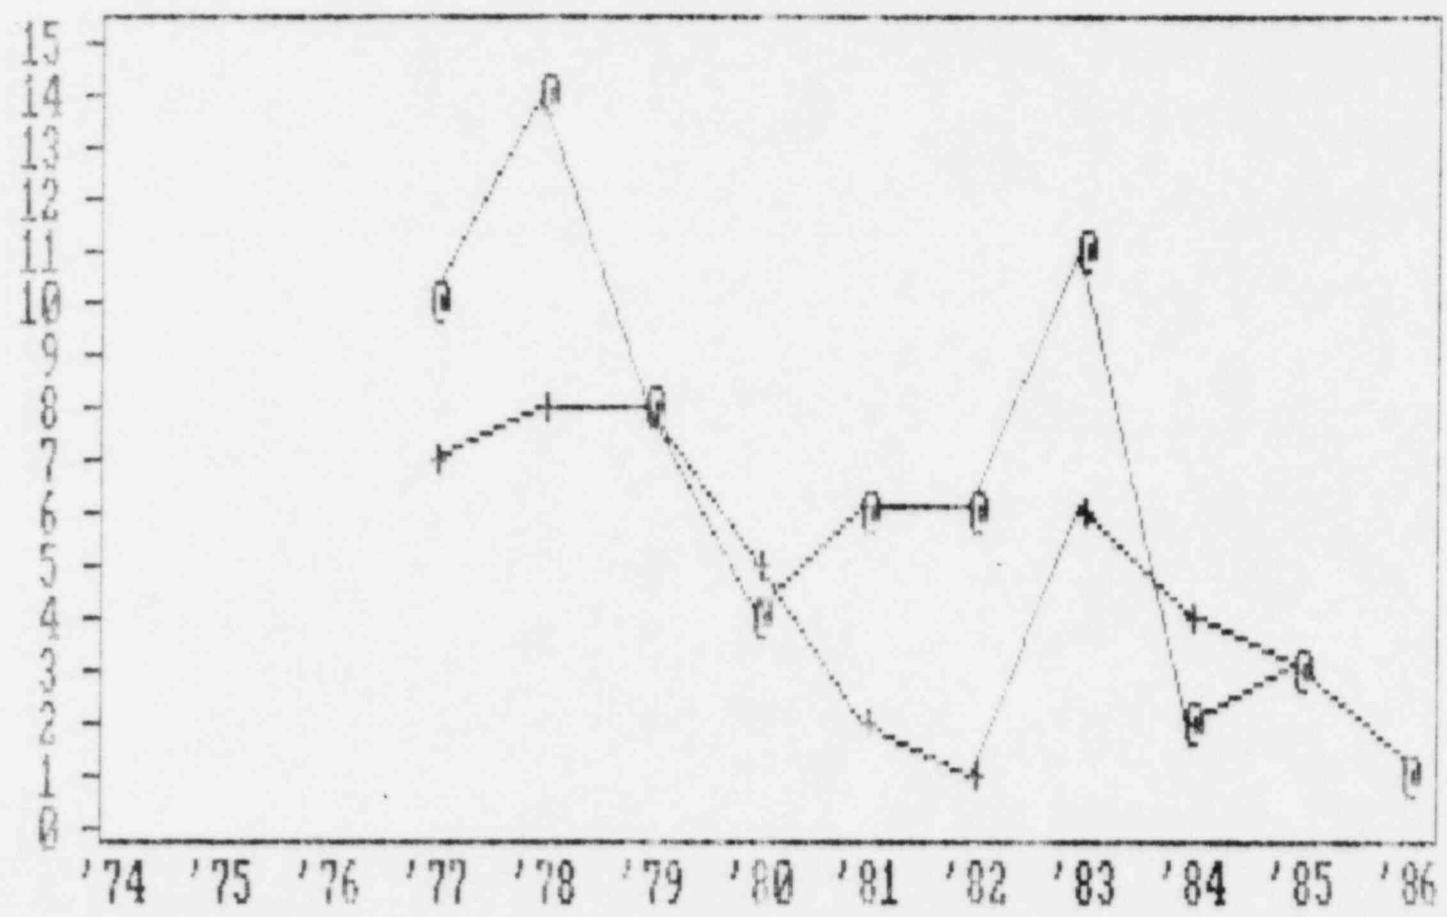
TOTAL NUMBER OF SHUTDOWNS & TRIPS PER YEAR
SINCE STARTUP
UNIT 2 SHUTDOWNS UNIT 2 TRIPS
-----+----- -----@-----
