CORPORATION
Crystal River Unit 3
Docket No. 50-302
Operating License No. DPR-72

Subject: License Amendment Request #235, Revision 1
Once Through Steam Generator Tube Surveillance Program,
Tube Repair Roll Process (TAC No. MA3592)

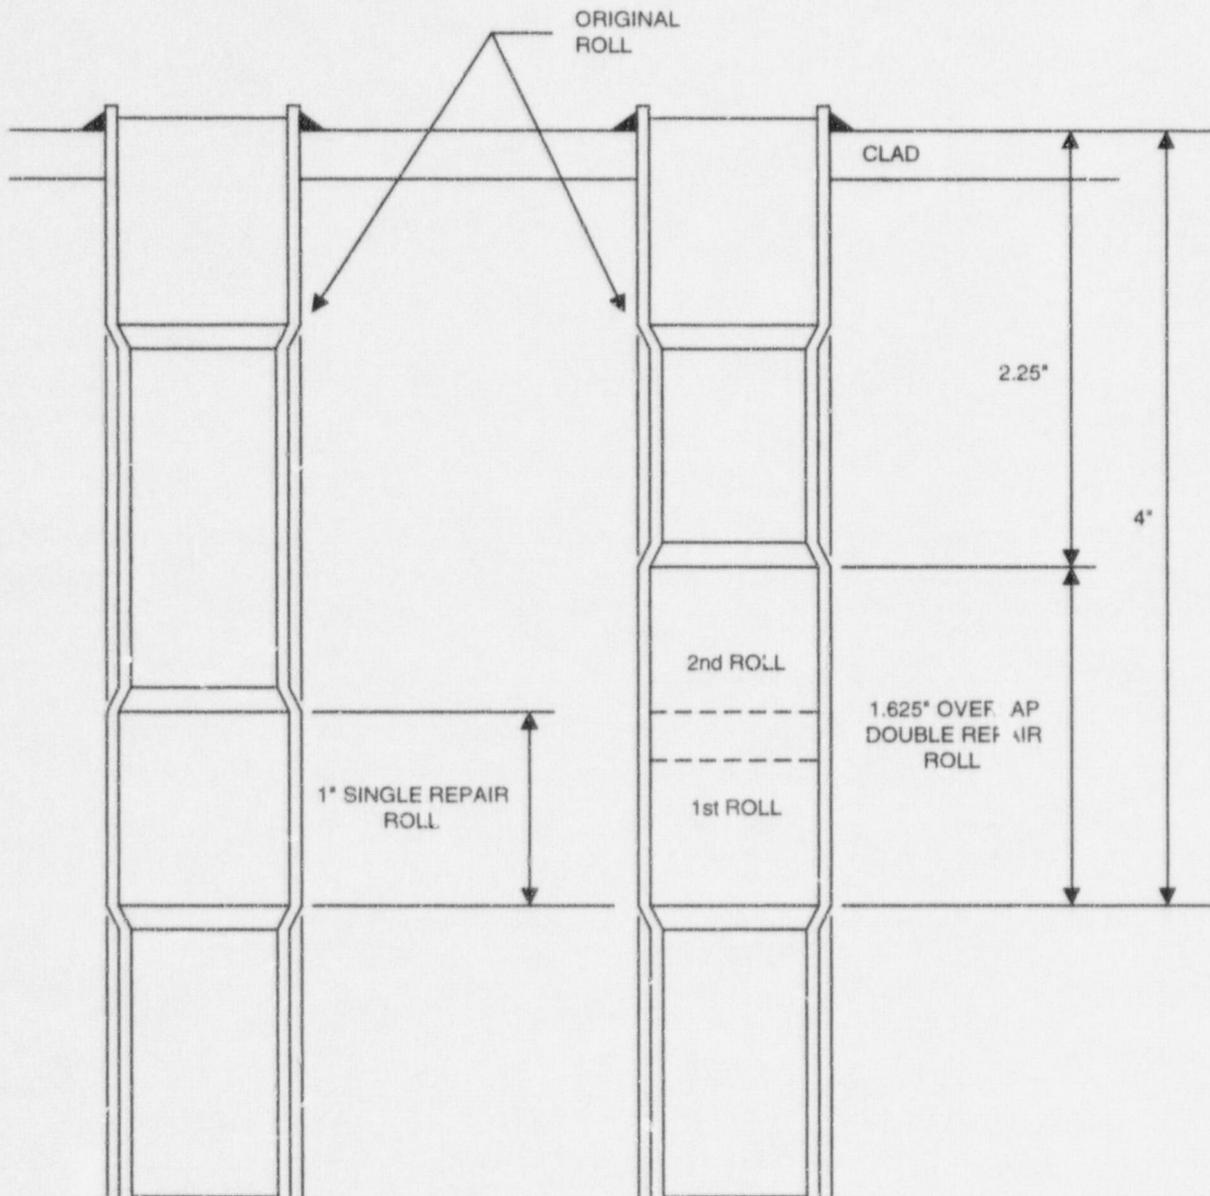
Figure 1: CR-3 OTSG Tube Repair Roll Process

TYPICAL REPAIR ROLL PLACEMENT

Currently, the approved repair methods for CR-3 are to plug or sleeve the defective tubes. This LAR proposes a method of repair for indications in the upper tubesheet by installing a repair roll. The repair roll creates a new pressure boundary by installing a repair roll joint below the existing tube-to-tubesheet joint containing tube defects in the upper tubesheet. The new pressure boundary joint will be the repair roll tube-to-tubesheet expansion joint that is closest to the secondary face of the tubesheet (See Figure 1).

3. Consistent with the conclusions of BAW-2342P, Revision 0, the double repair roll methodology (1.625 inch roll) will be implemented for tubes located at > 45 inches to < 56 inches radial position from the OTSG centerline. The double repair roll methodology, as detailed in BAW-2303P, Revision 3, will be applied with the exception that the double repair roll for CR-3 will not incorporate the original roll (See Figure 1).
