Commonwealth Edison  
Byron Generating Station  
P.O. Box B  
Byron, Illinois 61010

November 30, 1983

TO: R. Klingler, CECO  
FROM: J.T. Hill, QA/QC Manager  
DATE: September 19, 1983  
SUBJECT: N.R.C. Reinspection Program

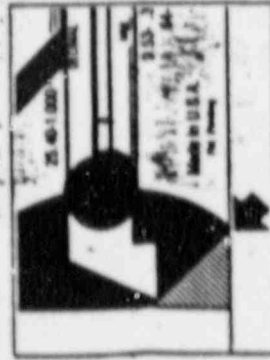
To measure fillet welds place irregular curve edge flush to horizontal toe of weld so the straight edge is in line with the horizontal member.

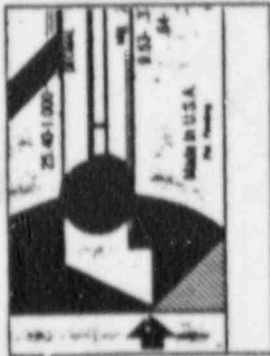
Adjust the offset arm up or down along the diagonal slots until the tip of the arm touches the top of the weld.

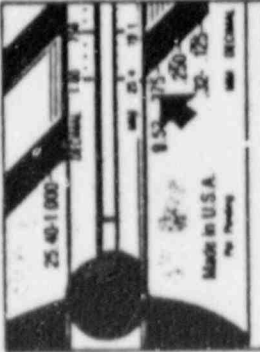
Read the weld size indicated. The increments are in 1/32" and 1/16" markings up to 1". All numerals are etched into the surface and filled for easier reading.

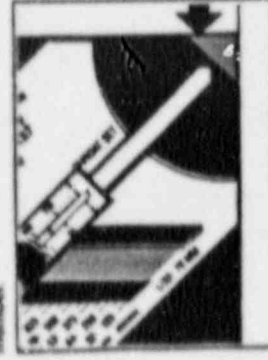
To measure weld throat thickness place the 45° angle end flush to the horizontal and vertical members. Loosen the thumb screw and slide the pointer until it touches the face of the weld.

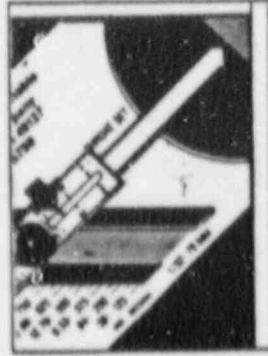
Tighten the thumb screw and read the measurement from the 1/32" calibrations along the pointer. A quick, sure way to find correct or concave welds and to correct them with additional filler material to meet standards.

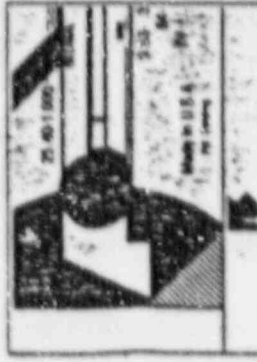
To measure fillet welds place irregular curve edge flush to horizontal toe of weld so the straight edge is in line with the horizontal member.

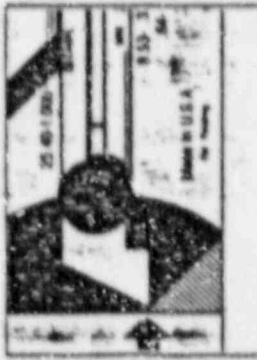
Adjust the offset arm up or down along the diagonal slots until the tip of the arm touches the top of the weld.

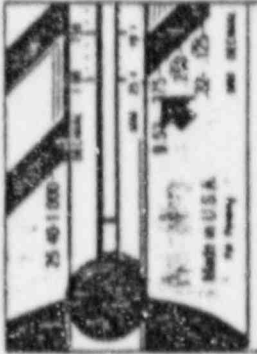
Read the weld size indicated. The increments are in 1/16" and 1/8" markings up to 1". All numerals are etched into the surface and lined for easier reading.

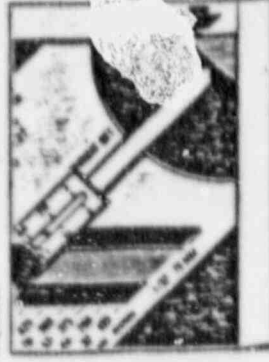
In measure weld throat thickness place the 45° angle end flush to the horizontal and vertical members. Loosen the thumb screw and slide the pointer until it touches the face of the weld.

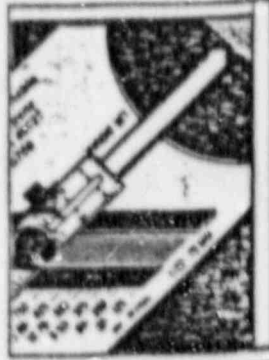
Tighten the thumb screw and read the measurement from the 1/16" calibrations along the pointer. A quick, sure way to find corners or concave welds and to correct them with additional filler material to meet standards.
