SUBJECT: GAP PETITION DATED JUNE 21, 1984 CONTAINING
APPROXIMATELY 300 ALLEGATIONS ON DIABLO CANYON

SUBJECT: SAFETY RELATED BOLTING AT DIABLO CANYON UNIT 1 - REQUEST FOR
TRANSFER OF LEAD RESPONSIBILITY - DOCKET NO. 50-275

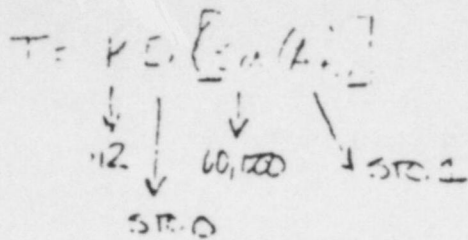
$$\sigma_{\text{CALC}} = \frac{8496}{.1416} = 60,000 \text{ PSI} \checkmark$$

32% DIFFERENCE
