UNITED STATES
NUCLEAR REGULATORY COMMISSION
WASHINGTON, D. C. 20555

SUBJECT: FEEDBACK INTERVIEW OF WITNESS A-44

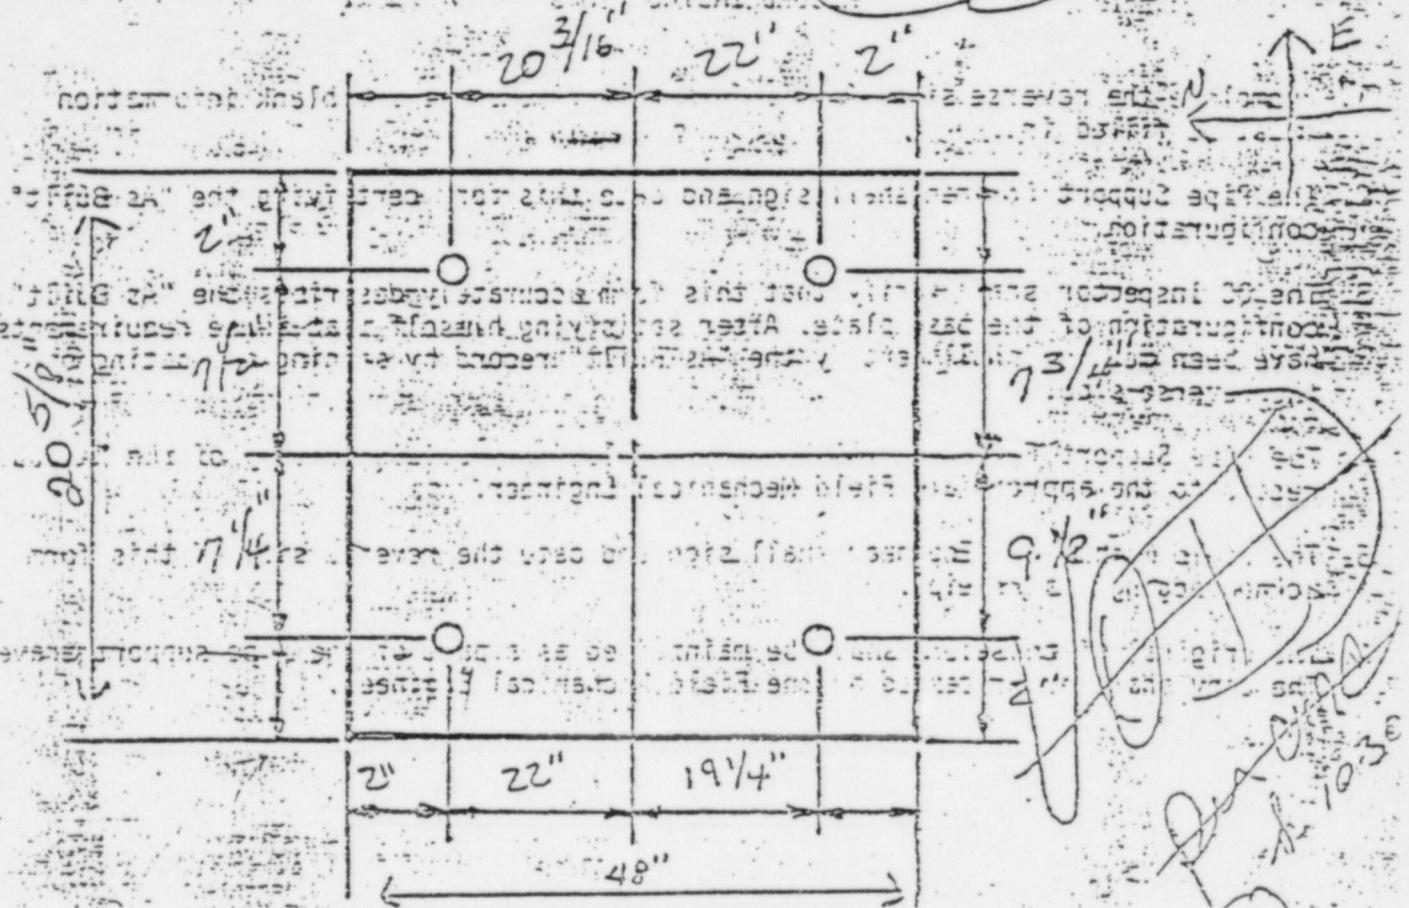
AS BUILT RECORD FORM

1. Hanger Number SW-1-010-004-A33R Rev. 0
2. Indicate Plate Orientation on above sketch
3. Plate Material Carbon Steel (SA515 GR65 or SA36)
4. Plate Thickness 1"
5. Hilt Bolt Size ~~1/2"~~ 1 1/4" x 12" (B)
6. If hanger has more than one plate, indicate which plate is covered. Attach additional forms for other plates as required.
