U. S. NUCLEAR REGULATORY COMMISSION

Report No.: 70-1113/97-01

Licensee: General Electric Company

General Electric Nuclear Energy Production NRC Inspection Report 70-1113/97-01

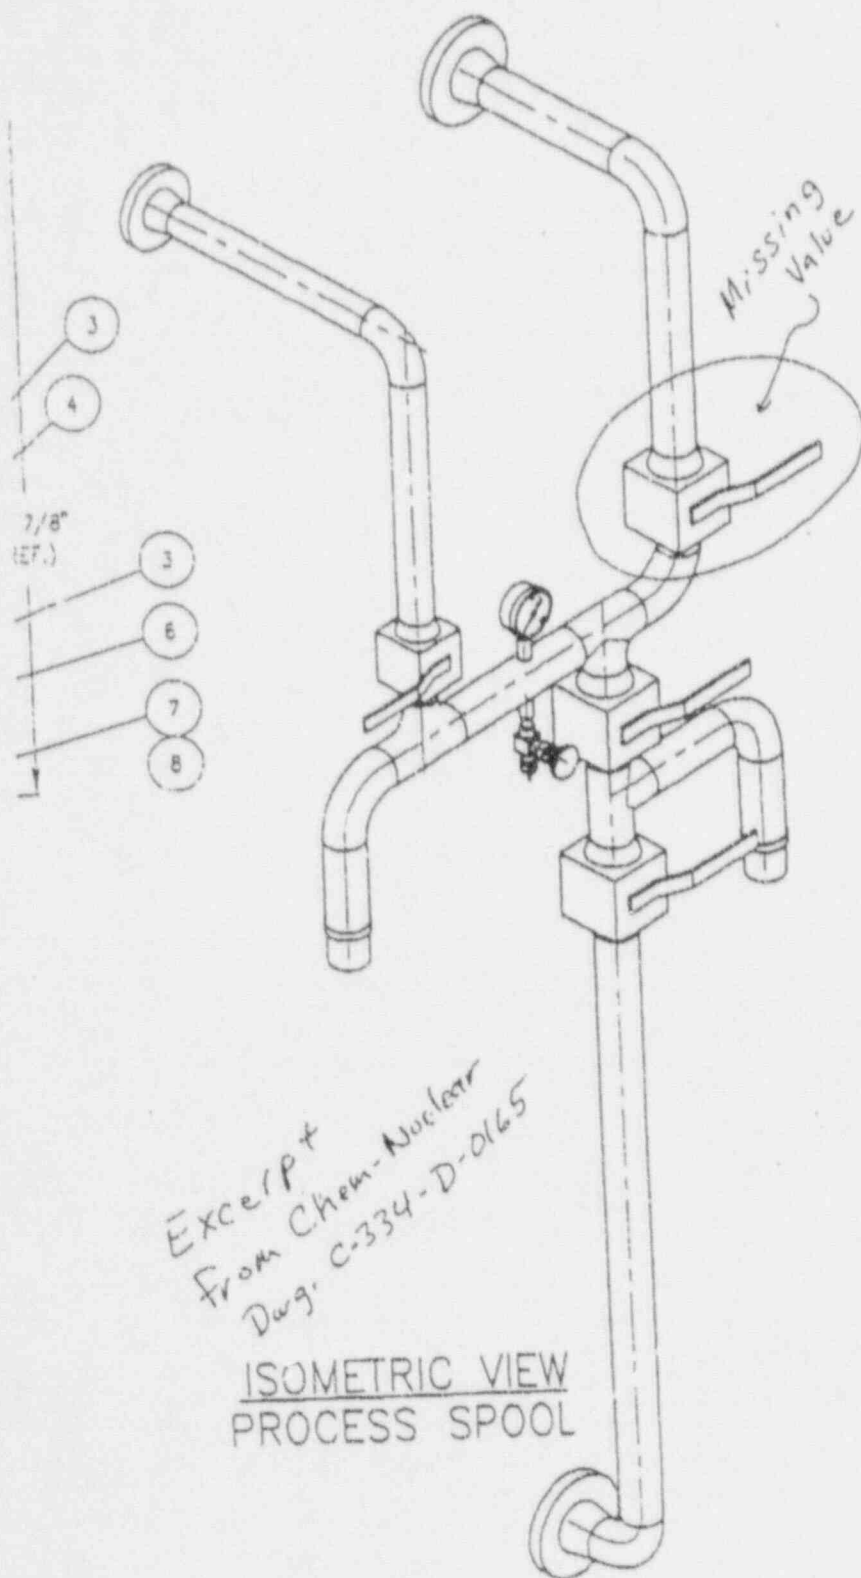
Excerpt
From Chem-Nuclear
Dwg. C-334-D-0165

SLUICE HEADER TO TOP IN/OUT

25	1	1 1/2" WELD NECK FLAN
24	1	1 1/2" PIPE, SCH. 40,
23	1	1 1/2" 90° L.R. ELBOW,
22	1	1 1/2" PIPE, SCH. 40,
21	1	1 1/2" BALL VALVE, FULL
20	1	2" REDUCING TEE X 1-1/2"
19	1	2" PIPE, SCH. 40, 14-1/2"
18	1	1/4" HOSE BARB x 1/4"
17	1	1/4" NEEDLE VALVE, 1/4"
16	1	1/4" HEX NIPPLE, S.S.
15	1	GAUGE, PRESSURE, 0-15
14	2	1/4" COUPLING, 150 LB
13	1	2" PIPE, SCH. 40, 34-3/4"
12	2	2" TEE, SCH. 40, B.W.,
11		
10	3	2" WELD NECK FLANGE,
9	1	2" PIPE, SCH. 40, 12"
8	3	2" CAM-TYPE CAP, ALUM
7	3	2" CAM-TYPE CONNECTE
6	3	2" PIPE, SCH. 40, 6" L
5	4	2" BALL VALVE, FULL PO
4	3	2" PIPE, SCH. 40, 6" L
3	6	2" 90° L.R. ELBOW, SCH.
2		
1	1	2" PIPE, SCH. 40, 25" L
ITEM	QTY

On March 27, 1997, individuals at the Millstone nuclear power plant reported to the NRC Operations center that a container received at the site was missing a valve that was contaminated with radioactive materials. The valve was from a vessel that was being transported by Tri-State Trucking from the Barnwell disposal site in South Carolina to the Millstone site. The truck driver indicated that the valve was on the vessel when he left the Barnwell site and was first noticed as missing at a fuel station in New Jersey.

Radiation surveys of the vessel performed in the vicinity of the valve prior to transport indicated a radiation level of 60 mR/hr. Therefore, the missing valve should not emit levels above this value.
