Omaha Public Power District 1623 Harney Omaha, Nebraska 68102 402/536-4000

SUBJECT: Instrument Air System at Fort Calhoun Station

## FIRE PROTECTION MODIFICATION USING INSTRUMENT AIR

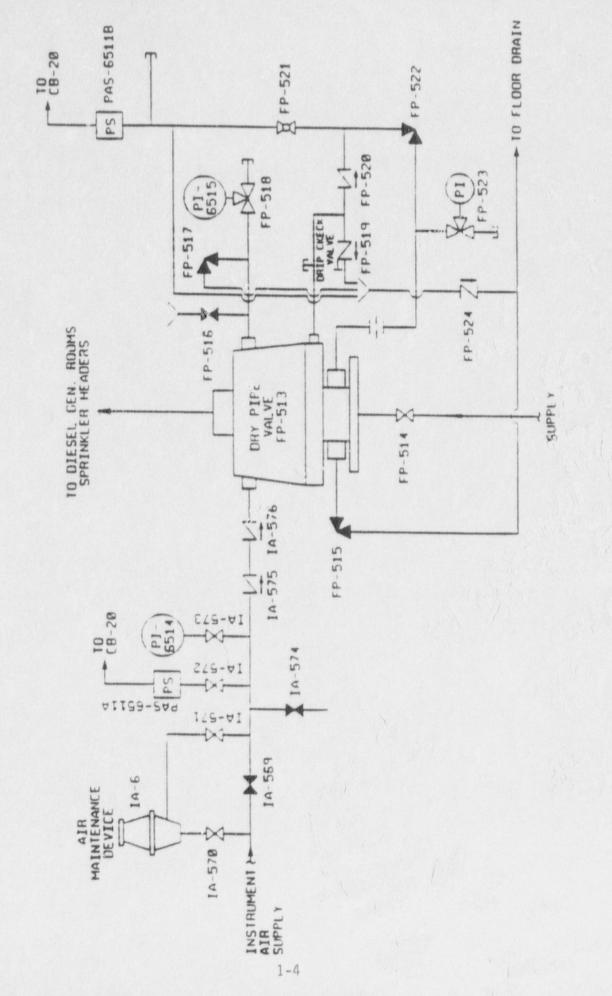
DRY PIPE SPRINKLER SYSTEM FOR DIESEL GENERATOR ROOMS (MR-FC-83-182).

- PROVIDE A CLEAN, DRY SOURCE OF COMPRESSED AIR, THUS MINIMIZING THE POTENTIAL FOR MOISTURE COLLECTION AND POSSIBLE FREEZING WITHIN THE SYSTEM.
- THE FOLLOWING CHECK MECHANISMS PROVIDE ASSURANCE AGAINST WATER IN THE INSTRUMENT AIR SYSTEM .

- 1) DRY PIPE CLAPPER
  - 2) CHECK VALVES IA-575 & IA-576
  - 3) AIR MAINTENANCE DEVICE IA-6
- THE DRY PIPE VALVE, IF THE CLAPPER IS RESET WILL NOT ALLOW WATER UP TO IA-576, THEREFORE, THE ONLY TIME WATER WILL BE AT IA-576 IS DURING SURVEILLANCE TESTING AND AN ACTUAL FIRE CONDITION.

- VENDOR RECOMMENDS USE OF ONLY ONE CHECK VALVE.

- 5. Opened FP-516 and poured priming water into body of dry pipe valve
  - 6. Closed IA-570; isolated air maintenance device
  - 7. Opened IA-569; noted water blowing out of FP-516

- 8. Opened FP-514; noted that both air and water pressure gauges on valve were at fire main pressure; know this was abnormal
  - 9. Opened IA-574; stream of water; know at this pint that there may be water in the IA system

- D. Evaluated Cause of Event
  - check valves IA-575 and IA-576 were prevented from closing fully by foreign matter
  - 2. When FP-514 was opened, water entered the IA system because the clapper in FP-513 was not reset, IA 569 was open and the water pressure was approximately 30 psi greater than the air pressure

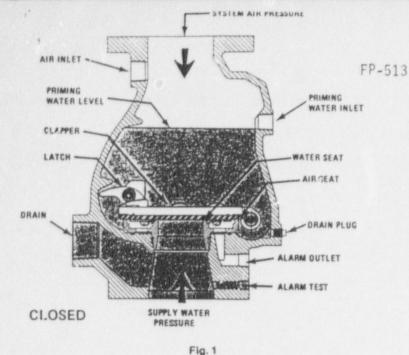
Fig. 2

The Reliable Model D Dry Pipe Valve in its closed and open positions is shown in Figures 1 and 2. The closed position is maintained as iong as the air pressure in the system piping above the Dry Pipe Valve is sufficient to exert a greater force on the top side of the clapper than is exerted on its underside by the pressure of the water supply. Since the area included by the Air Seat is approximately six times that of the Water Seat (The Differential Principle) the air pressure needed to keep the Dry Pipe Valve closed is only a fraction of that of the water supply. Table 1 gives the recommended air pressure for various water supply pressures for both sizes of Model D Dry Pipe Valves.
