August 24, 2020
GO2-20-118

Subject: **COLUMBIA GENERATING STATION, DOCKET NO. 50-397
RESPONSE TO REQUEST FOR ADDITIONAL INFORMATION
RELATED TO EXIGENT LICENSE AMENDMENT REQUEST FOR
CHANGE TO TECHNICAL SPECIFICATION 3.8.7 DISTRIBUTION
SYSTEMS – OPERATING**

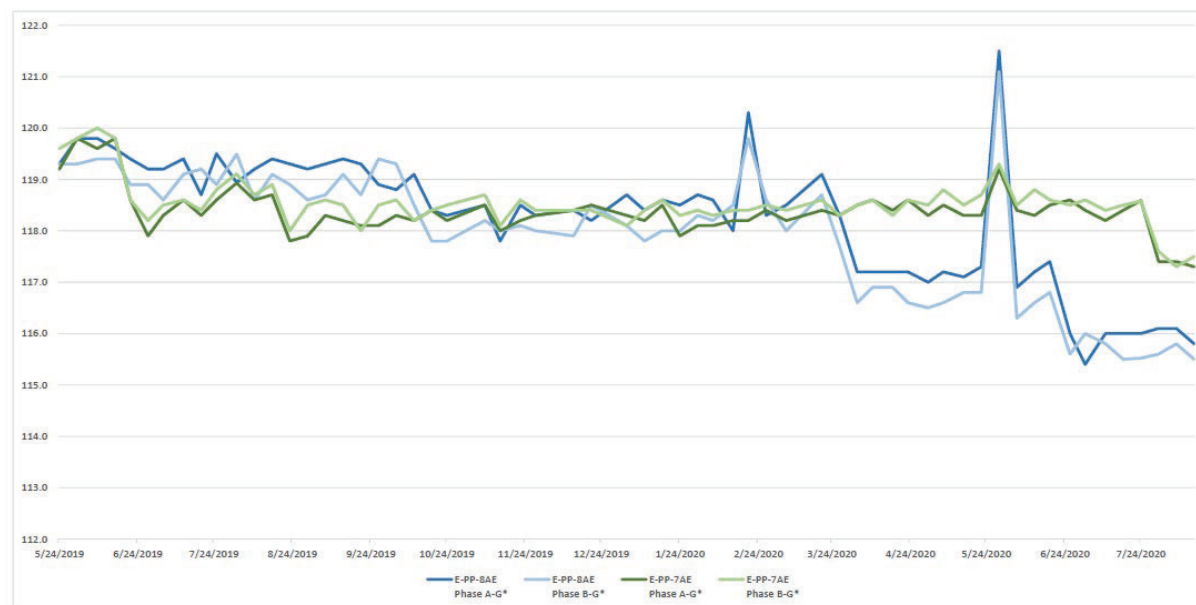
TS Bases 3.8.7 AC Distribution Systems Operating notes that OPERABLE AC electrical power distribution subsystems require the associated buses to be energized to their proper voltages. The figure below plots data obtained from weekly voltage surveillances under TS Surveillance Requirement 3.8.7.1 on E-PP-8AE and the Division 1 redundant power panel E-PP-7AE for the current operating cycle. While E-PP-8AE has shown gradual declining performance, the redundant subsystem E-PP-7AE has remained well above its administrative limit of 115 voltage alternating current (VAC). E-PP-7AE has experienced a recent step change in July 2020 however, the power panel output is stable above 117 VAC which is considered to be acceptable margin to the administrative limit of 115 VAC at this time.

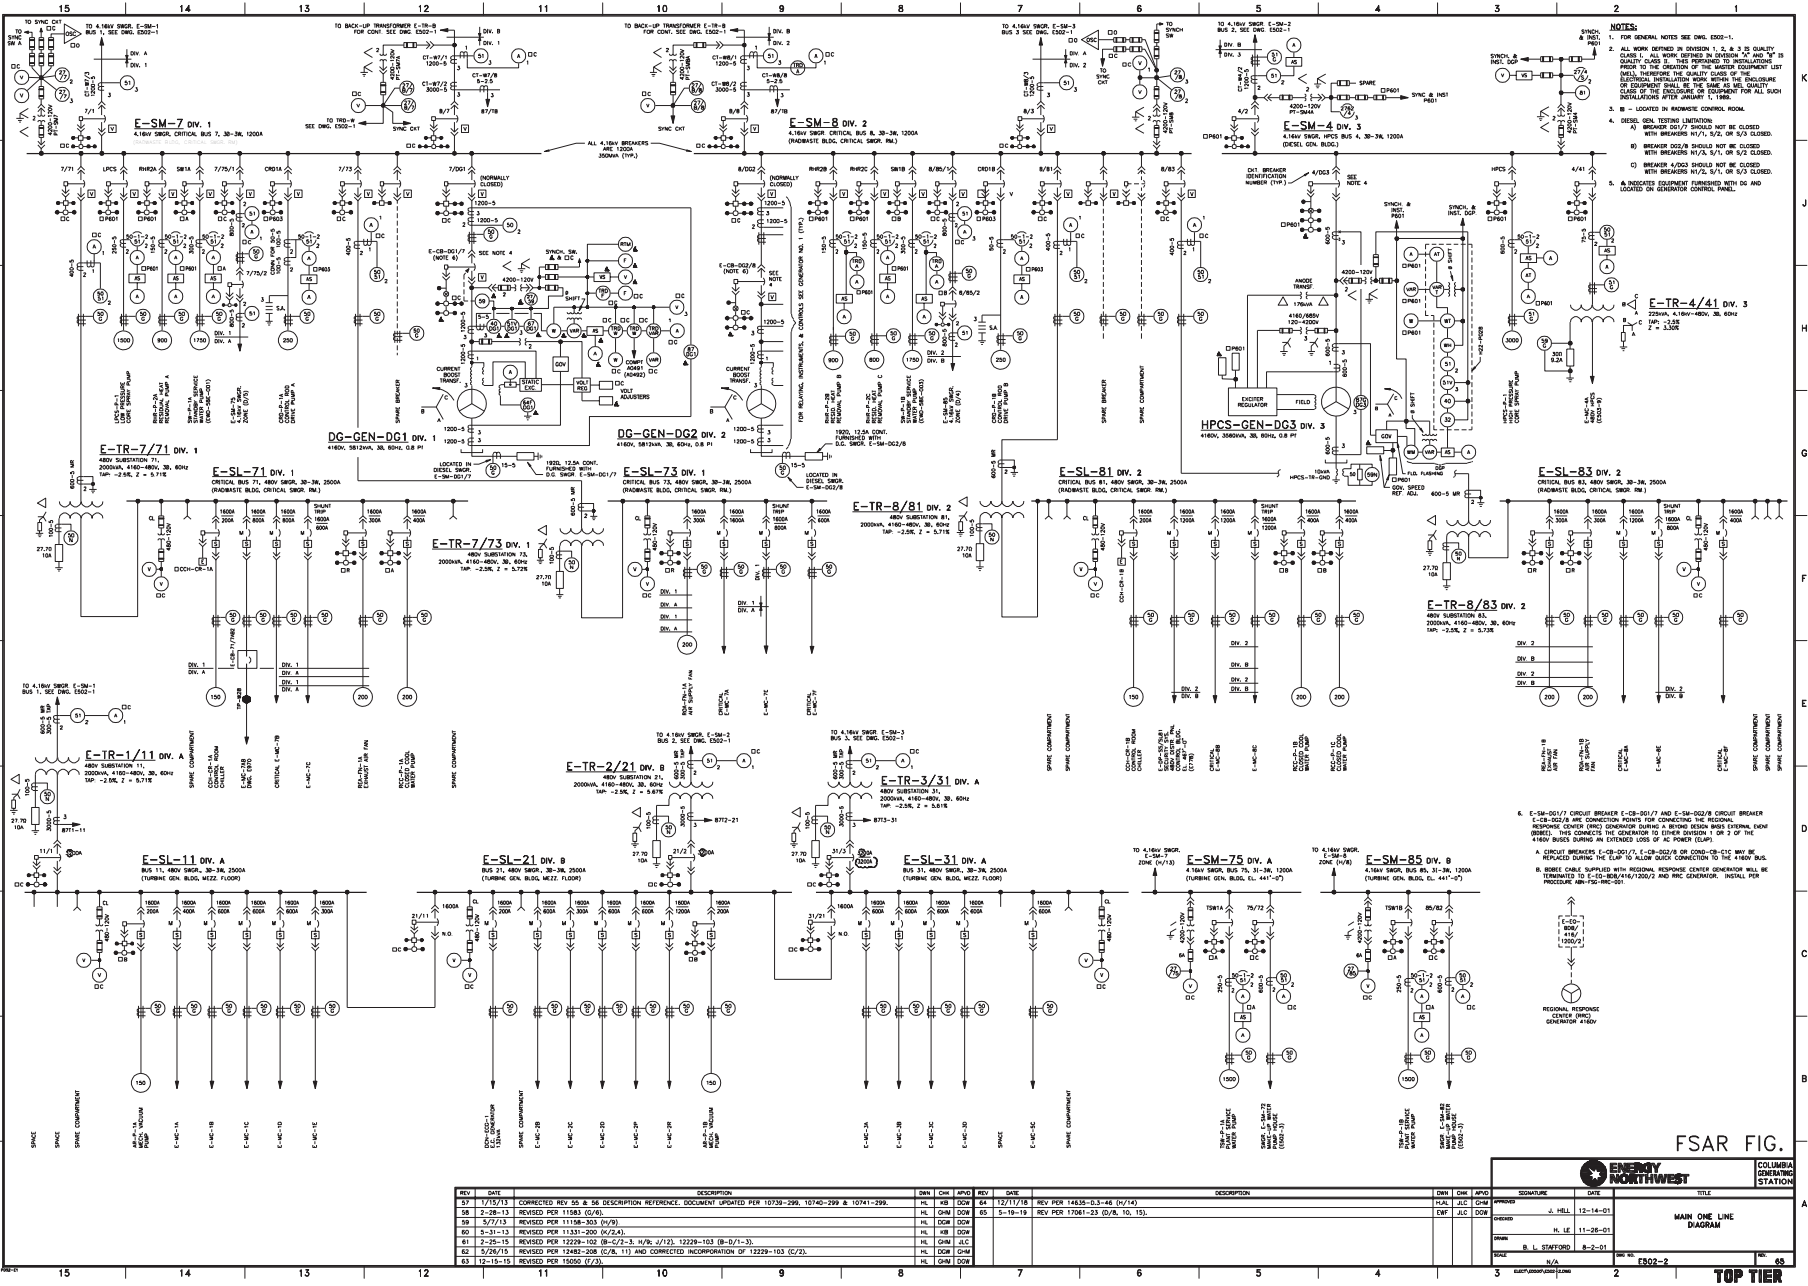
FSAR FIG.

ENERGY NORTHWEST			COLUMBIA GENERATING STATION
	OWN	CHG	APPRO	SIGNATURE	DATE	TITLE
9-6)	HL	GWM	JLC	APPROVED	12-14-01	MAIN LINE DIAGRAM
	HL	DOW	GWM	DESIGNED	J. HELL	
	HL	GWM	JLC	CHKD	H. LE 11-26-01	
	HL	KB	JAL			
	HL	GWM	JLC			
	HL	HL	CHKD	BY B. L. STAFFORD 08-13-01		
	TC	JAL	GWM	N.T.S.		OWN NO. ES02-1
						REV. 63
