U. S. NUCLEAR REGULATORY COMMISSION

Reports No. 50-373/89010(DRS); 50-374/89010(DRS)

Facility Name: LaSalle County Station, Units 1 and 2

## Inspection Summary

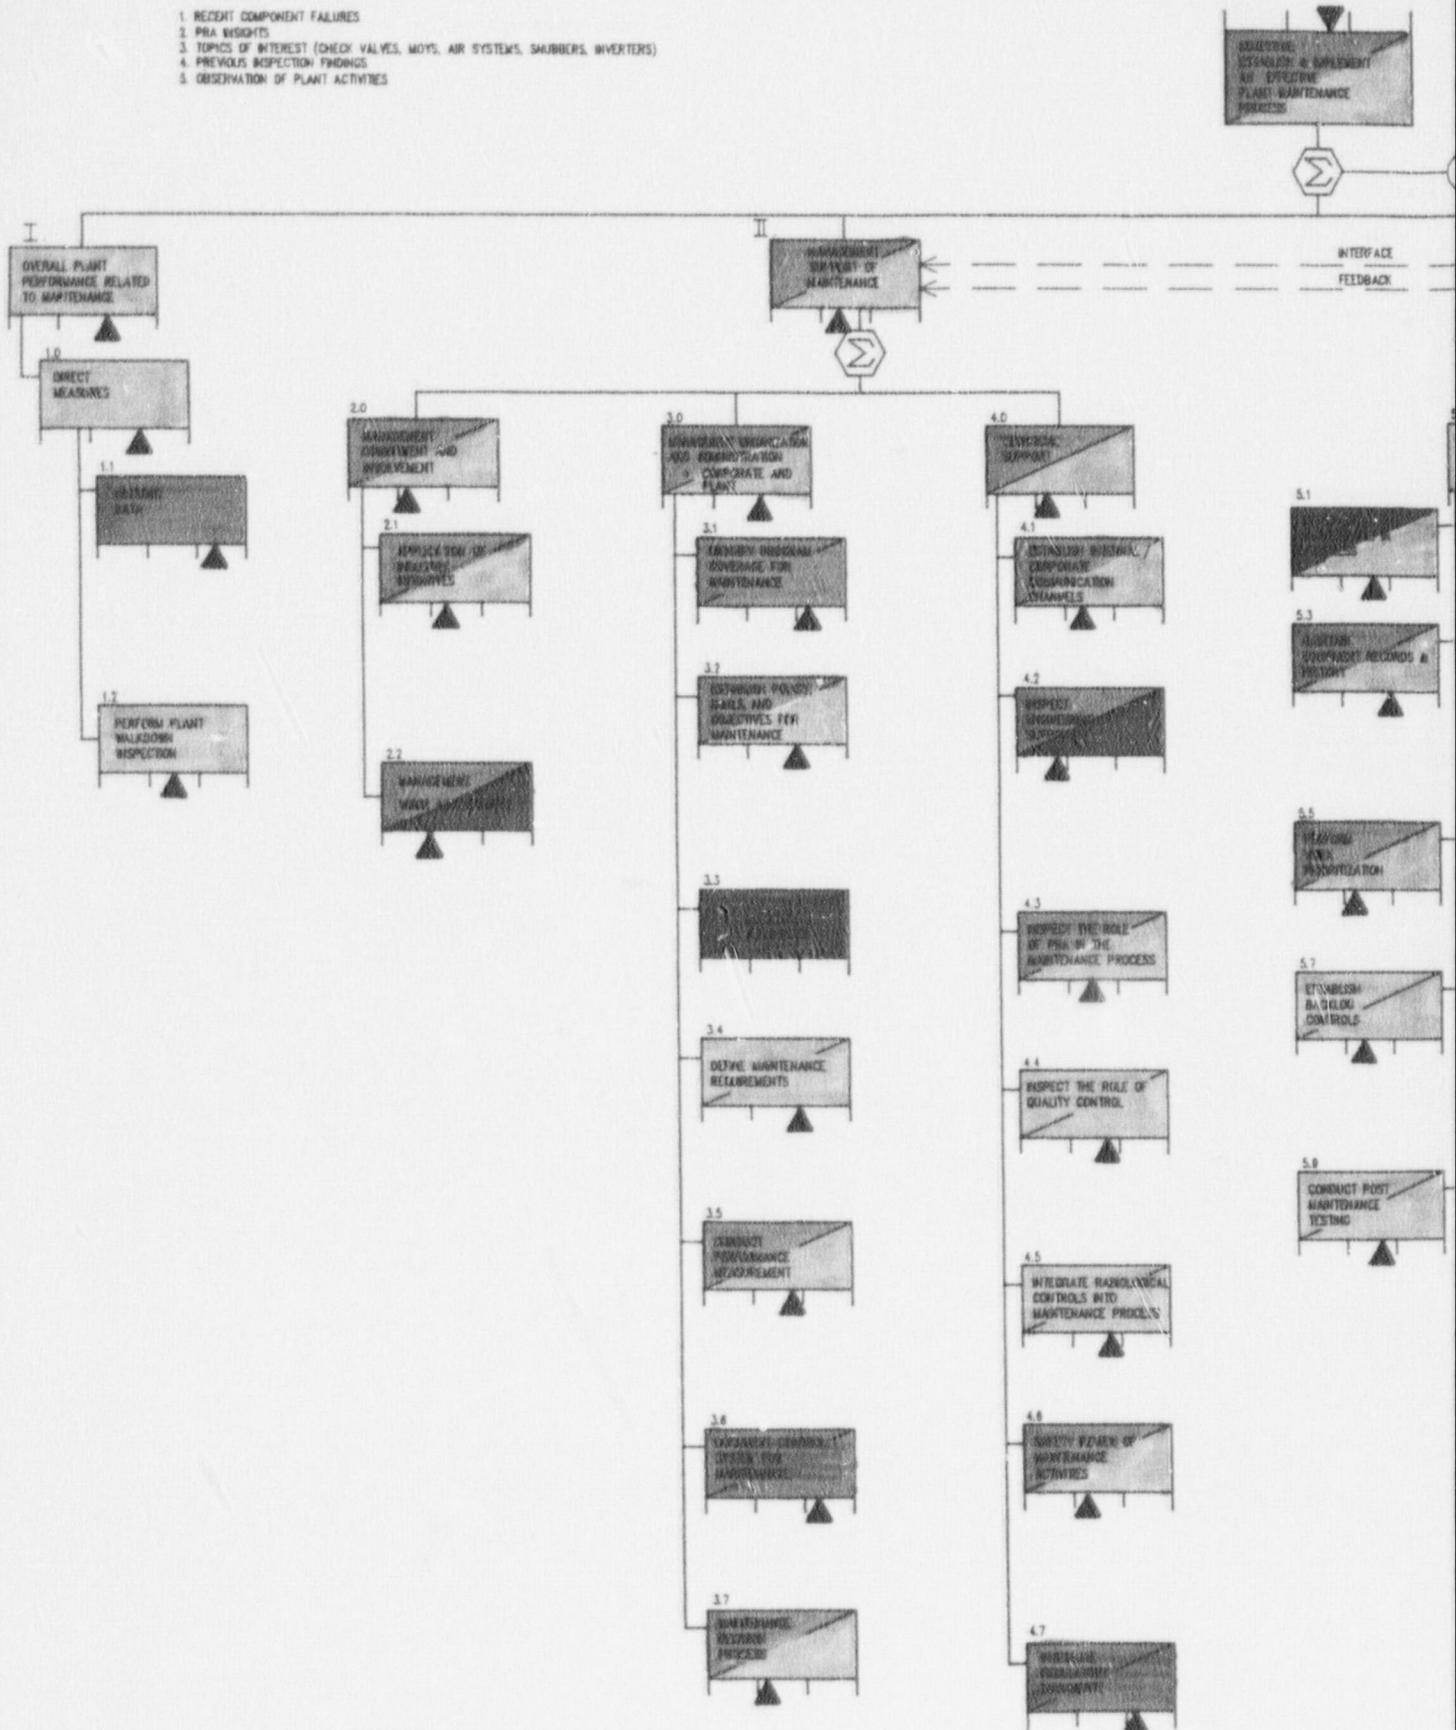
# PRESENTATION TREE MAINTENANCE INSPECTION

1. RECENT COMPONENT FAILURES
2. PRA INSIGHTS
3. TOPICS OF INTEREST (CHECK VALVES, MOYS, AIR SYSTEMS, SHUTTERS, INVERTERS)
4. PREVIOUS INSPECTION FINDINGS
5. OBSERVATION OF PLANT ACTIVITIES
