PEACH BOTTOM ATOMIC POWER STATION

SUBJECT: Licensee Event Report
Peach Bottom Atomic Power Station - Unit 2

TITLE (4)
Malfunctioning Electro-Hydraulic Control System Component Causes Scram When Removed From Service

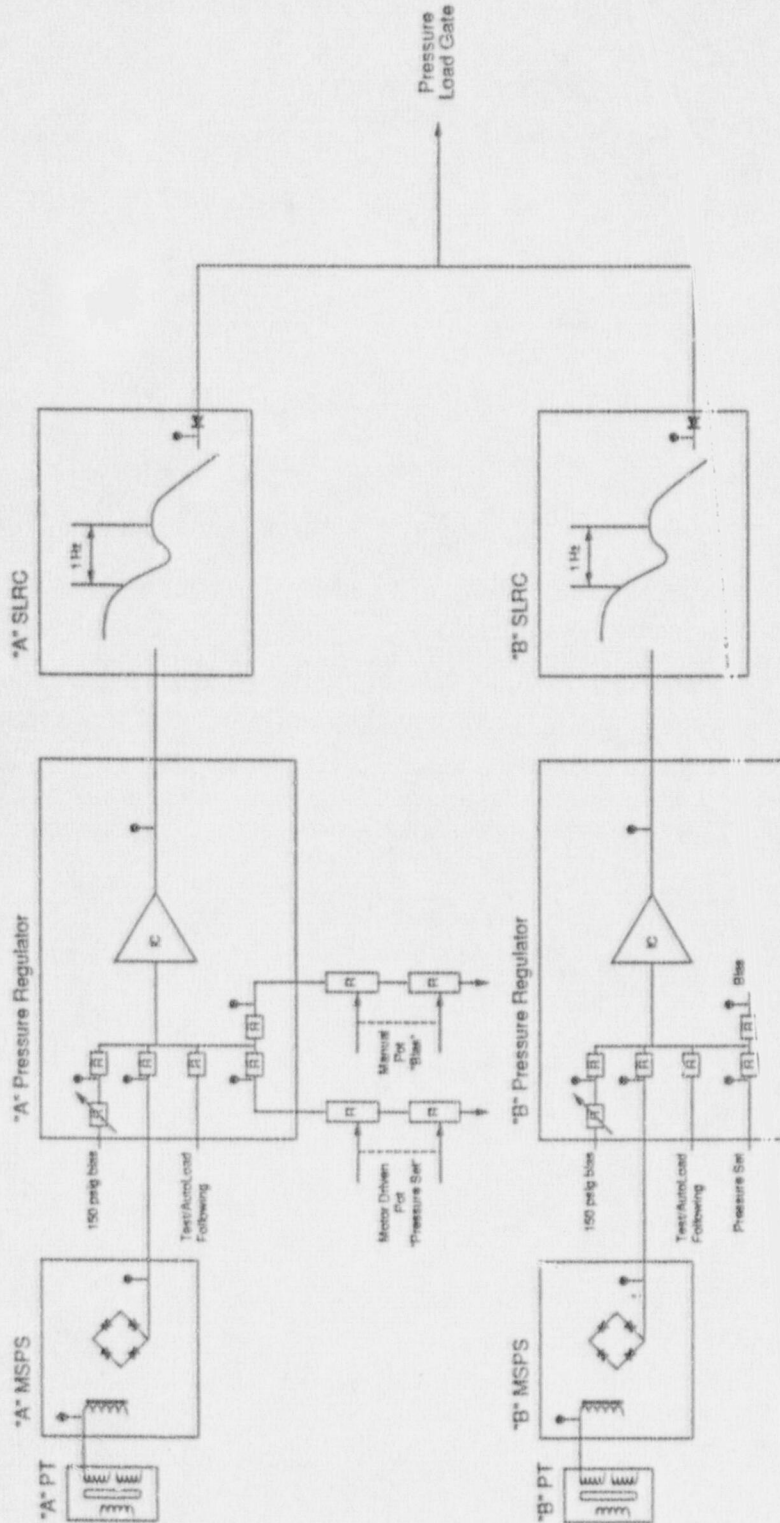
Attachment 1

RPV Pressure Control

On 7/3/89 while performing MT EHC Pressure Regulating System stability testing (with the "A" Pressure Regulator in service) it was noted that the signal output from "B" Pressure Regulator circuit was offset from the "A" approximately 15 psig (normal 3 psig). The offset was returned to the 3 psig setting by adjusting the pressure setpoint bias potentiometer. Continued observation revealed the pressure differential between regulator circuits to be increasing requiring periodic bias potentiometer adjustments to maintain 3 psid between channels (EIIS:CHA). Testing indicated the "A" Regulator signal output was increasing slowly (causing pressure to decrease 0.4 psig/day), while at the same time "B" Regulator signal output appeared stable. It was noted that the bias potentiometer was quickly running out of adjustment requiring action before a loss of the ability to maintain the required 3 psid between regulators occurred. The 3 psid value is required to enable a relatively smooth transfer to the redundant regulator in the event of failure of the regulator in service. On 7/20/89 the Plant Manager was informed of the problem and options available.

The cause of the EHC transient was determined to be the intermittent removal of the -30 volt supply to the "A" Pressure Regulator and the voltage transients that resulted. This voltage fluctuation apparently was caused by the slight side to side movement that occurred during the attempt to remove the SLRC circuit card.
