April 1989

Detailed Control Room Design Review

Supplementary Summary Report

Pilgrim Station

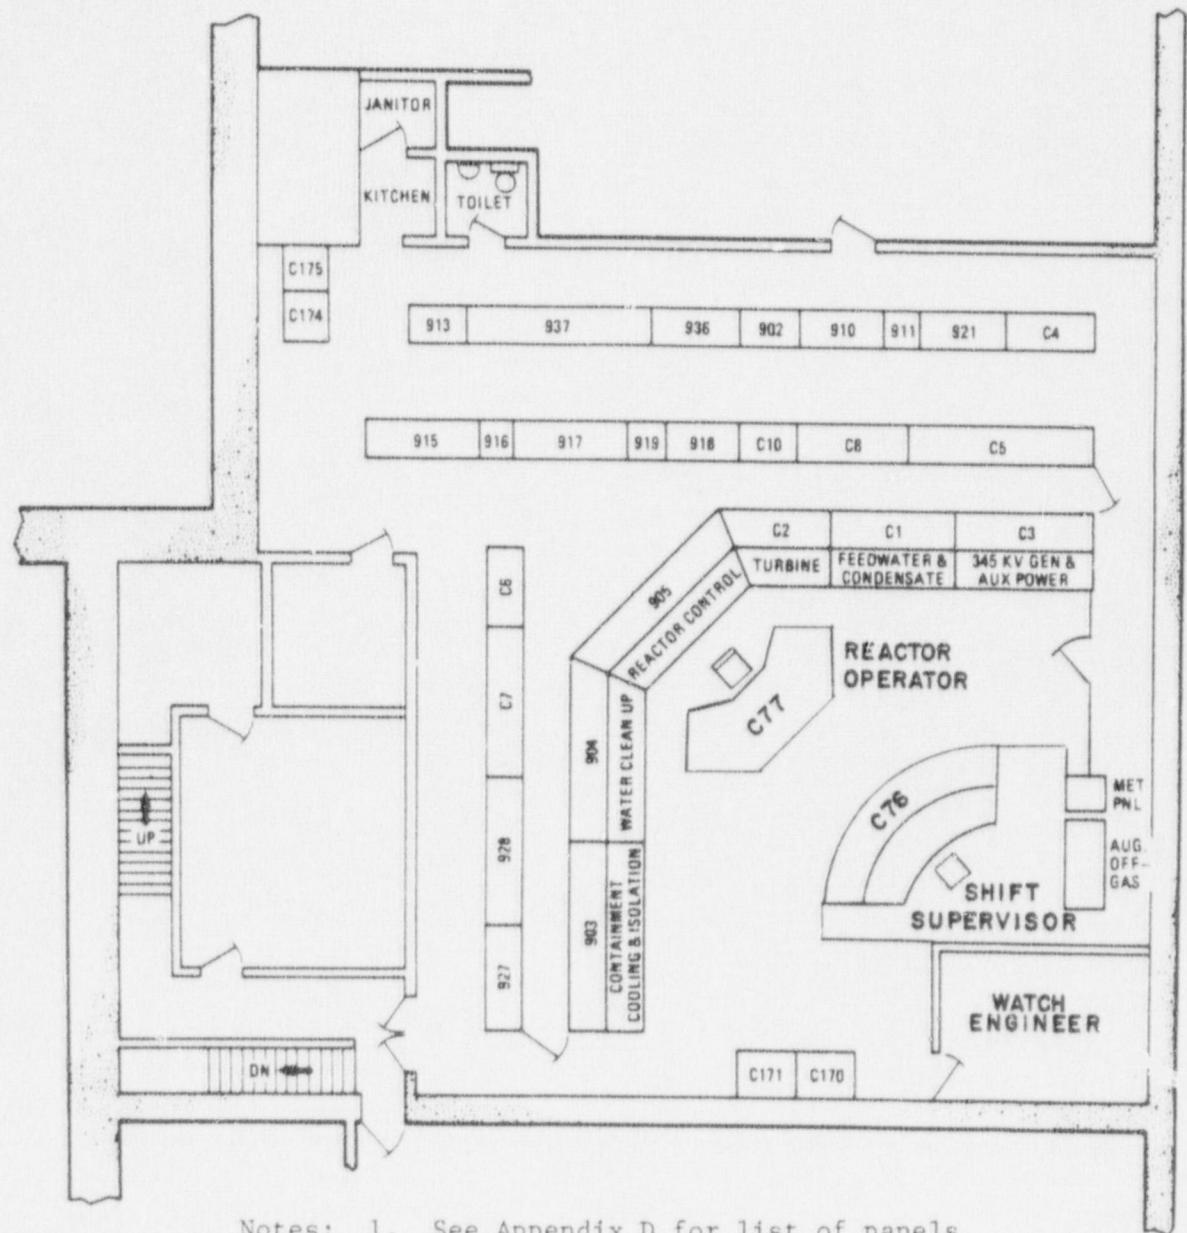
Notes:

1. See Appendix D for list of panels included in DCRDR scope
2. Some details omitted for clarity.

* See Figure III-1 for panel locations and Appendix D for full panel names.
