Subject: Tailing Disposal System  
Church Rock Uranium Project  
Job No. 74131-001 File No. 2.02.10

The Church Rock dam, as presently designed, will not be built in the same manner as the Homestake Partners dam which recently experienced a failure caused by erosion from a pipeline break. The present design of the Church Rock dam is described in detail in the report titled, "Design of Tailings Disposal System" dated February, 1976 by Kaiser Engineers. This report supercedes the tailings dam design included in the Environmental Impact Report for the Church Rock Uranium Mill, which describes a dam built of tailings, utilizing the centerline method of dam construction.

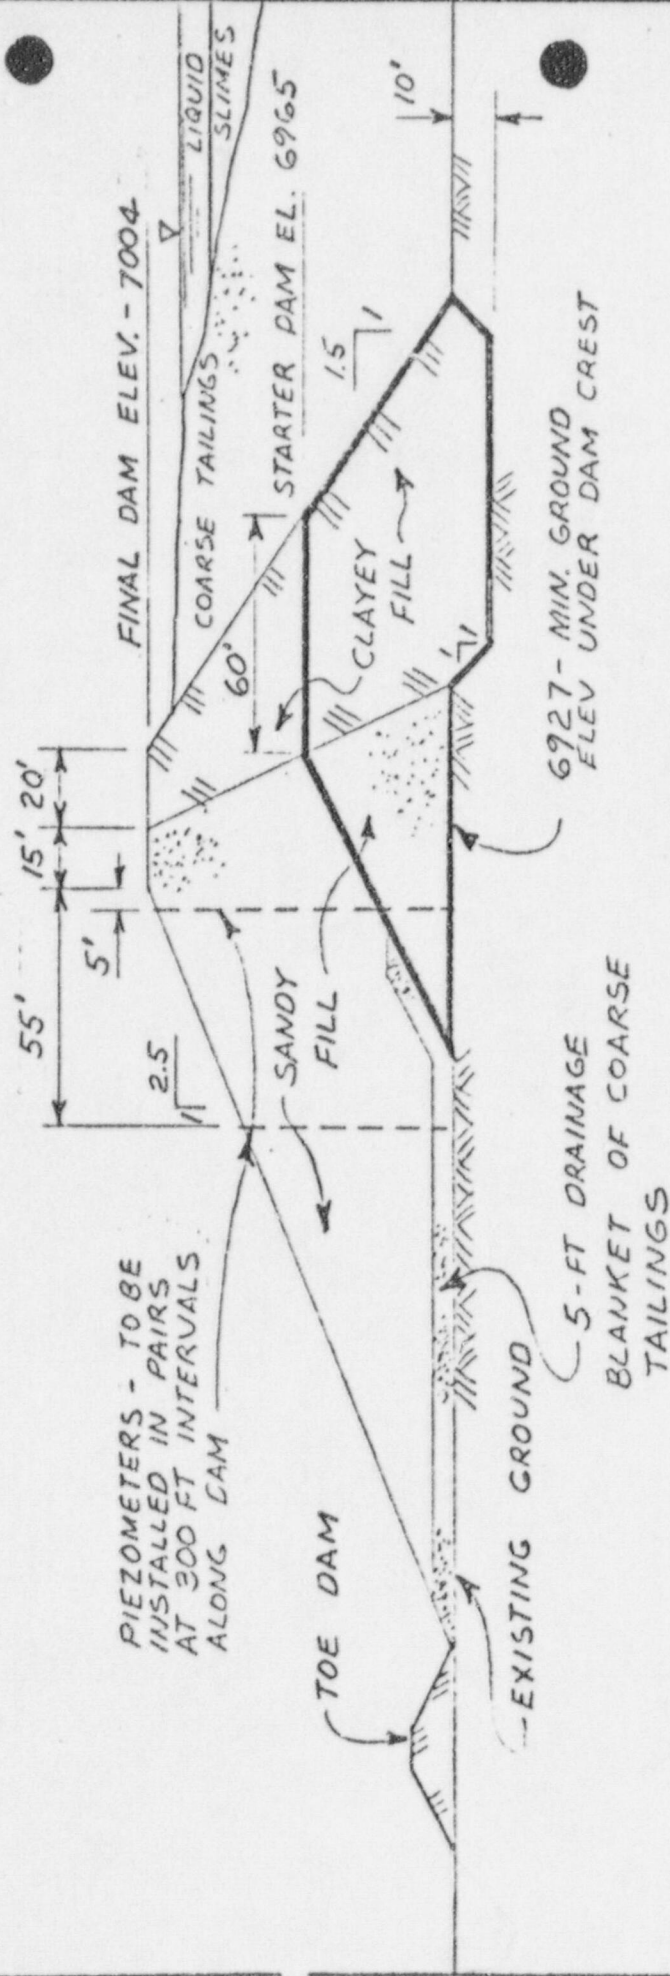
# TAILINGS DISPOSAL DAM TYPICAL SECTION SCALE 1" = 50'

The present design is shown on the attached cross section sketch and consists of compacted local soils. Tailings material will not be used for construction of the dam except for a 5 ft. layer of drainage material which will be constructed from coarse tailings sand. Tailings material must be used because clean sand or gravel suitable for use in the drainage layer is not available in the area. The dam consists of two sections. The first section consists of a core of relatively impervious clay soil which is placed in the upstream face of the dam. Its function is to minimize the amount of seepage through the dam. The second section consists of sandy soil placed in the downstream face. Its function is to keep the downstream side of the dam dry by allowing the small amount of seepage which passes through the core to drop quickly down into the drainage layer. The structural stability of the dam is

assured by keeping the downstream portion of the dam dry. Diagrams showing the seepage flow path are included in the February, 1976 report.
