**FSAR UPDATE**

**HUMBOLDT BAY ISFSI**

**FIGURE 2.6-47  
STRUCTURE CONTOUR MAP OF  
THE BAY ENTRANCE FAULT**

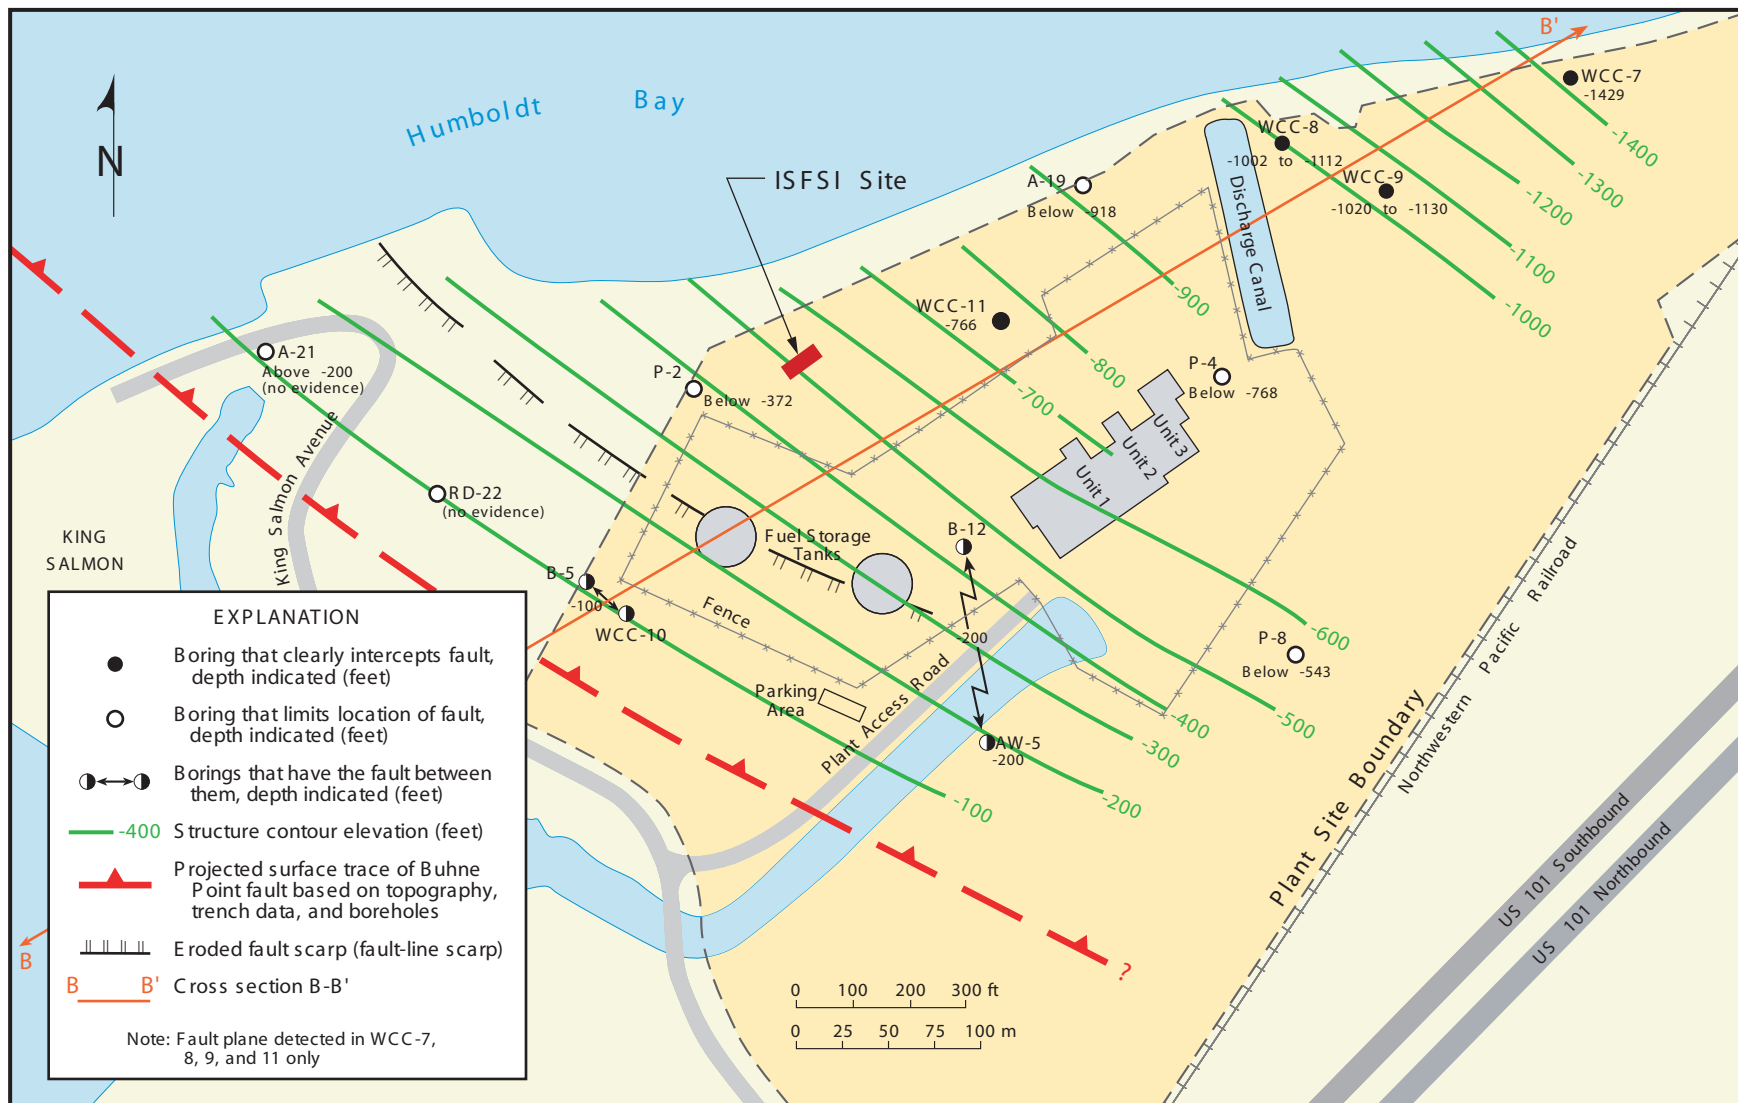
**FSAR UPDATE  
HUMBOLDT BAY ISFSI  
FIGURE 2.6-48**

**Structure contour map of the Buhne Point fault (reinterpretation of data presented on Woodward-Clyde Consultants, 1980, Figure C-25). Cross section B-B' is shown on Figure 2.6-50.**

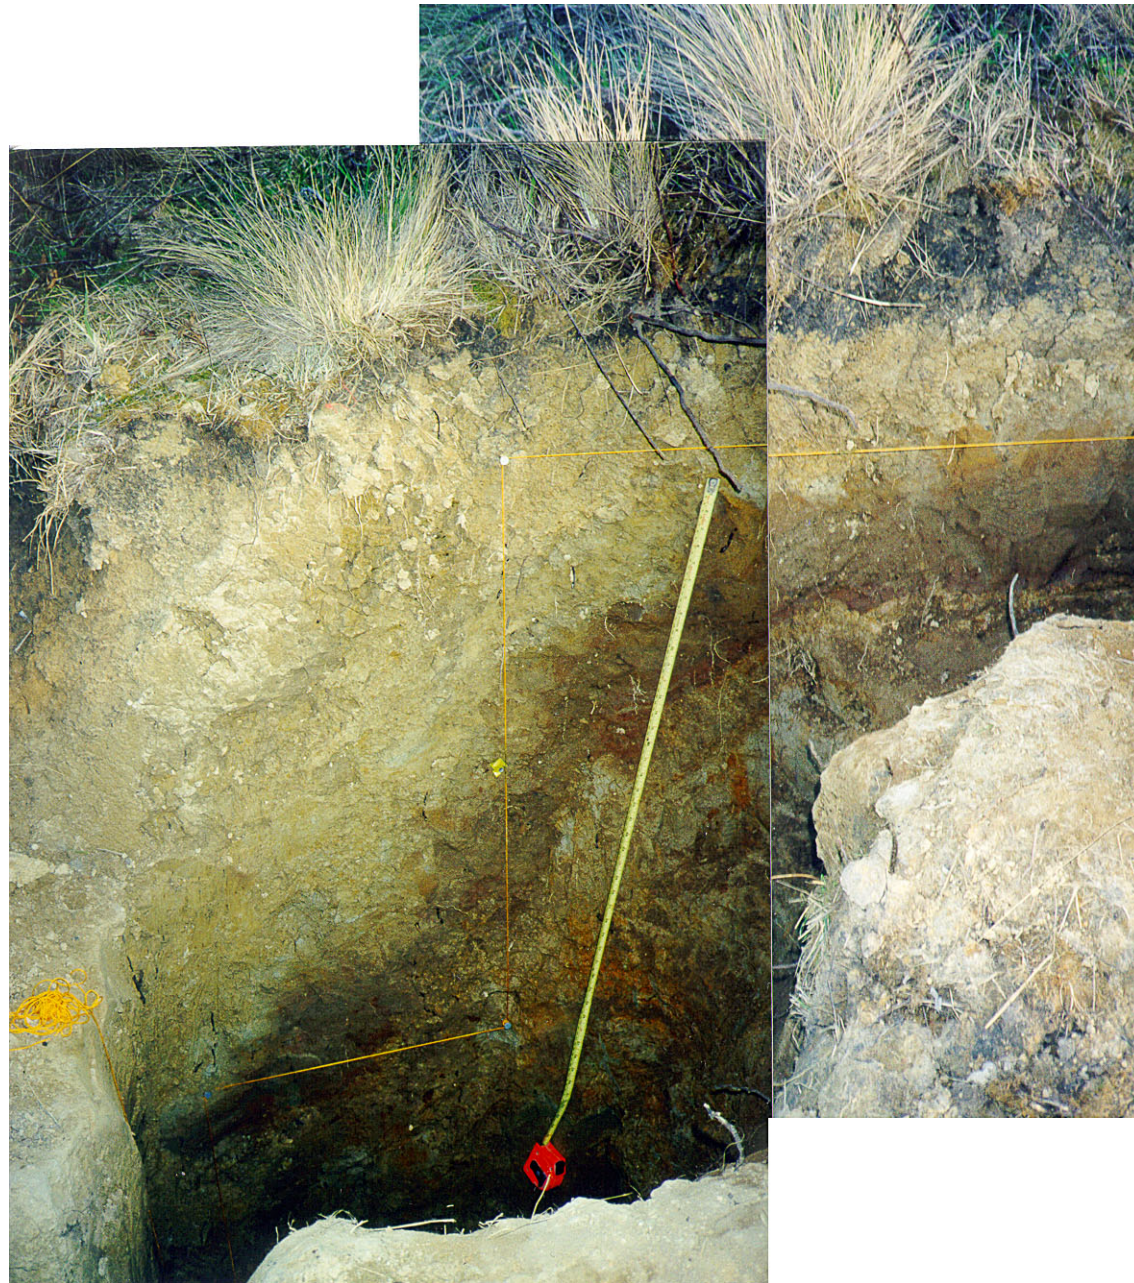
**FSAR UPDATE  
HUMBOLDT BAY ISFSI  
FIGURE 2.6-56**

**Exposure of Discharge Canal fault in sea cliff west of Discharge Canal. The vertical string line in the middle of the photograph is 100 cm long. (Photographs JW-3-23 and 24; taken on March 21, 2000). Location of exposure is shown as outcrop JW-7 on Figure 2.6-31.**

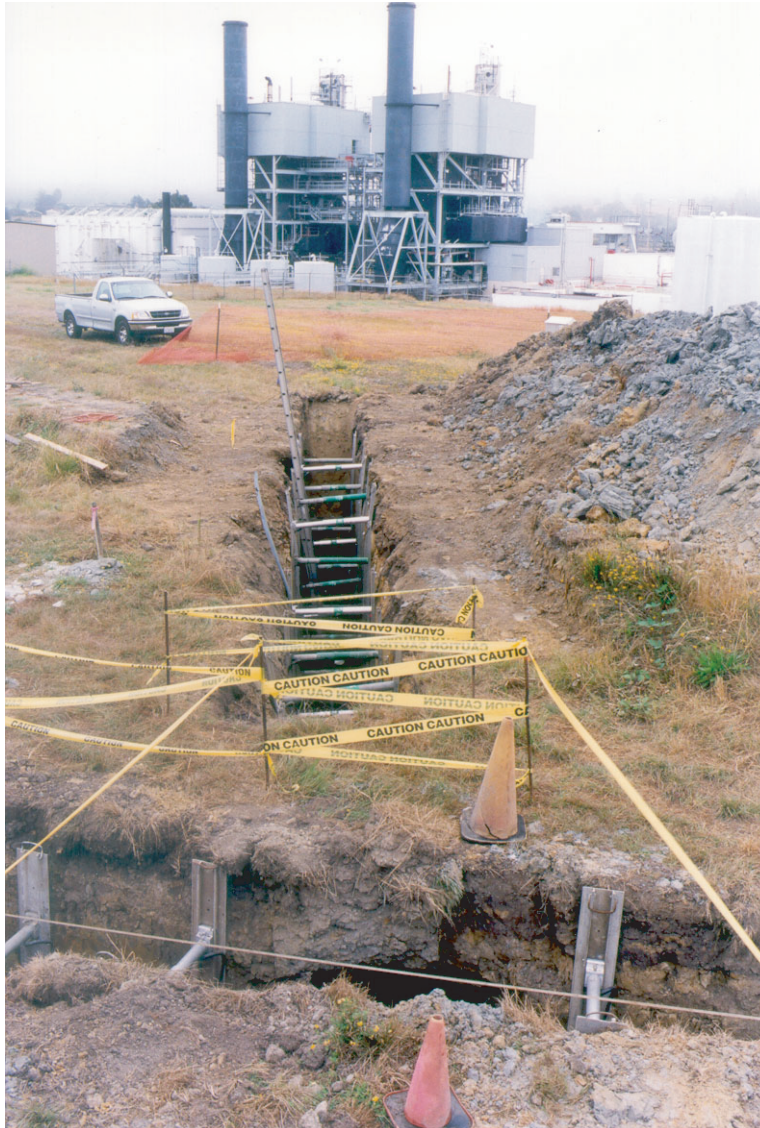
**FSAR UPDATE  
HUMBOLDT BY ISFSI  
FIGURE 2.6-60**

**Trench GMX-T1, view east-southeast. View along trench with Humboldt Bay Power Plant in the background. Part of trench GMX-T2 is in the foreground. (Photograph FHS-00/8-1 #29 taken August 1, 2000.)**

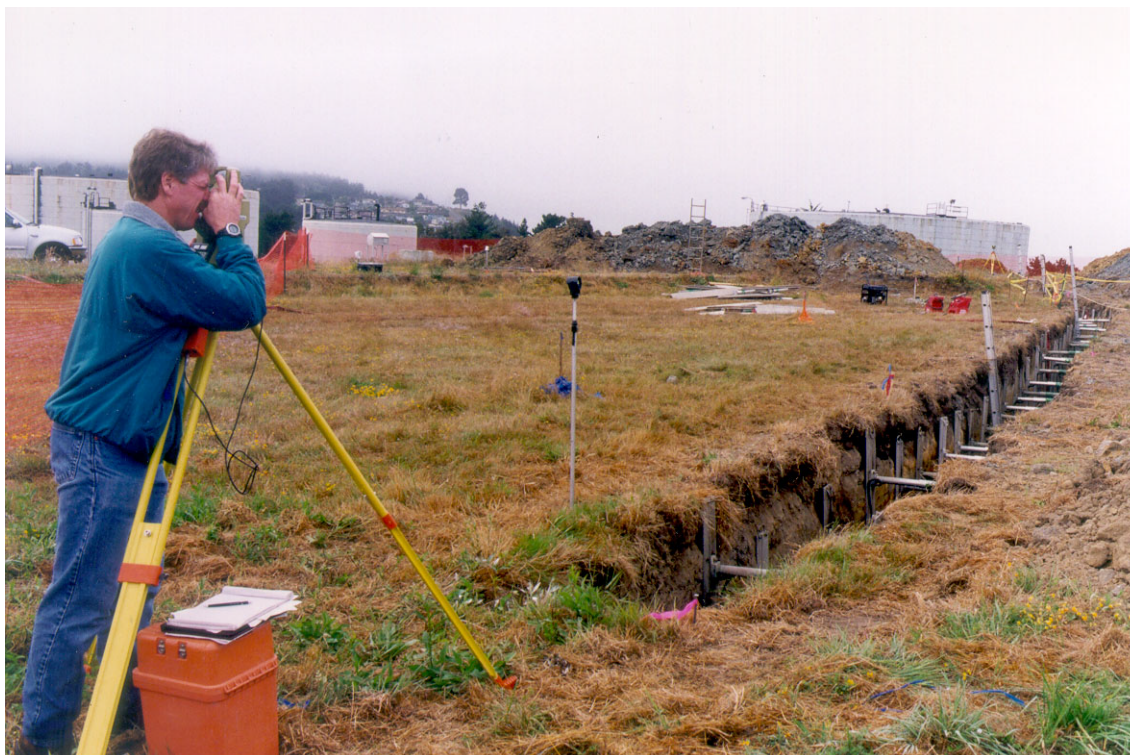
| <b>FIGURE 2.6-61</b><br><b>SURVEYING GEOLOGIC CONTACTS</b><br><b>IN TRENCH GMX-T2.</b><br><b>VIEW IS TOWARD THE SOUTH.</b><br><b>(PHOTOGRAPH FHS-00/7-4 #9 TAKEN</b><br><b>AUGUST 1, 2000.)</b> |

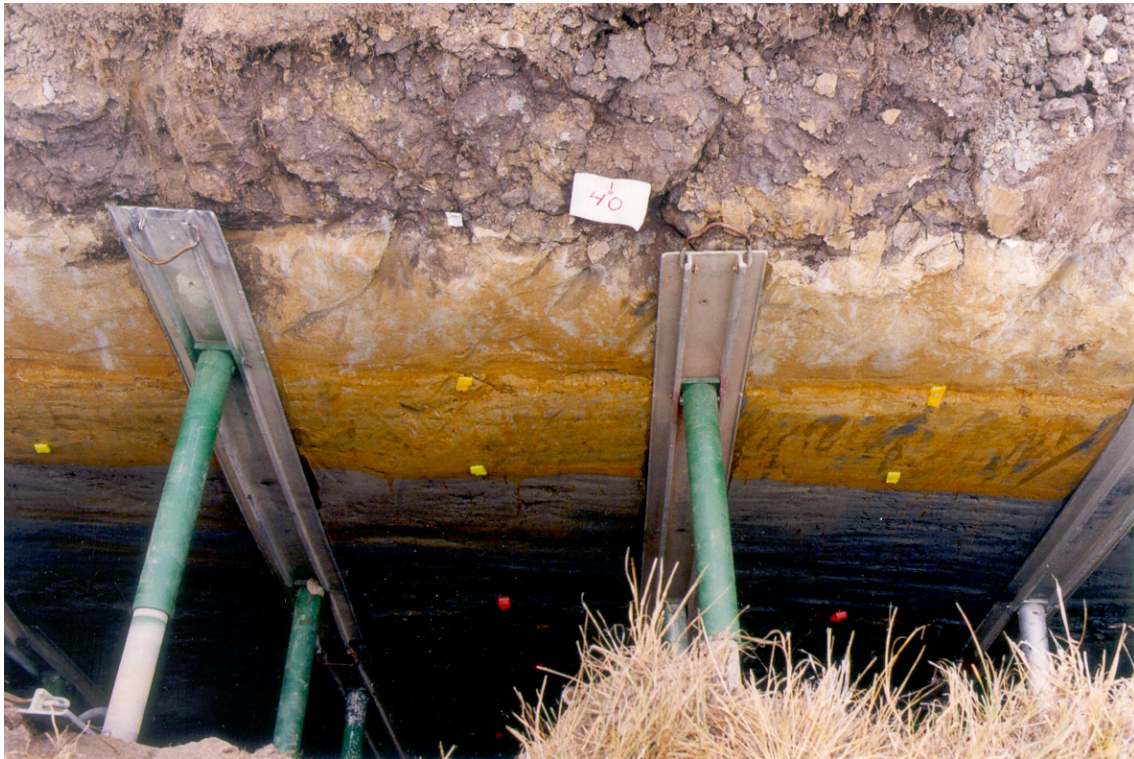
**SAFETY ANALYSIS REPORT  
HUMBOLDT BAY ISFSI  
FIGURE 2.6-62**

**Artificial fill overlying sand and silt layers of the upper Hookton Formation in northwest wall of trench GMX-T2 between station 36 ft. and station 44 ft. (Photograph FHS-00/7-4 #19 taken August 1, 2000.)**

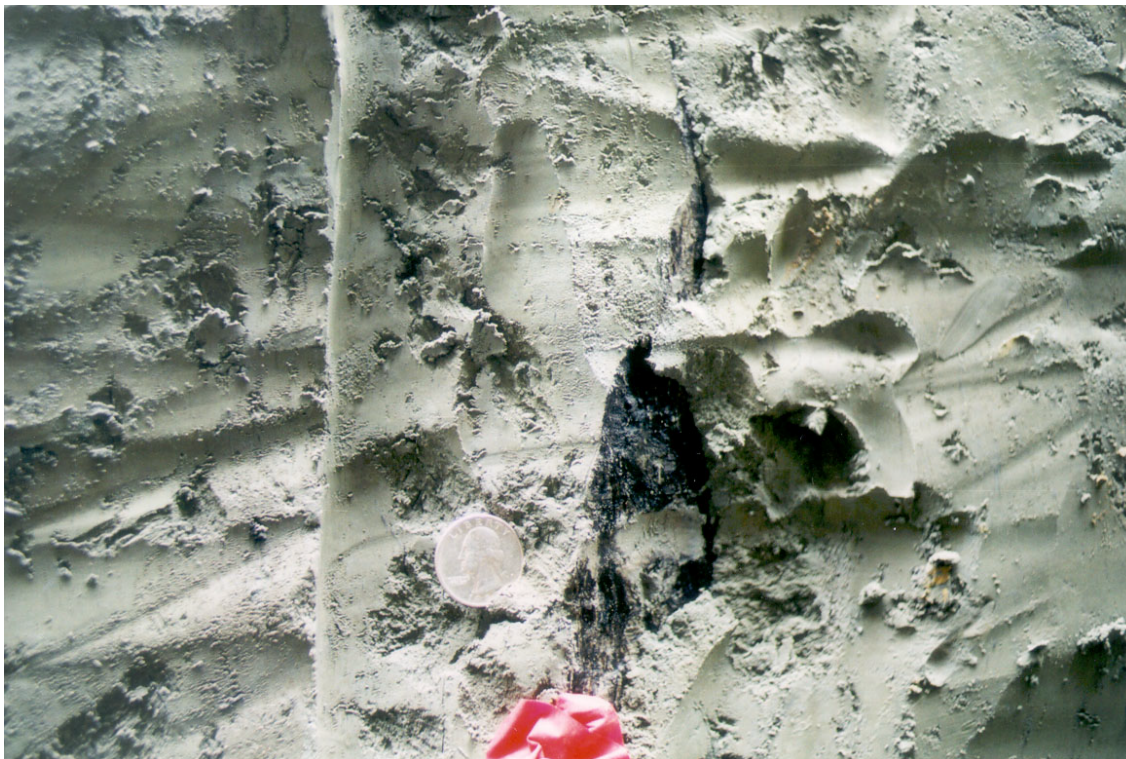
**FSAR UPDATE  
HUMBOLDT BAY ISFSI  
FIGURE 2.6-64**

**Fracture lined with black compressed rootlets in clayey-silt bed in trench GMX-T2. Fracture is at station 40 ft., depth ~11 ft. (Photograph FHS-00/7-3 #21 taken August 3, 2000.)**

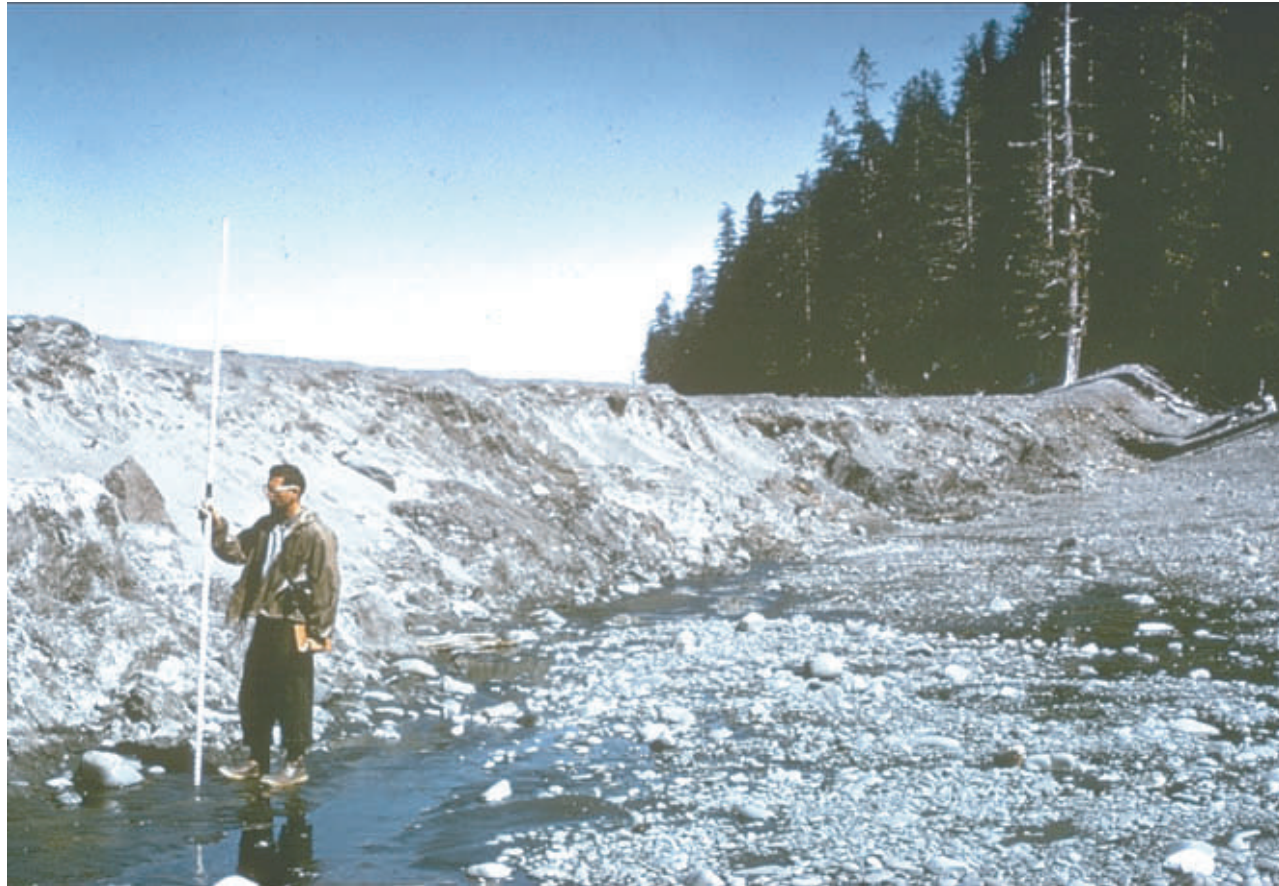
**FSAR UPDATE  
HUMBOLDT BAY ISFSI  
FIGURE 2.6-74**

**[Collapsed fault scarp in alluvium on the Hanning Bay fault, Montague Island, Alaska. The fault dips to the left into the scarp that formed during the 1964 Alaska earthquake (from Plafker and others, 1969).**

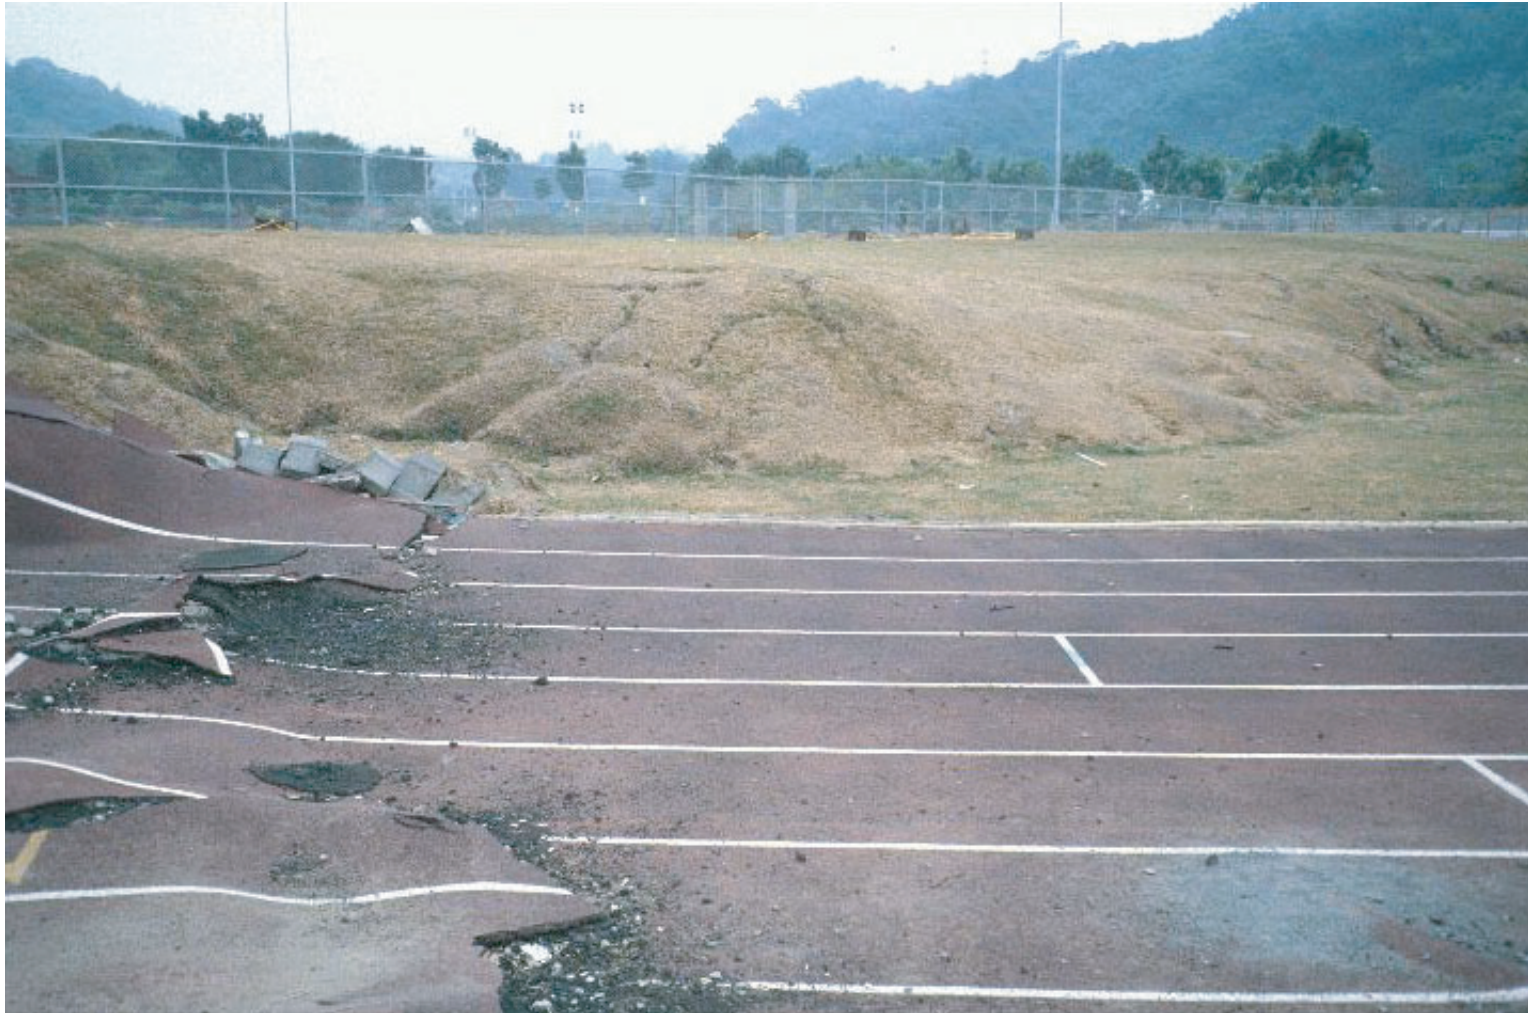
**FSAR UPDATE  
HUMBOLDT BAY ISFSI  
FIGURE 2.6-76**

**Fault scarp on the Chelungpu fault at the Kuang Fu Middle School, Taiwan. The scarp, formed during the 1999 Chi-Chi earthquake, illustrates the type of faulting in which the fault tip follows the ground surface.**

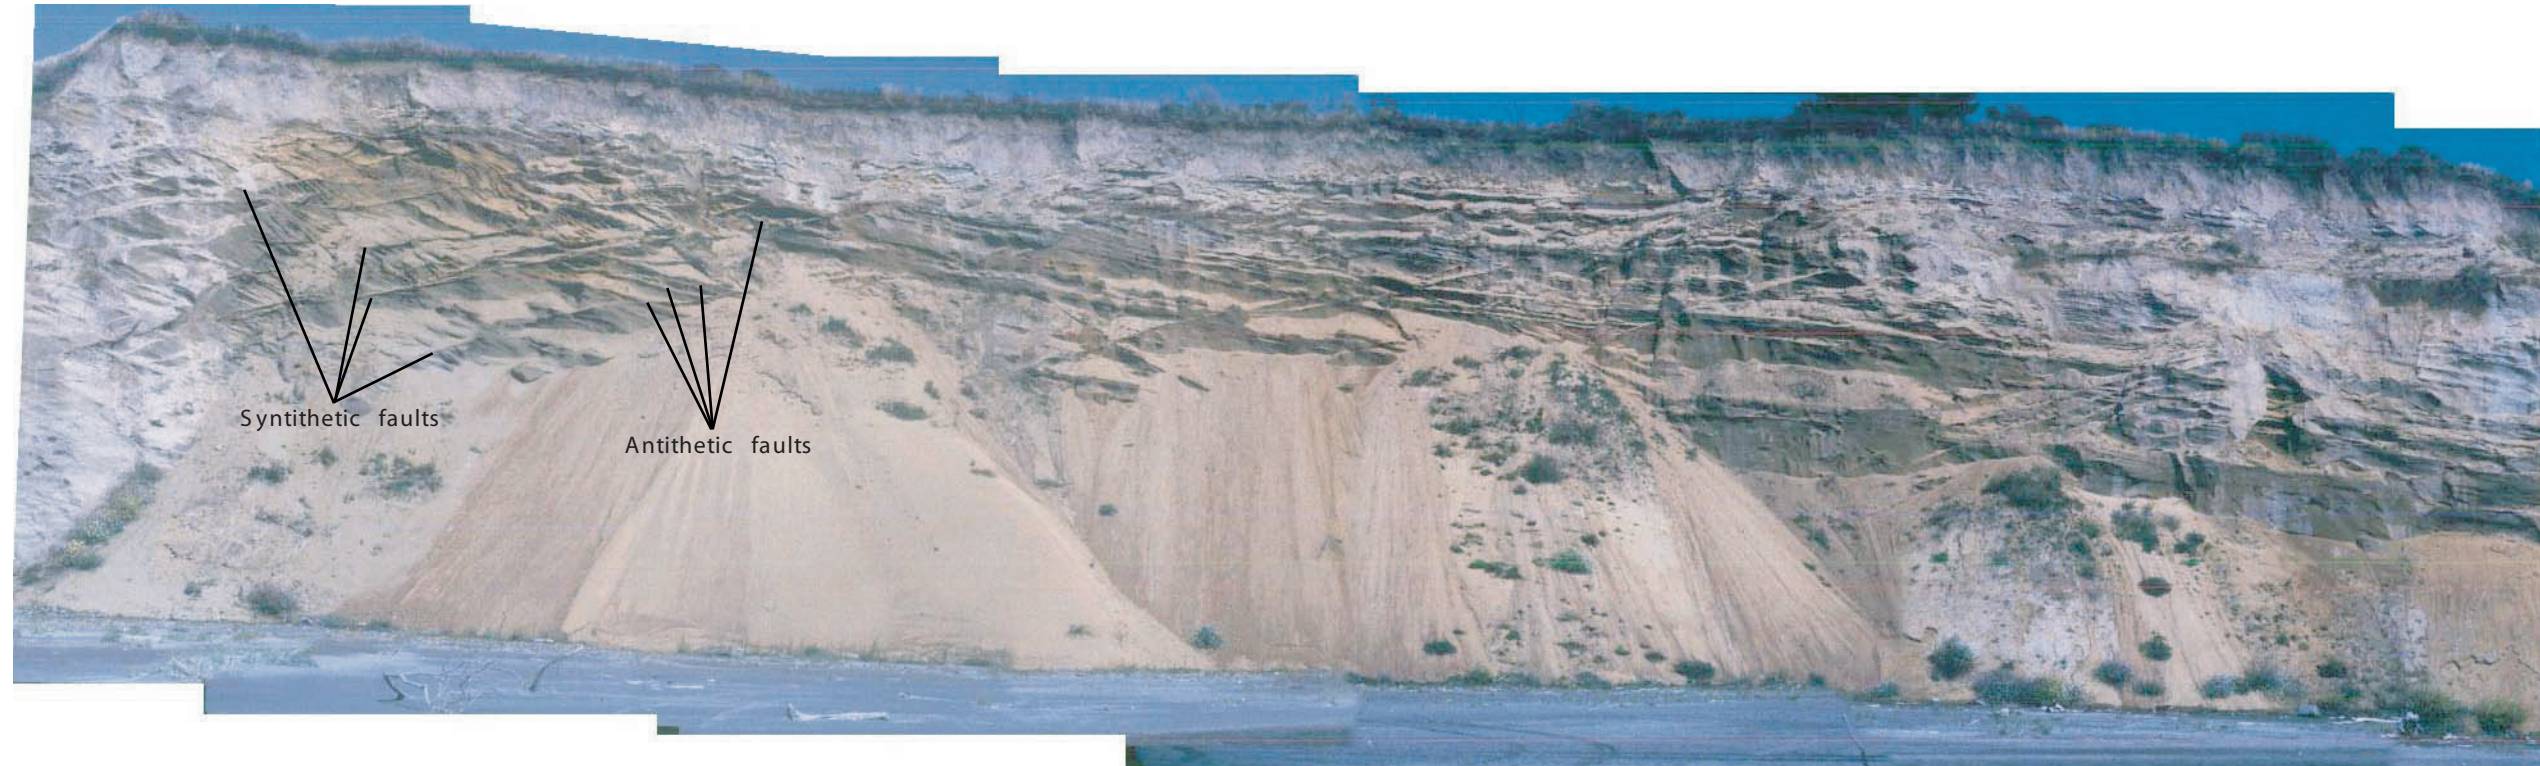
(a) Complex zones of deformation in the hanging wall of the McKinleyville fault (Mad River fault zone) exposed in the sea cliff at Clam Beach, north of Arcata (photograph by Thomas Dunklin, Arcata, California, 1999). The displacement is up to the northeast. The cliff is about 35 m high, and the photo shows a section about 150 m long.

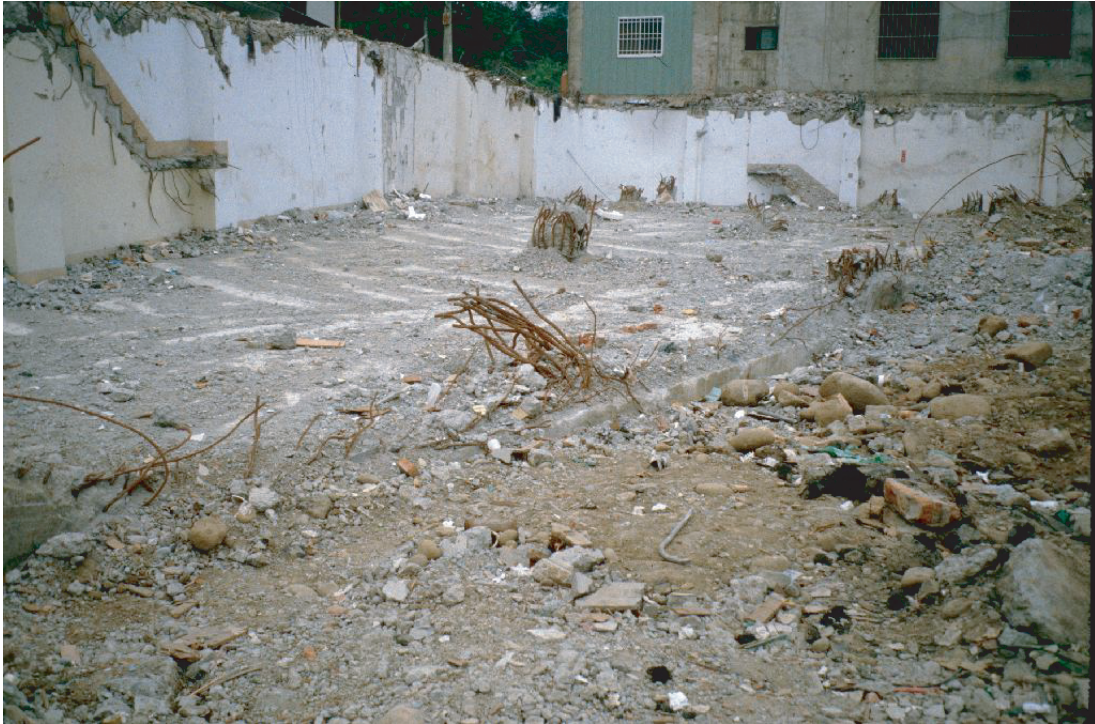
A) Fault bend fold appears as flexure on the floor of a building destroyed by surface faulting during the 1999 Chi-Chi earthquake.

### **FIGURE 2.6-81 FAULT BEND FOLD AND ASSOCIATED SHEARS AND FRACTURES ON THE CHELUNGPU FAULT, FENGYUAN, TAIWAN**

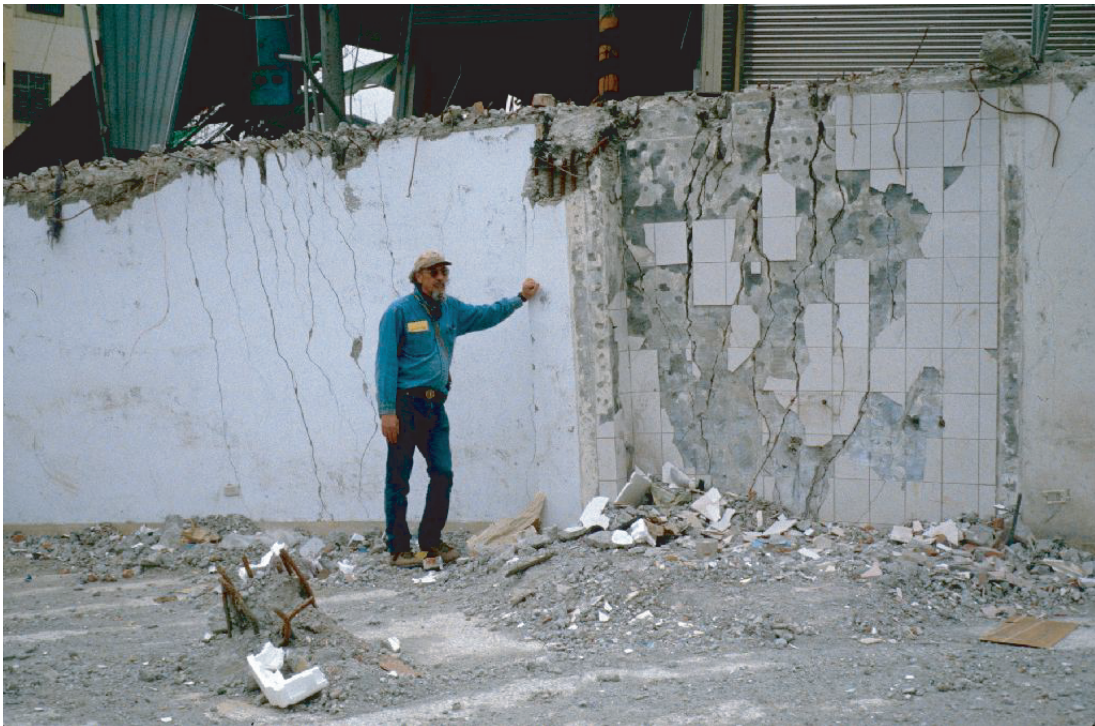
B) Shears and fractures in wall over the fault bend fold shown above.

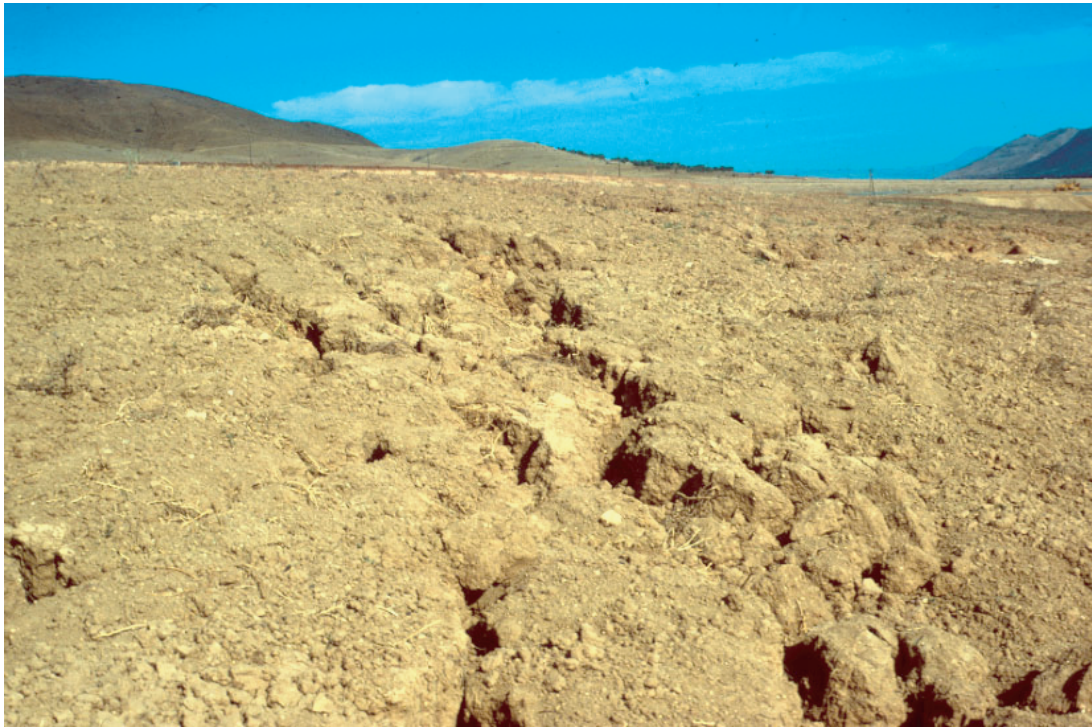
A) Tensional cracks and normal faults that formed in the 1980 El Asnam earthquake along a secondary fault that is about 7 kilometers from the main fault trace (photograph by F. H. Swan).

**FIGURE 2.6-82  
FRACTURES AND FAULTS IN THE  
HANGING WALL OF THE OUED  
FODDA FAULT, ALGERIA**
