SEABROOK STATION UPDATED FINAL SAFETY ANALYSIS REPORT	Regional Geologic Profile	
		Figure 2.5-3

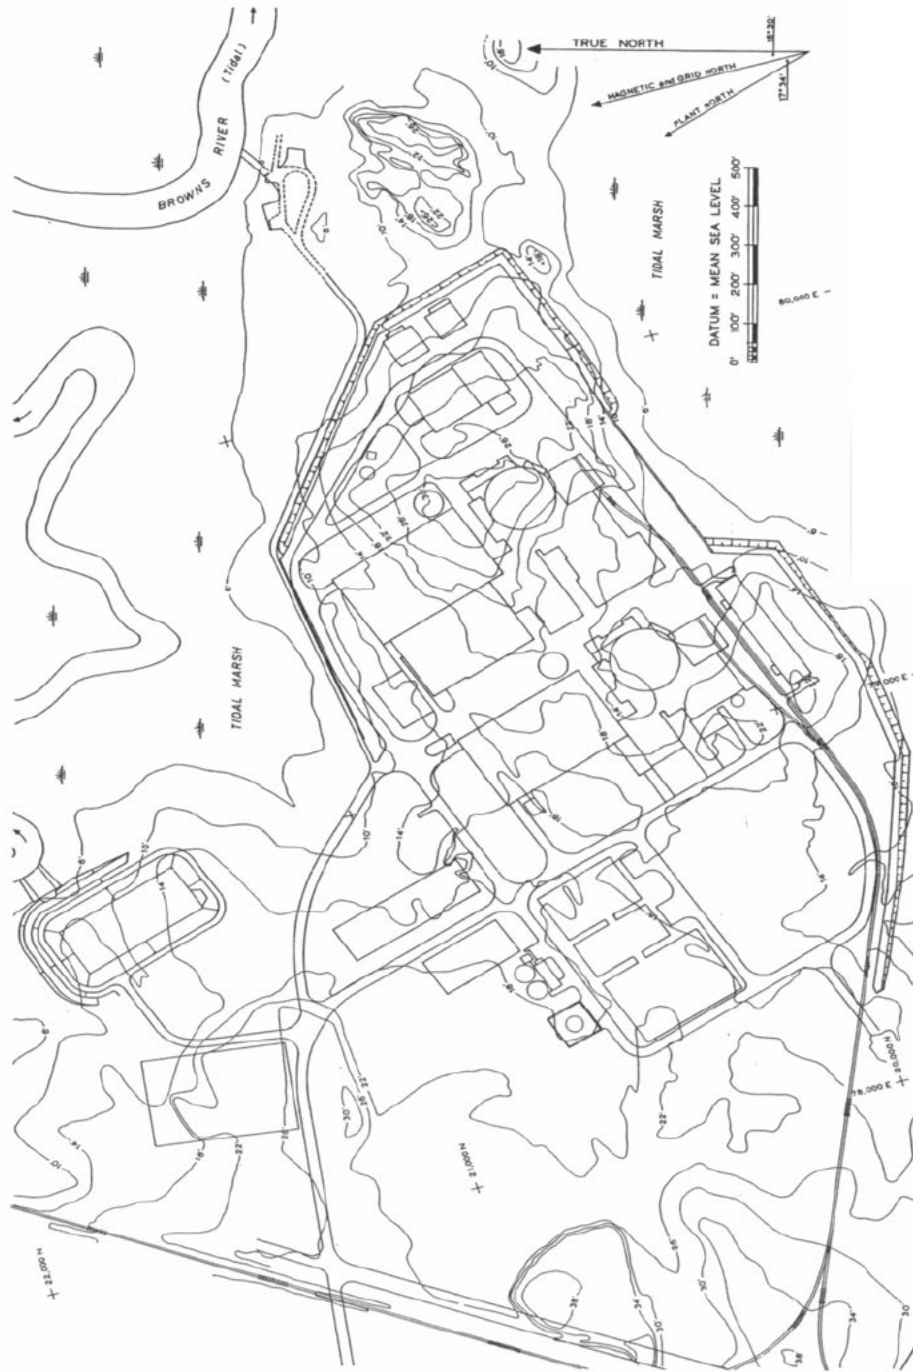
SEABROOK STATION UPDATED FINAL SAFETY ANALYSIS REPORT	ite Area – Plot Plan and Original Surface Topography	
		Figure 2.5-15
