# **Duane Arnold Energy Center Loss of Offsite Power Due to Derecho**

**May 27, 2021**

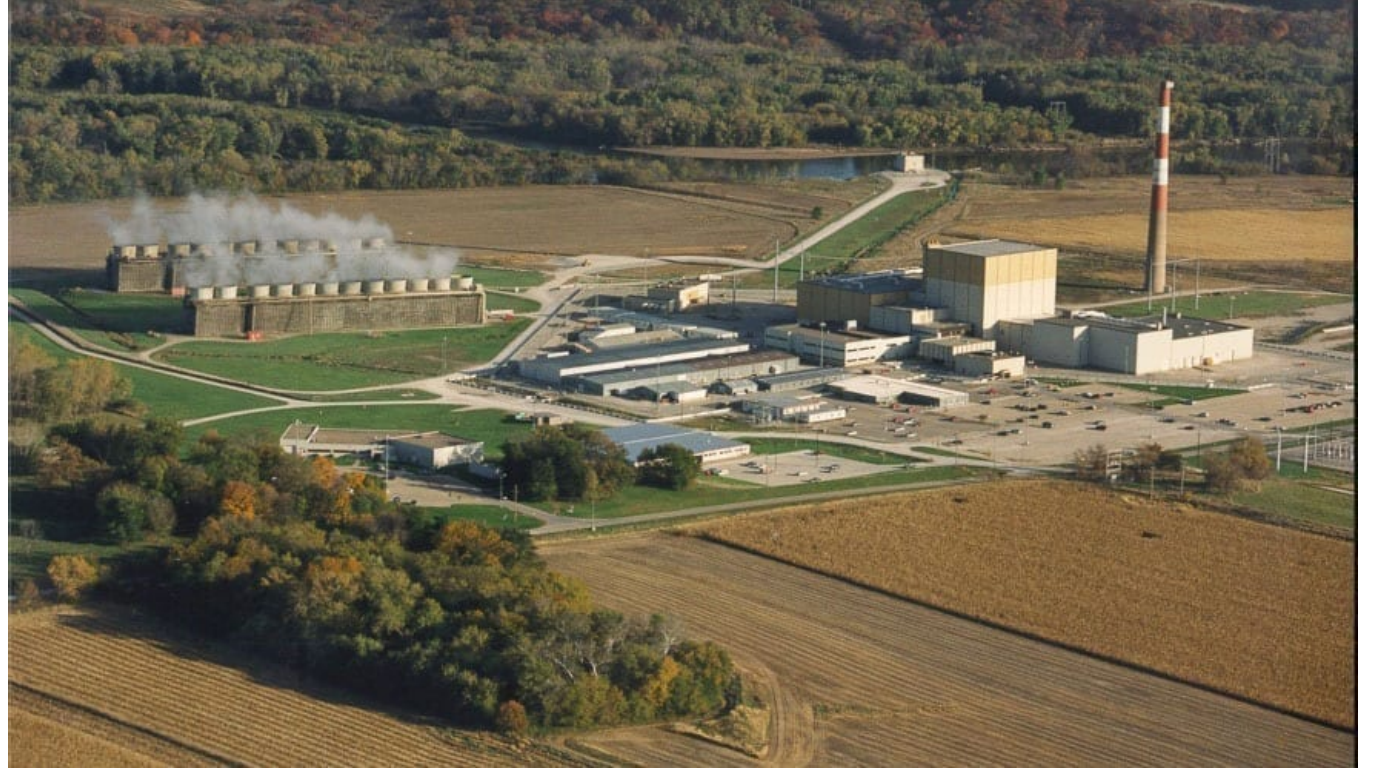
# DAEC Overview

- **GE BWR/4 – Mark I Containment**
- **Rated Thermal Power 1,912 MW(t)**
- **Rated Net Electric Power ~615 MW(e)**
