RE: St. Lucie Nuclear Plant, Unit 1
Docket No. 50-335
Refueling Outage SL1-30
Steam Generator Tube Inspection Report

SL1-30 Steam Generator Tube Inspection Report

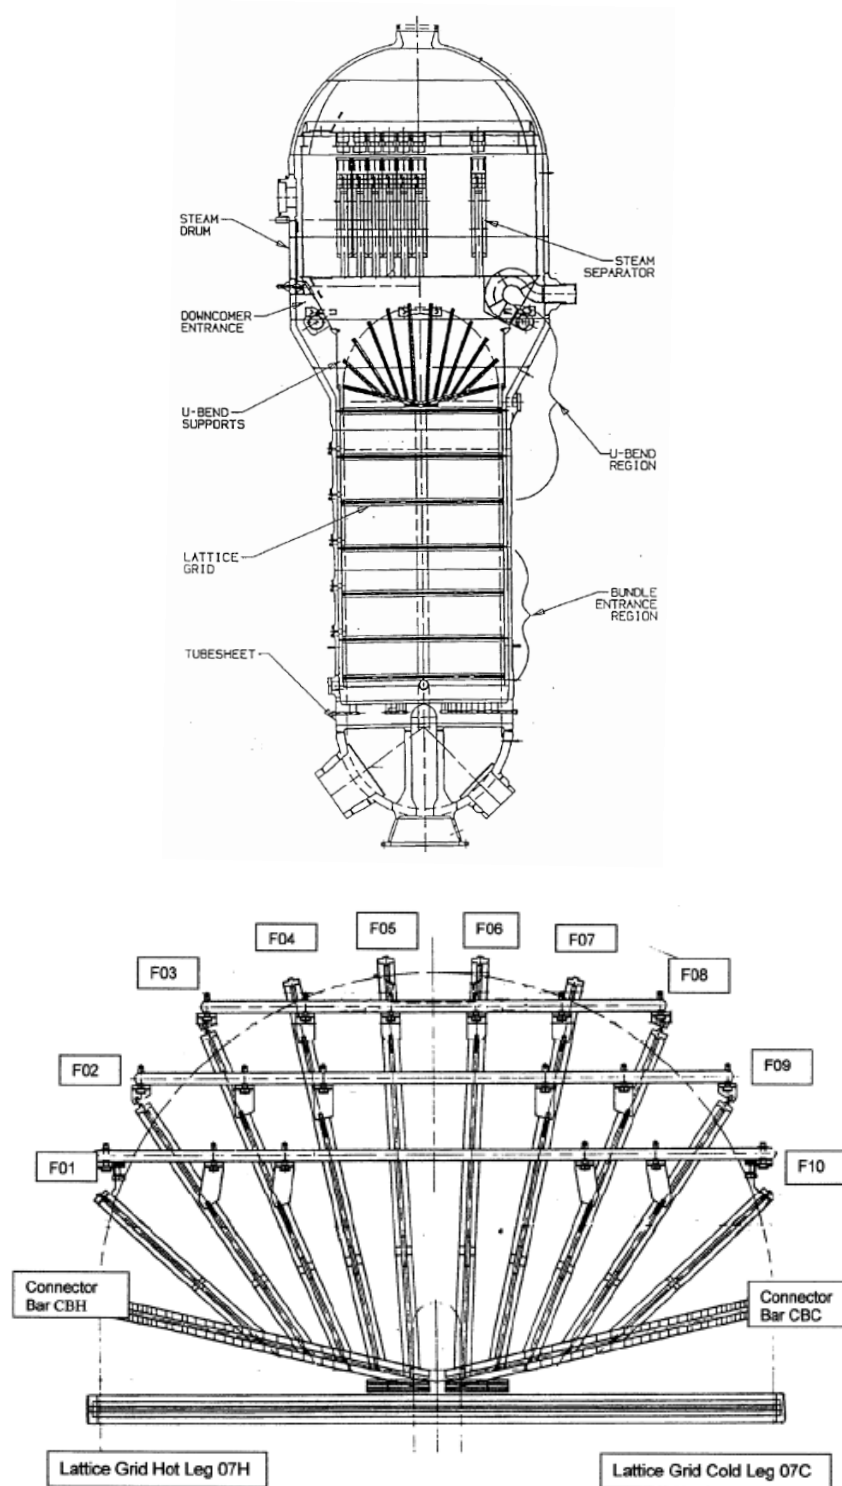
Note: Seven horizontal lattice grid support (LGS) elevations are labeled sequentially from bottom to top as 01H to 07H (or 01C to 07C) according to the following table. There is no baffle plate.

Tube Support	Horizontal LGS designation						
	1	2	3	4	5	6	7
Hot Leg	01H	02H	03H	04H	05H	06H	07H
Cold Leg	01C	02C	03C	04C	05C	06C	07C
