Finding of No Significant Hazard

In a license amendment request dated December 23, 2021, the NIST Center for Neutron Research (NCNR) requested an amendment to the facility license Technical Specifications (TS). As required by 10 CFR 50.91(a), the following analysis is presented to show the proposed amendment does not create a significant hazard using the criteria of 10 CFR 50.92(c).

3.9.2 Fuel Handling

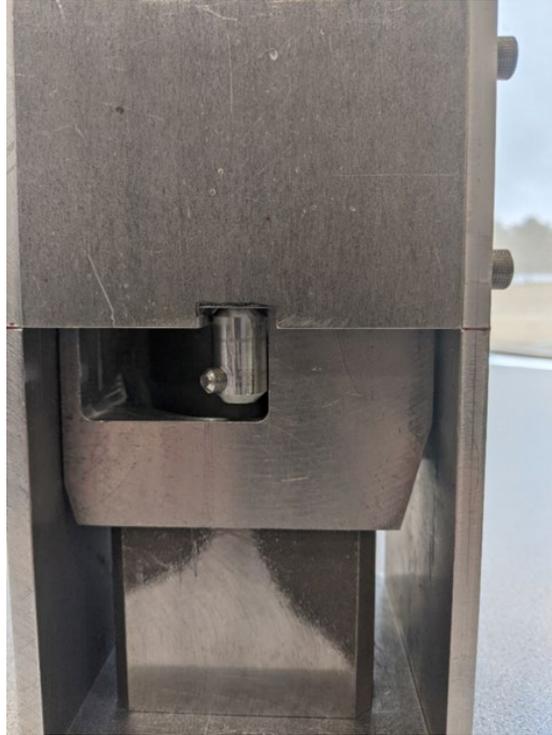
Figure 1. Fuel element head latched into a mockup of the upper grid plate.

Upon movement of a fuel element to its intended position in the core grid, the final mechanical manipulation is to push down on the fuel element head via the pickup tool and compress the spring on the head to move the latch to below the bottom of the upper grid. The tool is then rotated counterclockwise about 45° to its full stop position thus moving the latch underneath the notch in the upper grid. The tool is then raised slightly to release the spring, thus setting the latch into the notch. See Figure 1.

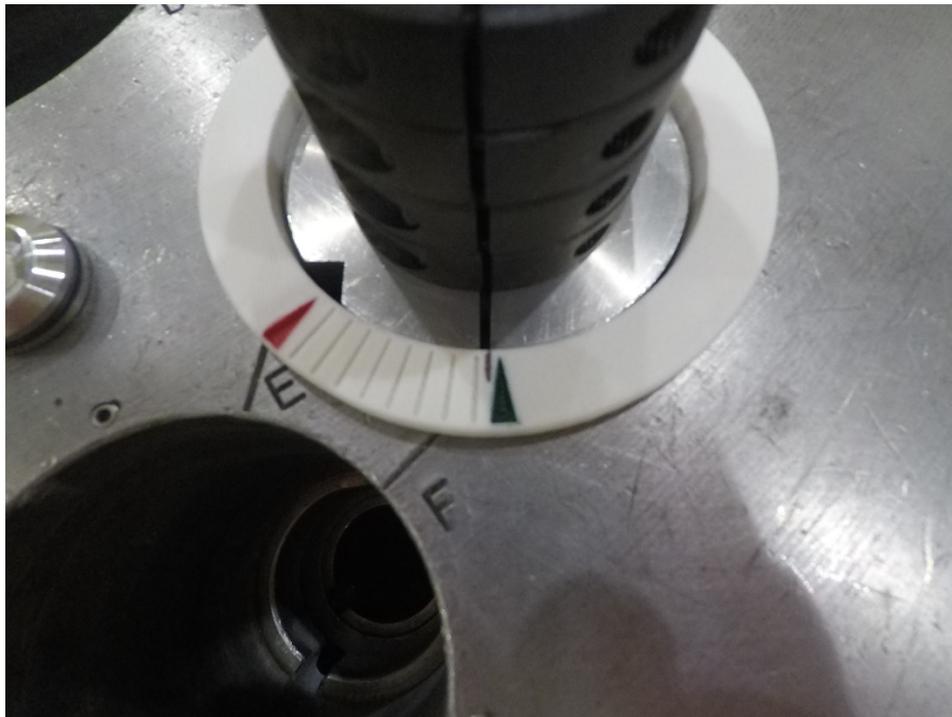
Figure 2. Fuel element latched in position H-7 (note: in this prototype the fully latched green triangle is about 2° off of the actual fully latched position. This will be corrected in future prototype and design development.)

Prior to removal of the tool from the head, the azimuthal position of the collar affixed to the tool is checked against fiduciary marks on a sleeve inserted into the element position in the index plate. Figure 2 shows the rotational check on a fully latched element against a prototype sleeve that is slipped into the tooling plate and that has fiduciary marks indicating latched (green triangle) and fully unlatched (red triangle). These marks are true fiduciary marks in that they relate back to machined notches in the bottom of the tooling plate that are true to the cartesian axis system of the upper grid plate. Figure 3 shows the rotational check of the same element with the latch bar in a position that is still within the notch, but rotated in a clockwise direction. Note that, although latched, this element *would be assessed as unacceptable* and would need to be rotated so that the indication aligns with the green fiducial reference mark. Obviously, elements found rotated further clockwise (and likely out of the notch) would also be found unacceptable. Variations of rotation angles due to tolerances in the upper grid plate and notches are being evaluated and will be clearly indicated on future designs of the marked sleeve to give a clear “passing” criterion.

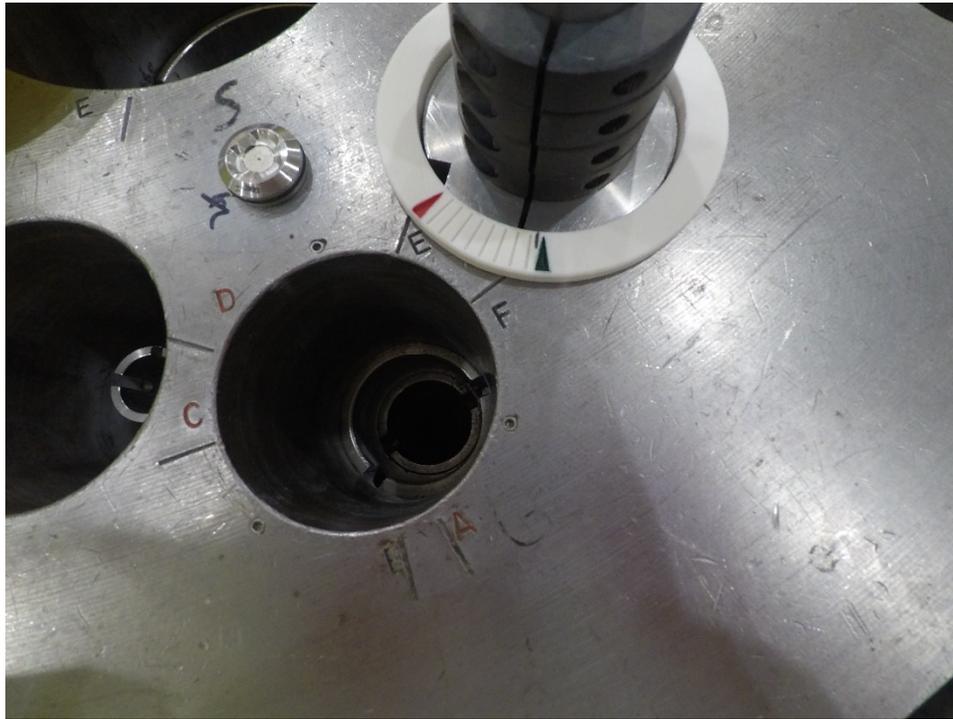
Figure 3. Fuel element in with latch about 6° off of full counterclockwise, but still in notch (H-7).

Photos of the video results of a test with a fully latched element in core position I-6 is shown in Figure 4. A photo of the H-7 element rotated about 6° off of full counterclockwise (the same as in Figure 3) is shown in Figure 5. The difference between the two can be easily seen, as the “ears” of the rotated element are clearly off perpendicular and would be rejected. Further rotation clockwise would also have the latch bar coming into view. As in the rotation check, evaluations are being made to clearly define acceptable visual check angle deviations.

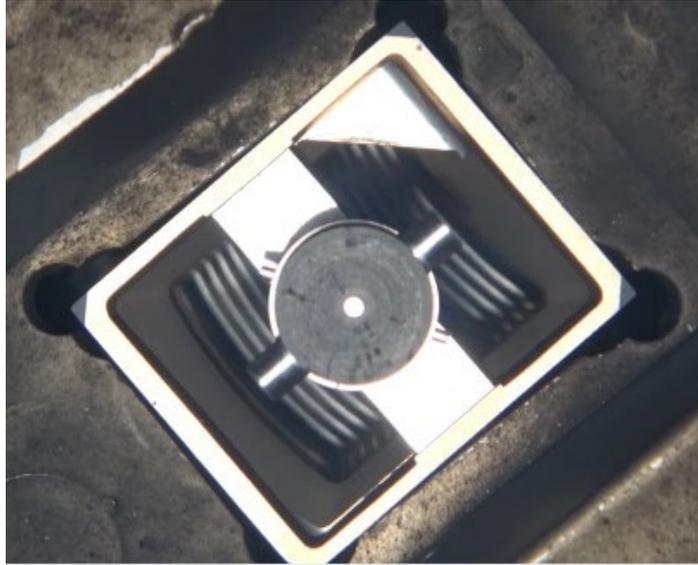
Figure 4. Video capture of element in latched position (core position I-6)

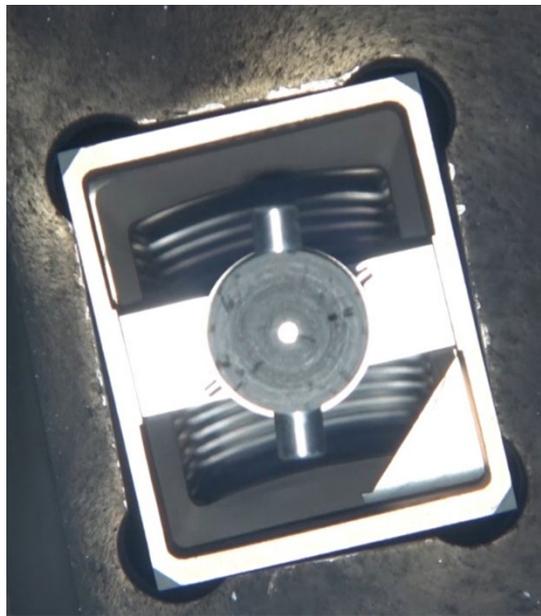
Figure 5. Video capture of element with latch rotated clockwise within the notch (core position H-7)
