**UNITED STATES
NUCLEAR REGULATORY COMMISSION**

**SUBJECT: GRAND GULF NUCLEAR STATION – INTEGRATED INSPECTION
REPORT 05000416/2021004**

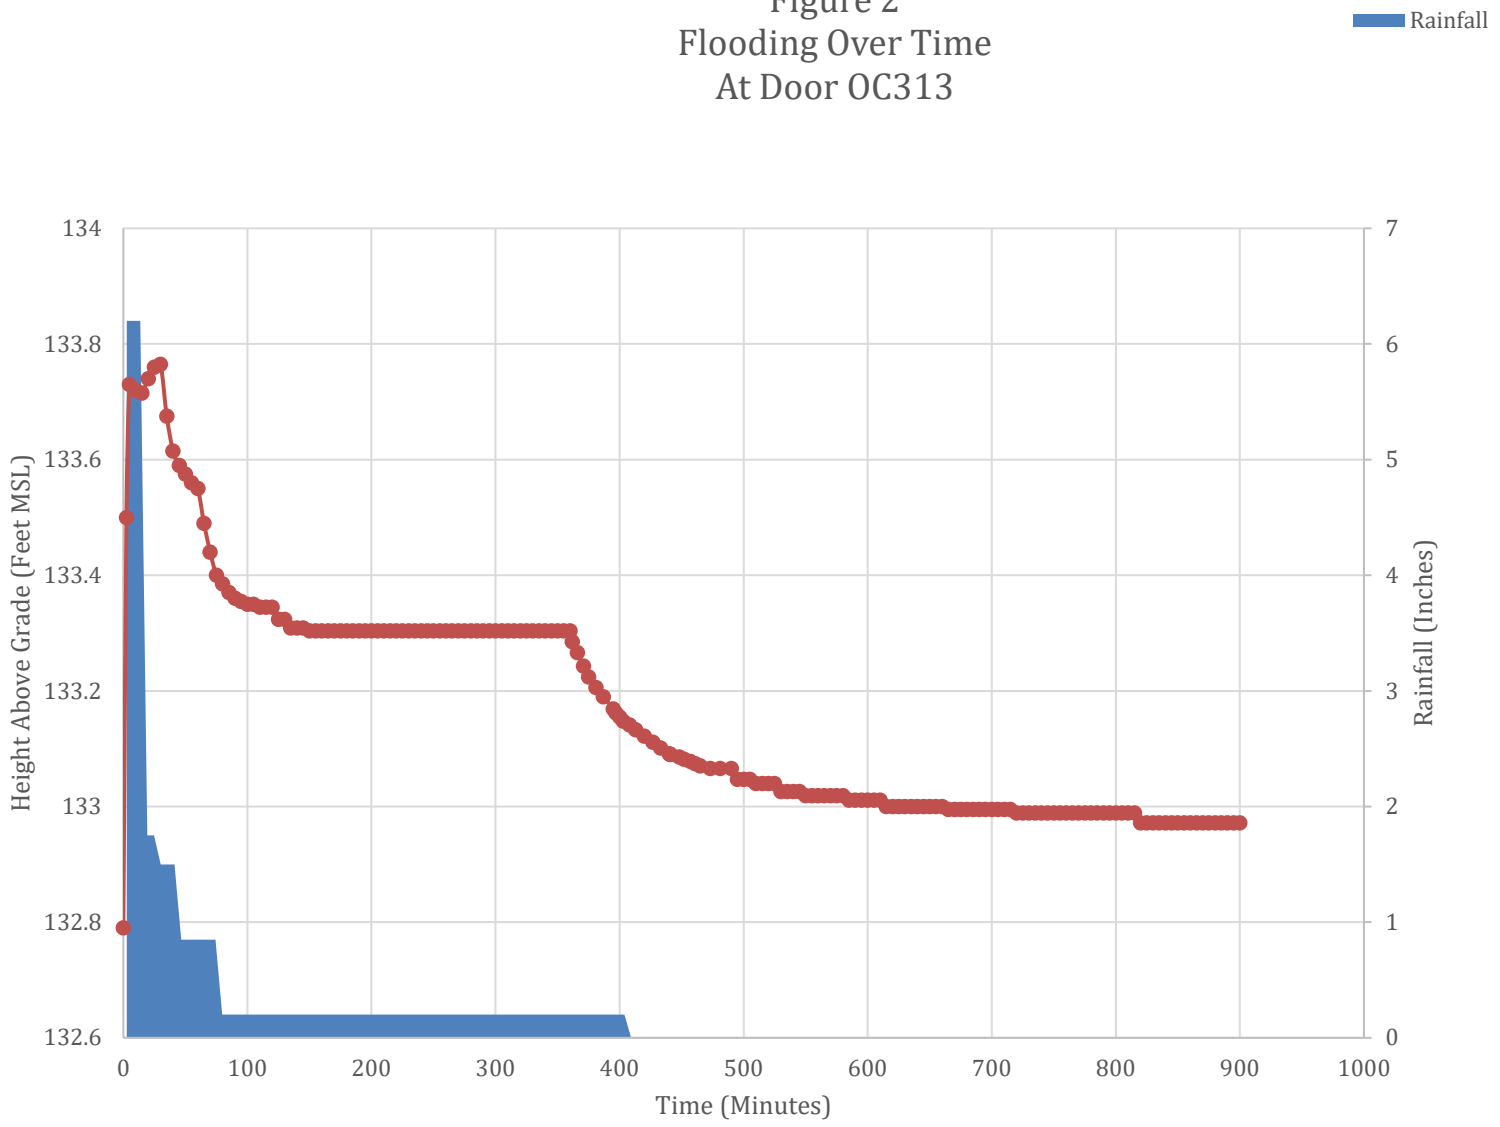
Figure 2
Flooding Over Time
At Door OC313

6. The hyetograph developed from Assumption 5 and provided in Figure 2 is appropriate for the subject assessment.
7. Figure 1, Figure 2, and flood elevations developed from the probable maximum precipitation, the current design basis, and the local intense precipitation events are the best available information for use in developing a flood height hazard curve.
