**UNITED STATES
NUCLEAR REGULATORY COMMISSION**
REGION II
245 PEACHTREE CENTER AVENUE N.E., SUITE 1200
ATLANTA, GEORGIA 30303-1200

SUBJECT: SURRY POWER STATION – INTEGRATED INSPECTION REPORT
05000280/2023001 AND 05000281/2023001

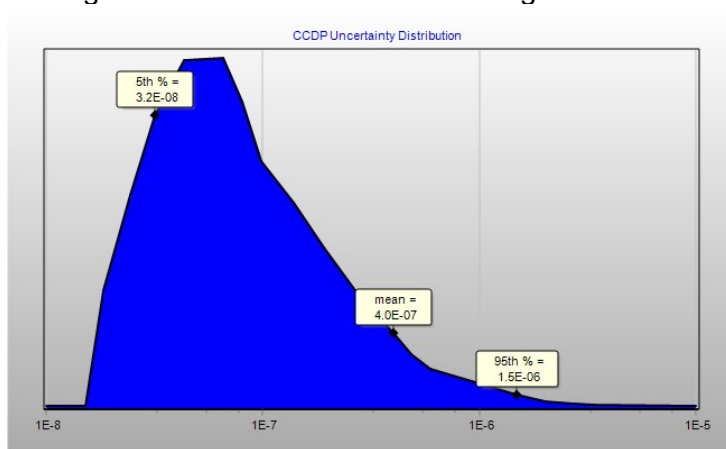
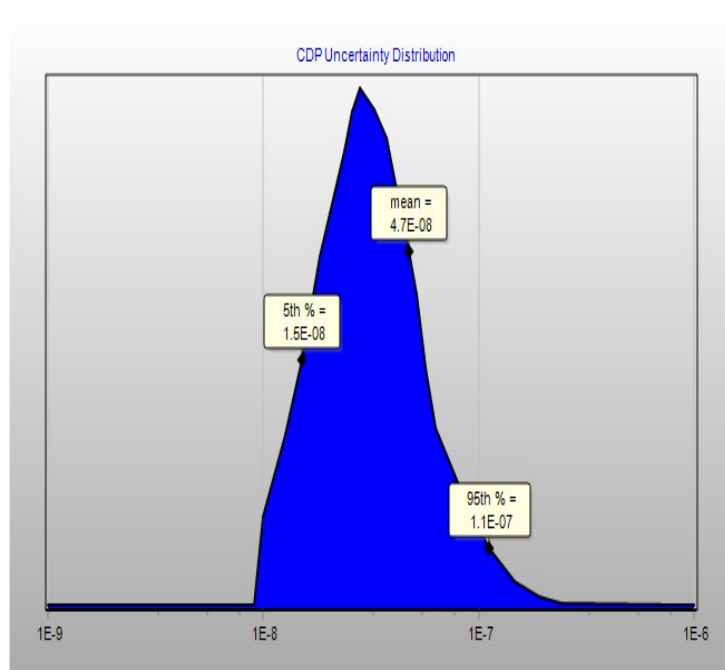
- 1) Varying HEP for establishing alternate cooling
- 2) By varying FLEX equipment reliability using Nominal, x3, and PWROG data
- 3) Common Cause sensitivity by setting failure to of 1-VS-7 FTR to True (CC) and 1.0 (No CC)

S1- No FLEX credit no repair credit

S2-Nominal FLEX Credit no repair credit

S3-Nominal FLEX Credit no repair and HEP Adjustment

S4-PRIB FLEX Credit (3X nominal) no repair and HEP Adjustment

FLEX CREDIT Comparisons with HEP Adjustments but no repair credit.

The HVC-XHE-XA-ALTHVAC and HVAC-REPAIR terms were the most sensitive terms. Each term would be present in all cut sets involving a failure of an AHU, so any change of either term results in approximately the same magnitude change in total risk.
