REPORT ON HIGH ENERGY ARCING FAULT EXPERIMENTS

Photometrics Report for Medium-
Voltage Bus Duct and Switchgear
Enclosures

High Energy Arcing Fault (HEAF) Photometrics 2022 Test Report

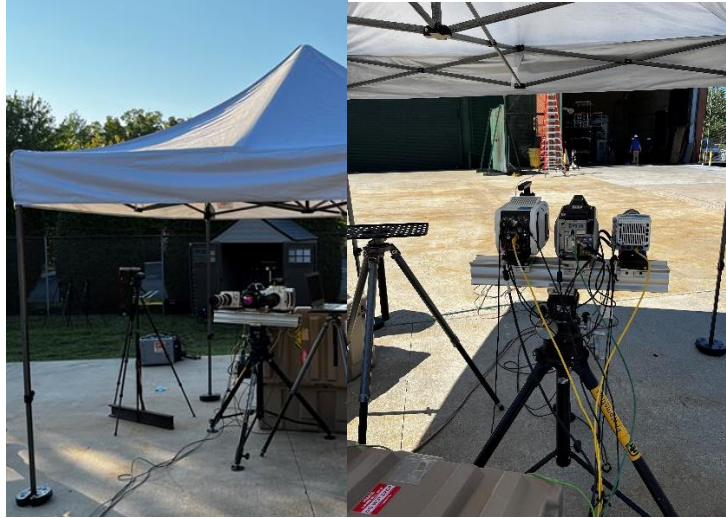
Figure 1-3: Front (left panel) and back view (right panel) of the HS remote cameras collecting during the bus duct tests.

Note that some cameras were deployed in a group: the v1212s, the 4k VEO and the X6901, as shown in Figure 1-3. This group of cameras was deployed at approximately 97 feet south/southwest from the test article to measure the speed of ejected material, provide fine timing of events, provide imaging through dust and smoke, determine breach timing, and capture an overall view. The cameras were placed close to each other with the intention of reducing parallax.

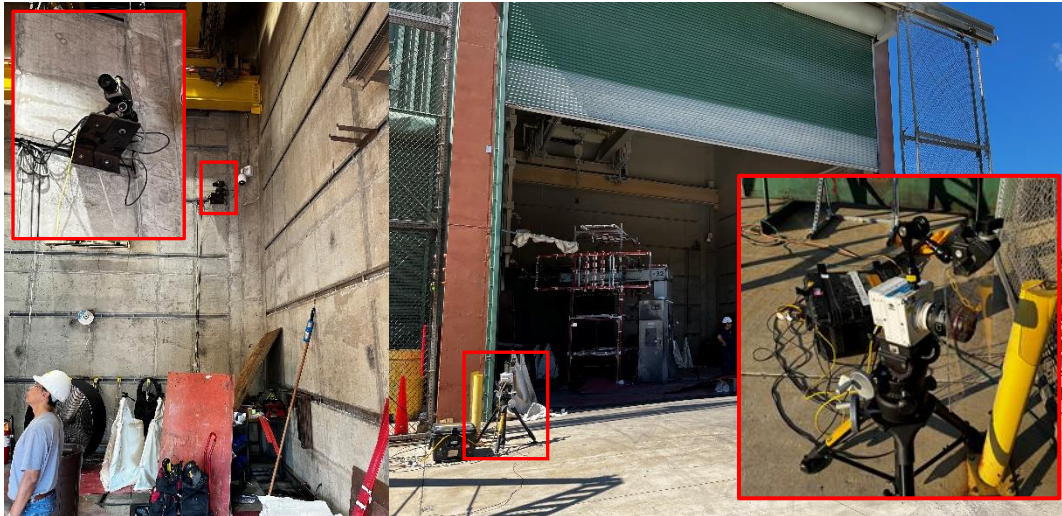
Figure 1-4: Phantom v7 HS camera (left panel) perched at the top of the northeast side of TC9; 1310 VEO (right panel) near the ground and southeast, just outside TC9. Both cameras were looking in these locations at the bus ducts. The insets show close up of the cameras.

A Phantom v7, Figure 1-4 (left panel), was deployed inside TC9 at its northeast side corner to look for breach timing at the top and north side of bus ducts. This camera was not deployed for the switchgear tests. Similarly, the 1310 VEO, Figure 1-4 (right panel), was deployed to look from below and the south side of the bus ducts to look for breach timing. The 1310 VEO was also deployed on the switchgear tests behind a wall and looking through a mirror. It was found in these tests that this camera was impacted by smoke and dust in detecting breaches; the IR camera was more effective in detecting breaches for the switchgear tests.

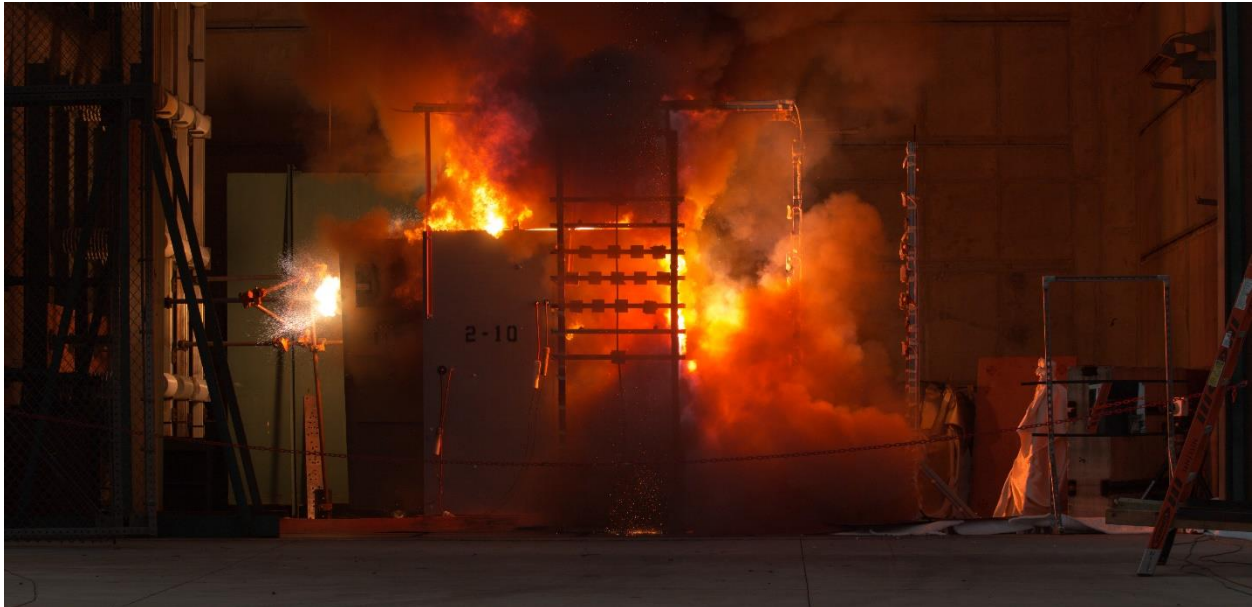
Figure 2-2: Test 2-10 imaged through 4k VEO camera – camera imaging at 1,000 fps. Notice the yellow orange/red color in the background 0.5 seconds from trigger.

The first switchgear test had an intended duration of 2 seconds with a steel enclosure and copper bars. The test was captured with the three external “remote cameras”, the interior camera looking through a mirror, and the two GoPros (one in the northeast side in the floor, and one on the top radiometer rack looking at the front of the switchgear). Note that images from all of the color cameras show orange flames. The high speed v1212 indicates that flame and hot gases are incident into the top radiometer rack for the first time around 55 milliseconds into the test and reaches the first radiometer layer to the east at 71.5 milliseconds elapsed time, engulfing the radiometers in the south at around 74 milliseconds. Smoke occludes the views in the floor at around 173 milliseconds and covers everything at around 1666 milliseconds. Camera settings are shown in Table 2-1.

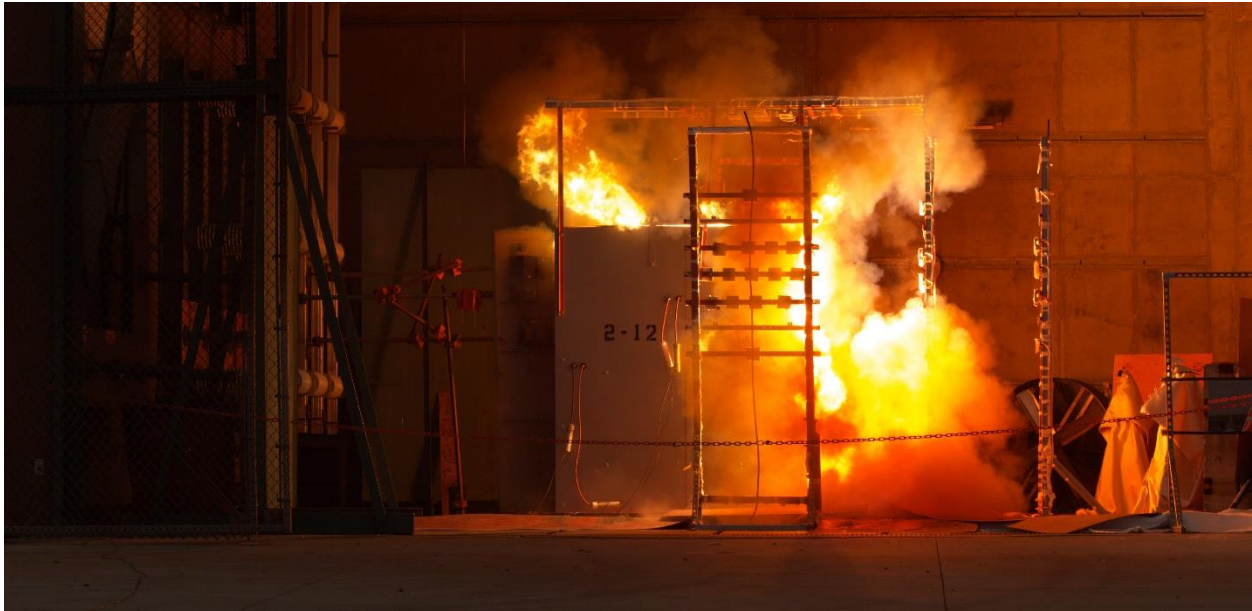
Figure 2-5: Test 2-12 imaged through 4k camera –camera imaging at 1000 fps. Notice the orange/red color in the background 0.17 seconds from trigger.

The second switchgear test had an intended duration of 4 seconds with a steel enclosure and copper bars. This test is captured with the three external “remote cameras”, the camera looking through a mirror, and two GoPros. Note, the GoPros were placed in similar locations as the first test. Note that images from all of the color cameras show orange flames, the same as the first test. The high speed v1212 indicates that flame and hot gases are incident into the bottom east radiometers at 70 milliseconds and the top radiometer at 88 milliseconds. Smoke starts occluding the views by the floor at around 85 milliseconds and covers everything at around 2500 milliseconds. The settings of the cameras can be seen in Table 2-2.

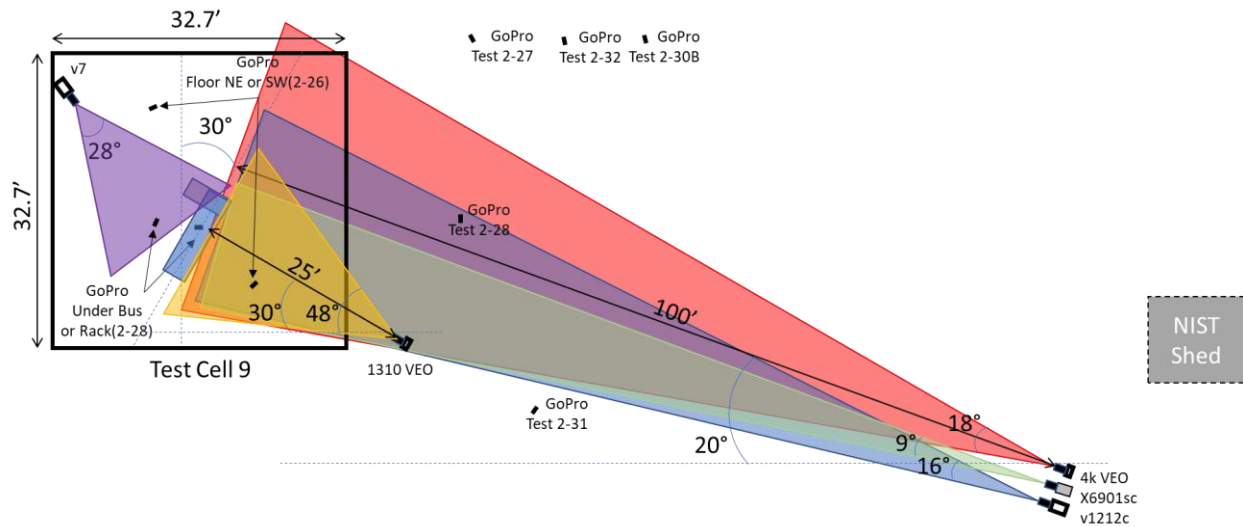
Figure 3-1: Bus duct cameras locations

Figure 3-1 shows the locations of the cameras used in the bus duct tests (2-25, 2-26, 2-27, 2-28, 2-30, 2-30B, 2-31 and 2-32) with their respective horizontal field of views (GoPros field of view are large and fixed; not depicted in the figure). The location of the remote camera station was intended for easy protection, and to provide a semi orthogonal view of the bus placement. This camera station location was centered on the bus duct, but as mentioned before it was placed 10 degrees off (counterclockwise looking from the top) to image the west side where the connection to the three phases is located. This station had a v1212c, a X6901 and a 4k VEO. The proximity of the cameras reduced parallax to allow data fusion between the data of the X6901 and the 4k VEO. A 1310 Color was deployed southwest, just outside the rolling doors to visualize the bottom and south of the busduct. A black and white (no Bayer filter) Phantom v7 was placed at the northeast inside corner of TC9, 4.5 meters above the floor to view the top and north side of the bus duct. Two GoPros were placed in different locations near the test duct, and a third GoPro was added to image outside TC9.

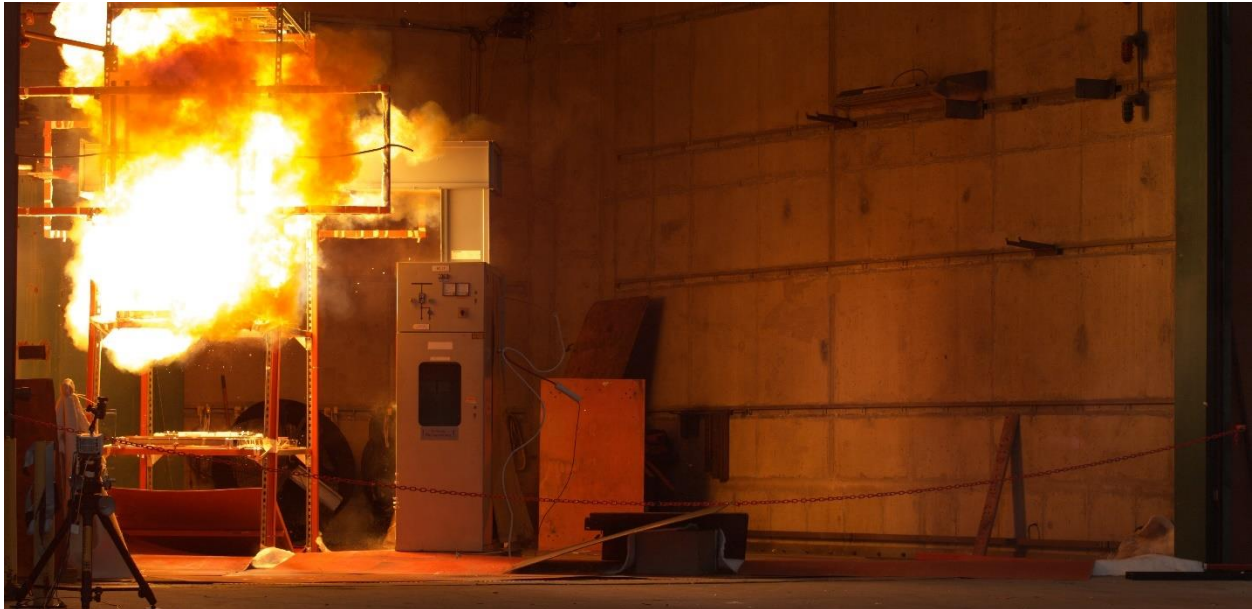
Figure 3-2: Test 2-25 imaged through 4k camera – camera imaging at 1000 fps. Notice the orange/red color in the background 0.19 seconds from trigger.

Test 2-25 (the first bus duct test) had an intended 2 second duration with a steel enclosure and copper bars. Two GoPros were used in this test: one at the north side (same as the two switchgear tests), and one in the floor under the bus duct. Images from all color cameras show orange flames, the same as the switchgear tests. Smoke becomes dominant around 600 milliseconds with some openings showing the duct connection to the switchgear in fire. At 1.2 seconds, there is an ejection of red/orange particulate. By 2 seconds everything is covered in dark smoke. The settings of the cameras can be seen in Table 3-1.

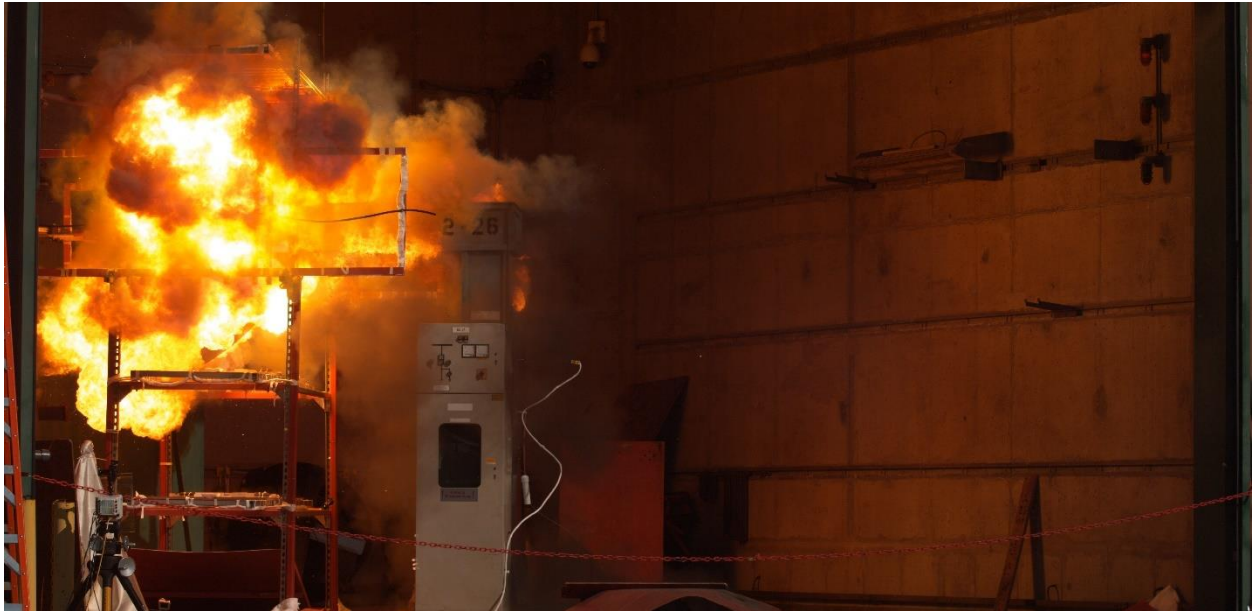
Figure 3-5: Test 2-26 imaged through 4k camera – camera imaging at 1000 fps. Notice the orange/red color in the background 0.25 seconds from trigger.

Test 2-26 (the second bus duct test) had an intended 4 second duration with steel enclosure and copper bars. Two GoPros were used in this test: one at the southwest side floor, and one in the floor under the bus duct. Images from all of the color cameras show orange flames and dark smoke. Smoke and dust are dominant in the view by 0.45 seconds with red/orange particulate seen at around 2.5 seconds. The settings of the cameras, specially the 1310 VEO, were tweaked due to the proximity to the duct and the changed conditions seen in the test, as shown in Table 3-2.

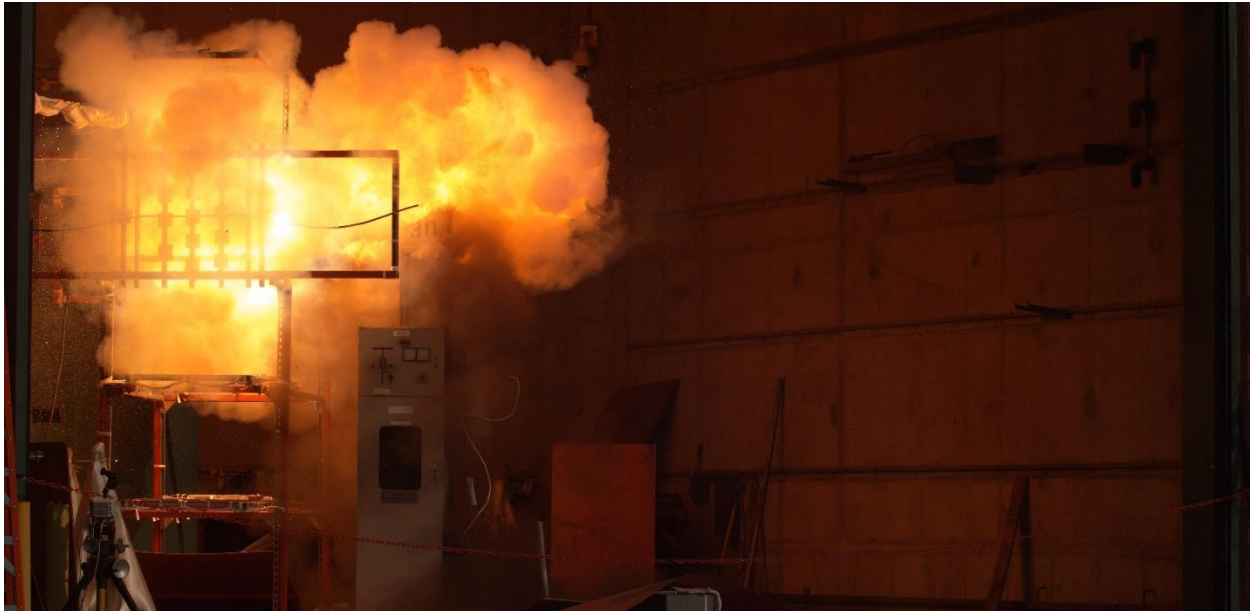
Figure 3-8: Test 2-30 imaged through 4k camera – camera imaging at 1000 fps. Notice the orange/red color in the background 0.24 seconds from trigger. The first 100 milliseconds seems to show a white cloud.

Test 2-30 (the third bus duct test) had an intended 4 seconds duration with steel enclosure and aluminum bars. Two GoPros were used in this test: one at the northeast side floor, and one under the bus duct. Images from all color cameras show orange flames, the same as the switchgear tests. However, the first 100 milliseconds show a white cloud, a possible indication of aluminum burning. An arc at the 3-phase connection was detected by the Phantom v7 at 39.919 μ s of the camera triggering (48.252 μ s from “data collection start”), and with a 45 μ s delay in applying current from “data collection start”, the arc started 3.25 μ s from applying current. Smoke and dust are dominant in the 4k VEO view by 400 milliseconds, and white bright particulate starts falling after 500 milliseconds, believed to be burning aluminum. After 1 second, there is a large ejection of white particulate towards the east, with the dark smoke still being dominant in the background. The settings of the cameras can be seen in Table 3-3.

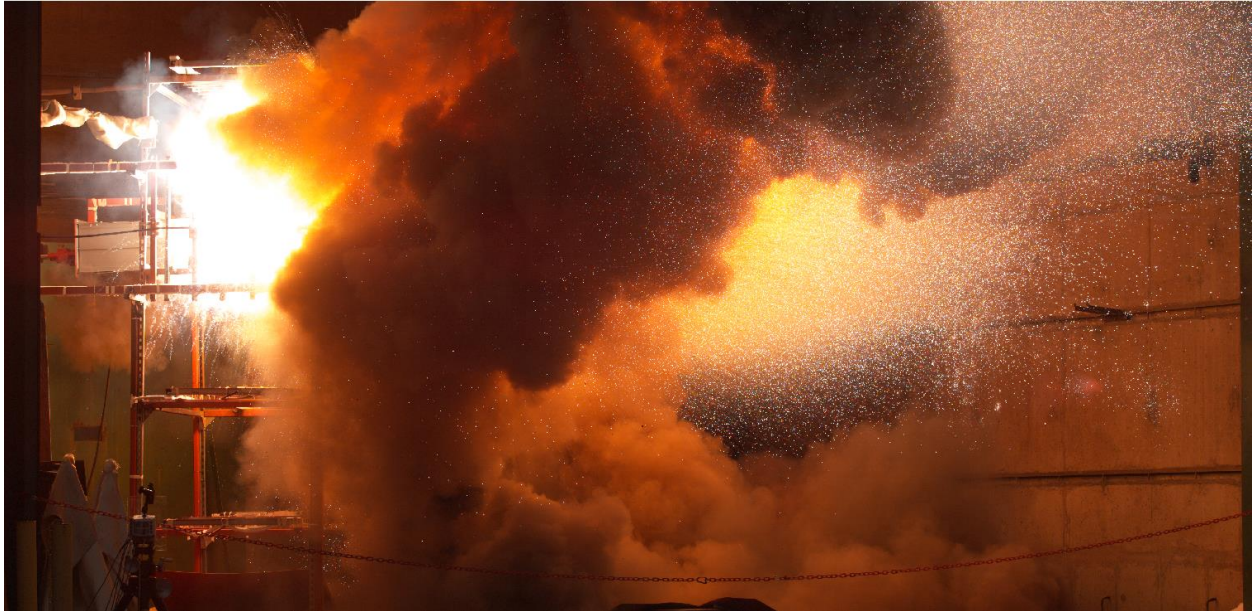
Figure 3-11: Test 2-27 imaged through 4k camera – camera imaging at 1000 fps. Notice the orange/red color flame and dust, and the bright white particulate 0.93 seconds from trigger.

Test 2-27 (the fourth bus duct test) had an intended 2 second duration with an aluminum enclosure and copper bars. Three GoPros were used in this test: one at the northeast side floor, one under the bus duct, and the last one outside southeast of TC9 about 30 feet from the rolling doors. Images from all color cameras show orange flames and dark smoke on the east side of the setup. At about 300 milliseconds, a breach is detected which starts showing what seems to be burning aluminum particulate flying towards the east from the test setup. Eventually bright particulate starts falling under the arc too. The settings of the cameras can be seen in Table 3-4.

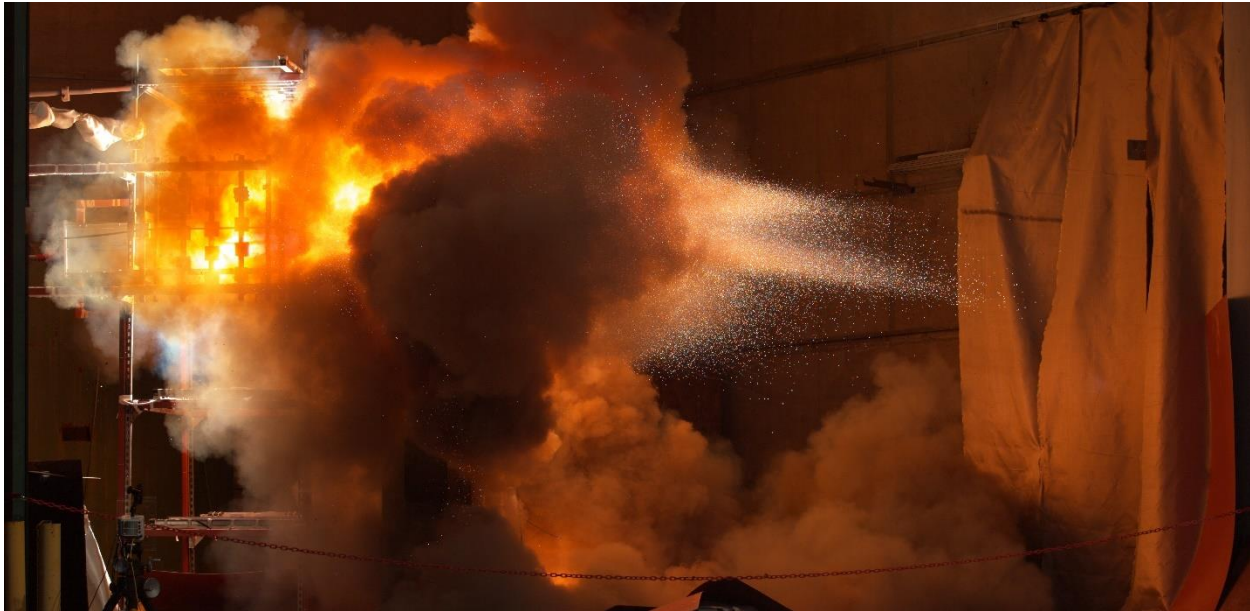
Figure 3-14: Test 2-28 imaged through 4k camera – camera imaging at 1000 fps Notice the orange/red color flame and dust, and the bright white particulate ejected towards the east 0.65 seconds from trigger.

Test 2-28 (the fifth bus duct test) had an intended 4 second duration with aluminum enclosure and copper bars. Three GoPros were used in this test: one at the northeast side floor, one by the first lower radiometer rack north of the bus duct, and the last one outside south of TC9 about 30 feet from the rolling doors. Images from all color cameras show orange flames and dark smoke that envelopes the duct 100 milliseconds into the test. At about 350 milliseconds, it is possible to see two plumes of bright white particulate flying towards the east, which is believed to be burning aluminum. About a second into the test, it is possible to see falling burning particles with white smoke (burning aluminum) right under the arc. The settings of the cameras can be seen in Table 3-5.

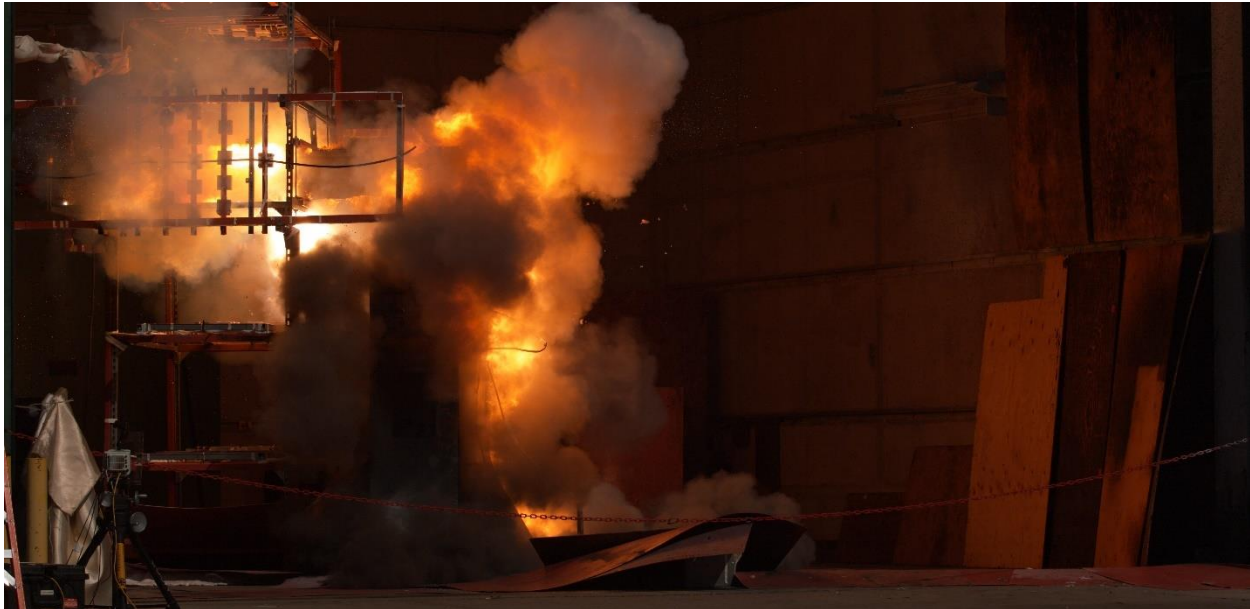
Figure 3-18: Test 2-30B imaged through 4k camera – camera imaging at 1000 fps. Notice the orange/red color in the background 0.180 seconds from trigger. The first 130 milliseconds seems to show a white burning cloud.

Test 2-30B (the sixth bus duct test) had an intended 4 second duration with a steel enclosure and aluminum bars. Three GoPros were used in this test: one at the northeast side floor, one under the bus duct, and the last one outside southeast of TC9 about 50 feet from the rolling doors. Images from all color cameras show a white burning cloud that engulfs the duct during the first 130 milliseconds. Afterwards, there is an orange flame illuminating the white smoke which gets thick and dark towards the end. At around 900 milliseconds into the test, bright white particulate are ejected towards the east. The settings of the cameras can be seen in Table 3-6.

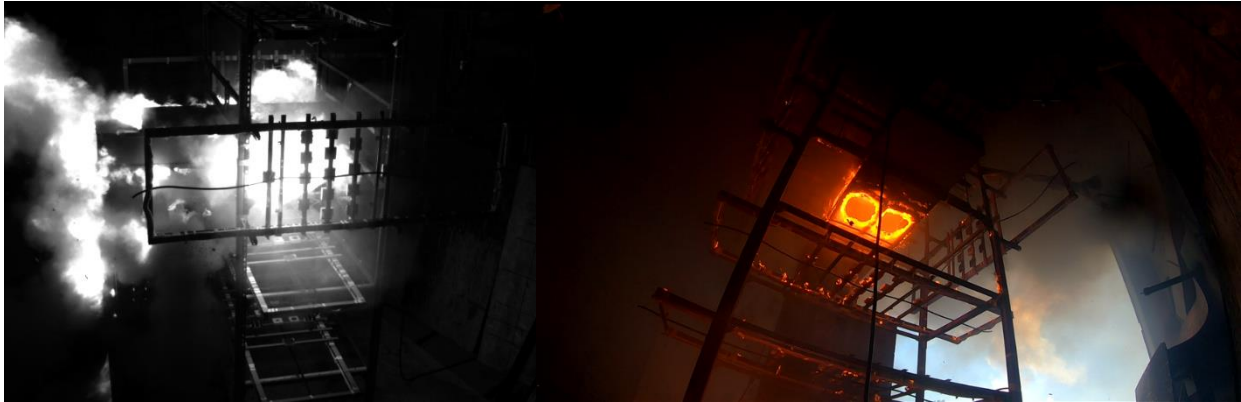
Figure 3-19: From left to right: Phantom v7, 4,000 fps, at top northeast side 0.150 seconds from trigger; GoPro at the bottom of the radiometer racks after the end of the arcing and some of the smoke is cleared.

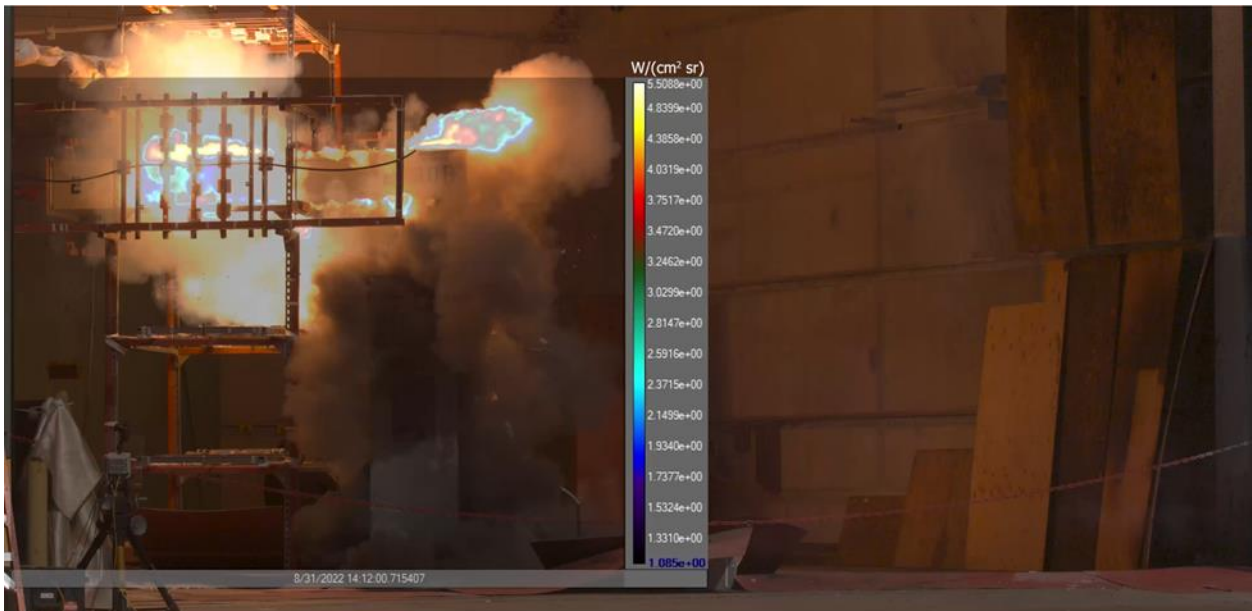
Figure 3-20: Image fusion of IR camera (in radiance units of $W/cm^2 \text{ sr}$) synchronized with a visible image 0.12 seconds from trigger.

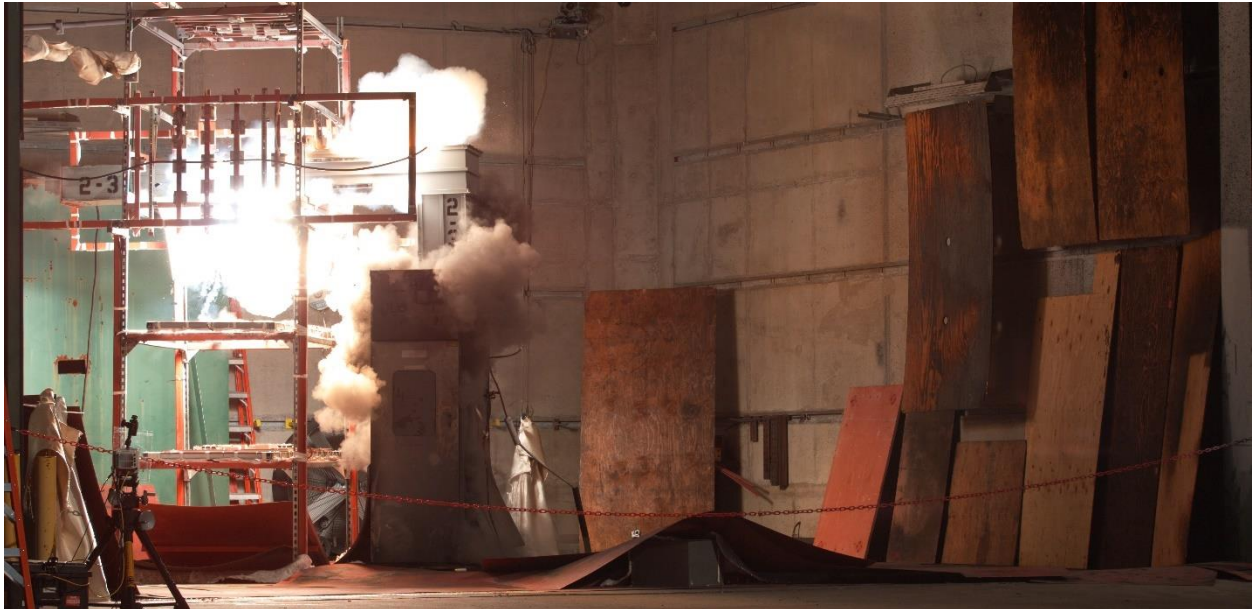
Figure 3-21: Test 2-31 imaged through 4k camera – camera imaging at 1000 fps. Notice the luminosity of the white cloud of Alumina illuminated by the arc and the burning aluminum 0.09 seconds from trigger.

Test 2-31 (the seventh bus duct test) had an intended 2 second duration with an aluminum enclosure and aluminum bars. Three GoPros were used in this test: one at the northeast side floor, one under the bus duct, and the last one outside southwest of TC9 about 50 feet from the rolling doors. Images from all color cameras show a test dominated by white smoke (compared to the previous tests) and bright particulate that is ejected to the east at 400 milliseconds, and eventually under the arc. The falling particulate dominates the view of the cameras with the luminous smoke in the background at the middle and end of the test. The settings of the cameras can be seen in Table 3-7.

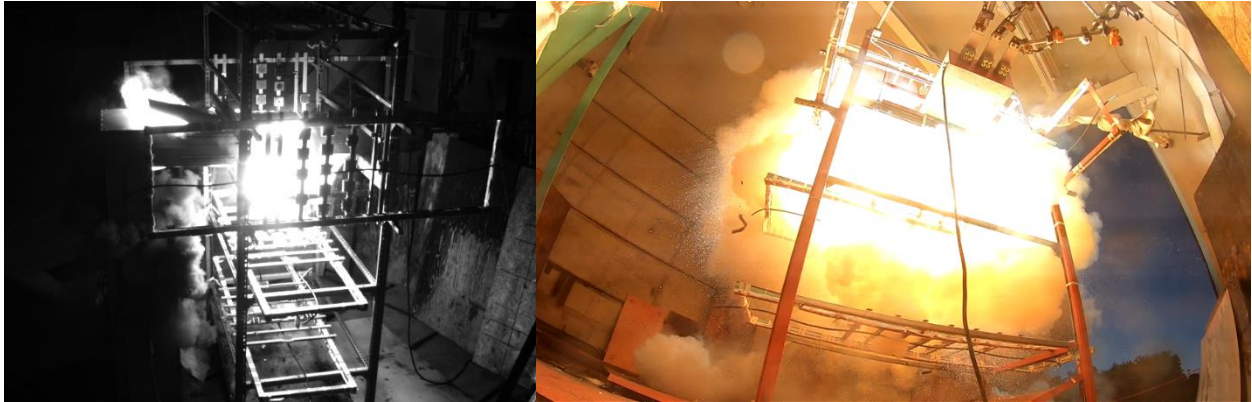
Figure 3-22: From left to right: Phantom v7, 4,000 fps, at top northeast side 0.07 seconds from trigger; GoPro at floor at north side.

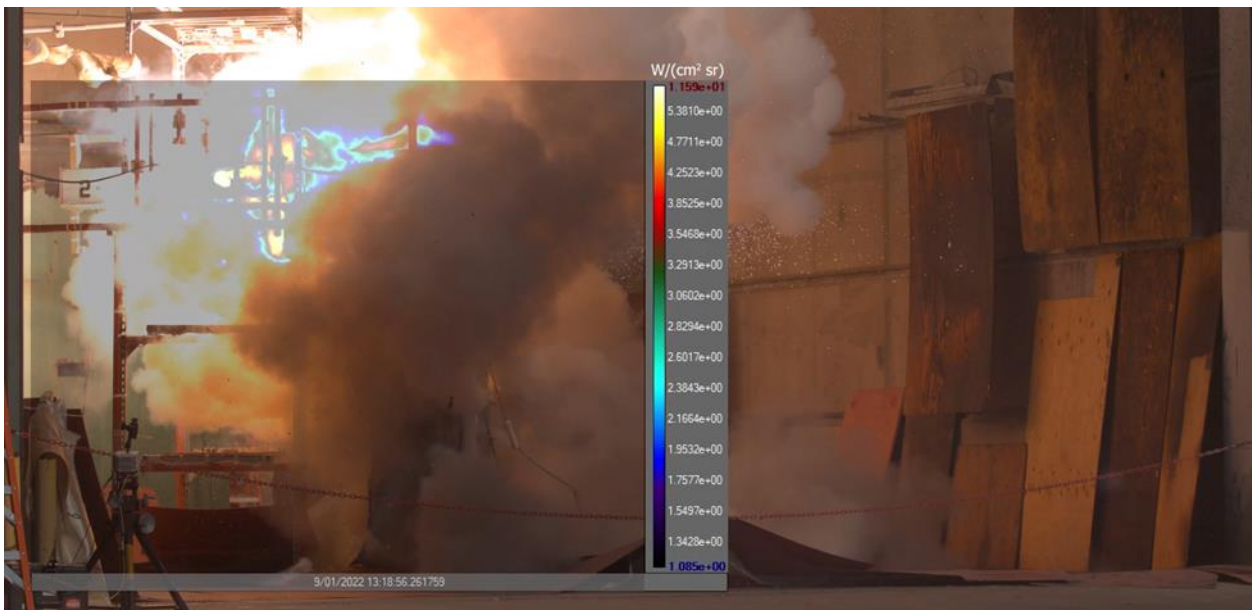
Figure 3-23: Image fusion of IR camera (in radiance units of $W/cm^2\ sr$) synchronized with a visible image 0.64 seconds from trigger.

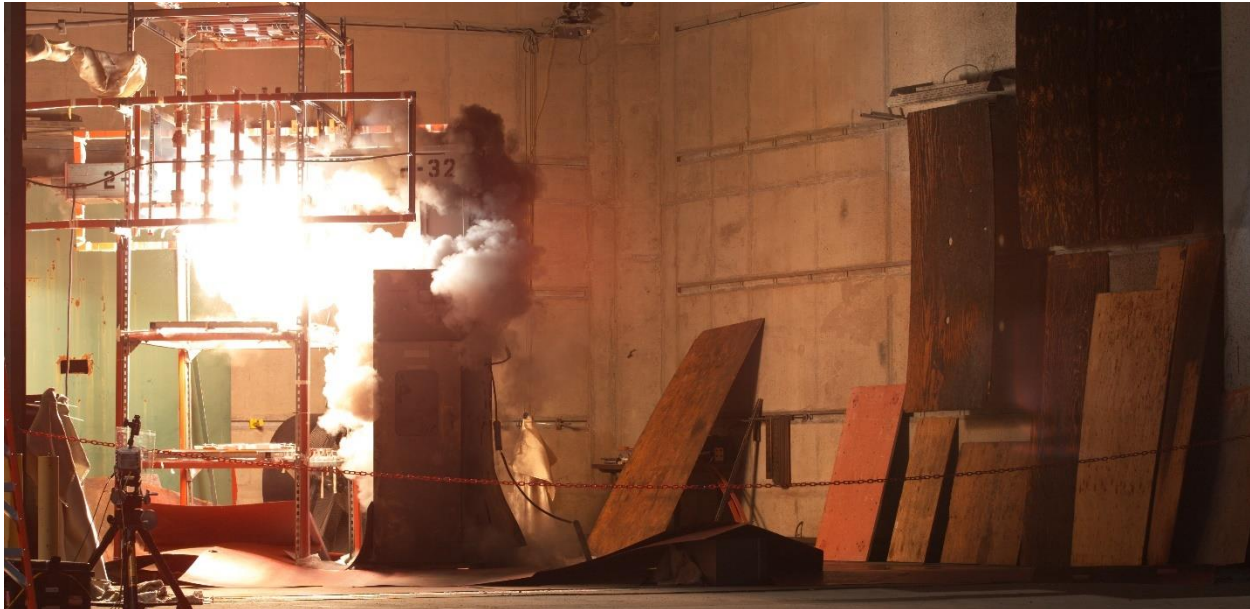
Figure 3-24: Test 2-32 imaged through 4k camera – camera imaging at 1000 fps. Notice the luminosity of the white cloud of Alumina (similar to 2-31) illuminated by the arc and the burning aluminum 0.08 seconds from trigger.

Test 2-32 (the eighth bus duct test) had an intended 4 second duration with an aluminum enclosure and aluminum bars. Three GoPros were used in this test: one at the northeast side floor, one under the bus duct, and the last one outside southeast of TC9 about 50 feet from the rolling doors. Images from all color cameras show a test that is not as dominated by white smoke (compared to Test 2-31). There is bright particulate that is ejected at 350 milliseconds towards the east, and eventually under the arc. It is worth noting that the connecting enclosure duct to the switchgear is made of steel. The falling particulate dominates the view of the cameras with a still luminous smoke (despite the orange/dark smoke) in the background at the middle and latest stages of the test. The settings of the cameras can be seen in Table 3-8.

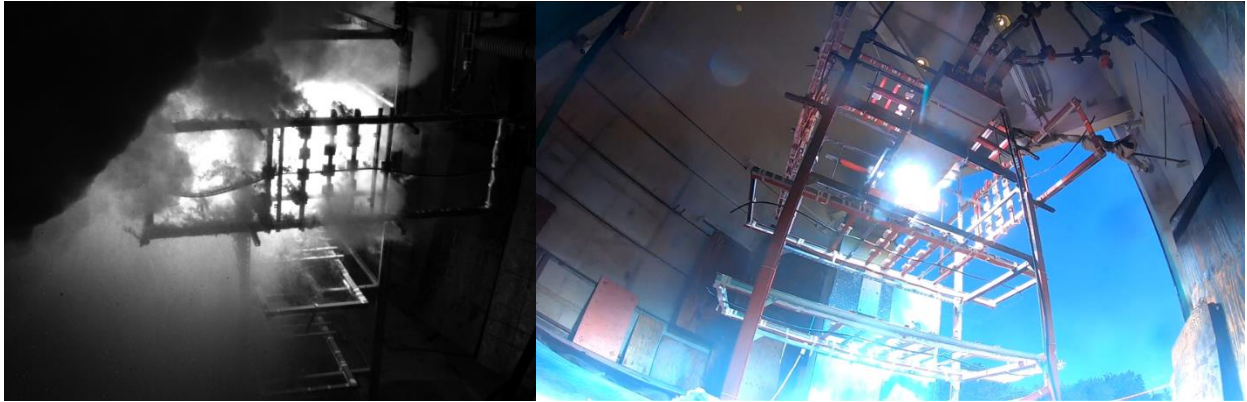
Figure 3-25: From left to right: Phantom v7, 4,000 fps, at top northeast side; GoPro at floor at north side with view of the first frame of the arcing 2.4 seconds from trigger.

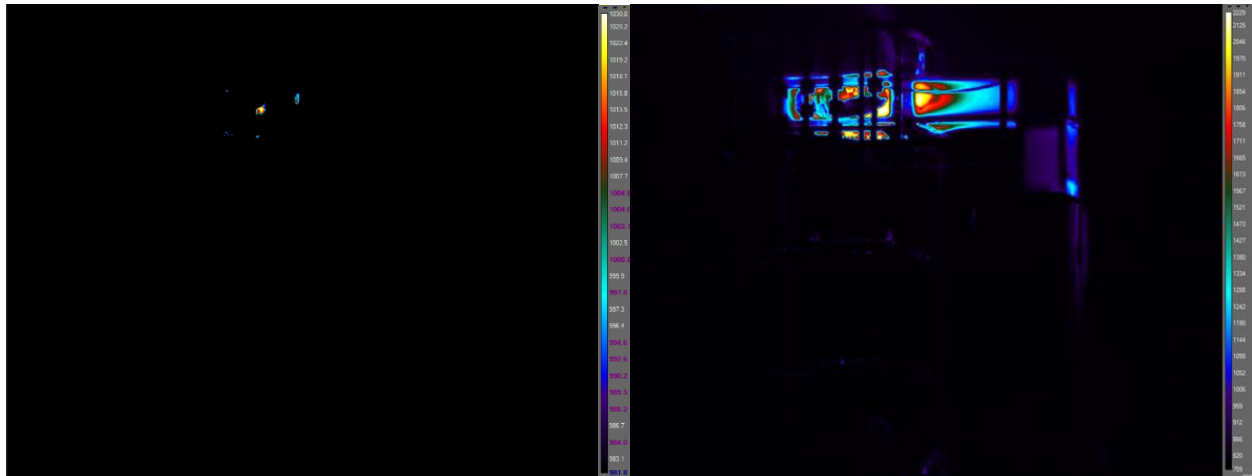
The steel enclosures do not go through the same process as aluminum. Steel is not as rapidly consumed by the arc. At the end of the IR camera recording (~ 20 seconds), the steel temperature is still close to $1,000^\circ\text{C}$ in some regions. This is significant, given that the measurements from the camera at this time are reliable because there is minimum smoke and dust in the air. See Figure 4-2 for Test 2-30B

Figure 4-2: Test 2-30B – Al bars – Steel enclosure – 4 seconds. Left panel is the calibrated temperature (°C) with some signal. The right panel is the uncalibrated counts (counts below 12% of 16384 counts are considered uncalibrated). The panels are the data after 20 seconds of finishing the test.

These results seem to indicate that the aluminum enclosures will be hotter but will be consumed in a matter of few seconds. Conversely, the steel enclosures would continue to radiate heat for several tens of seconds after the arc is finished. A better measurement should be considered if this is a real problem. For this suggested measurement, slow frame rate LWIR cameras should be used. These cameras can record for several minutes after the arc finishes and the smoke and dust settle, and they also provide a larger temperature range.
