Limerick Generating Station, Units 1 and 2
Renewed Facility Operating License Nos. NPF-39 and NPF-85
NRC Docket Nos. 50-352 and 50-353

Subject: Response to Request for Additional Information for
Application to Adopt TSTF-477, Revision 3, “Add Action for Two Inoperable
Control Room AC Subsystems” and Associated Technical Specification
Changes

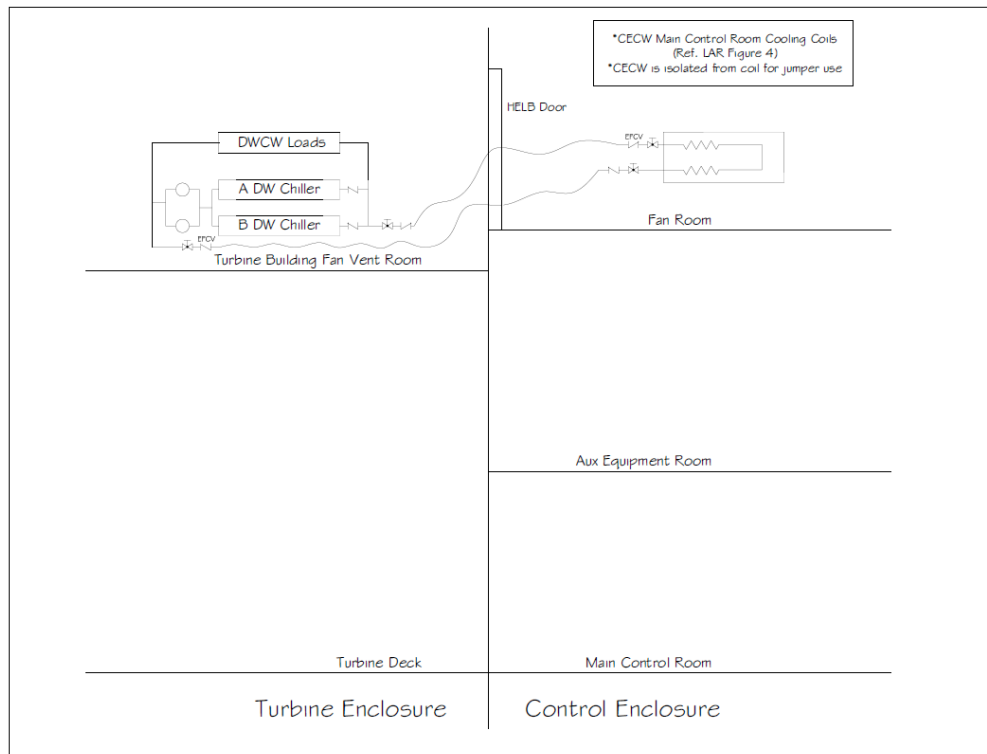
- a. *Describe (e.g., via a simplified sketch or drawing) the temporary chiller water hose's (jumper's) proximity to the control room (including a description of where the jumper will be located and routed from the turbine enclosure to the control enclosure). (Refer to Audit Question 3.)*

Response: Simplified drawing (not a controlled drawing):

The DWCW cooling supply and return jumper connections are only installed on Unit 1. The Limerick primary means of temporary supplemental MCR cooling documented in the LAR utilizes cooling methods that do not breach the MCR envelope while in the LCO. Opening MCR doors that breach the MCR envelope during normal operating conditions is not an effective temporary cooling provision, because the steady state turbine deck temperature is 105°F during warm weather conditions. This would accelerate MCR heat up and negate temporary cooling efforts.
