Providing useful information to our inspectors, by our inspectors!

Near Death: The Birth of the ROP

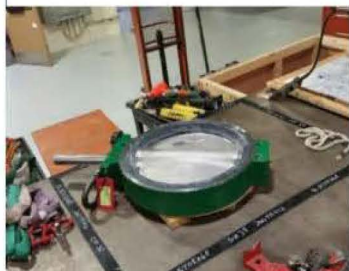
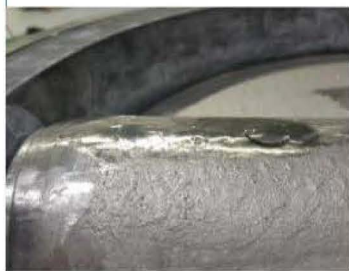
Shopping for issues: The inspectors typically do a maintenance shop walk-through prior to the work to look for component and/or quality control issues. In this case, the inspectors identified that one of the three taper pins holding the butterfly valve disk to the stem appeared to be loose.

In response to the inspector's observation, the licensee performed repairs by resetting and re-staking the pins in accordance with mechanical maintenance procedure DB-MM-09317 "Fisher type 9100 Butterfly Control Valve Maintenance." This resulted in the large ends of the taper pins being flush with the surface of the disk which still didn't appear to be quite right to the inspectors. Based on the licensee's initial response (simply tapping the loose pin back into

After review of the licensee's actions taken to repair the valve, the inspectors noted that the pins were improperly set and staked and brought the concern to the licensee. Additionally, the inspectors identified that the associated mechanical maintenance procedure, DB-MM-09317, included the vendor manual as a reference, but did not incorporate the vendor manual criteria ensuring the ends of the pins were below the surface of the disk before peening.

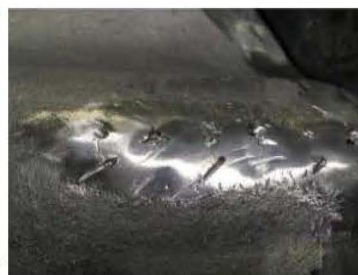
Vendor drawing showing flush

taper pin ends
After licensee's repair attempt

OpE-tunity: Based on additional digging, the inspectors noted that NRC Information Notice 2005-23 and NRC Part 21 Report 2005-42 described the issue of loose taper pins, with corrective actions to include the proper seating and staking of the pins. These references state that degradation of butterfly valves supplied by Fisher Controls and other manufacturers has occurred during plant operation as a result of the loss of taper pins used to connect the valve disk to stem. The degradation can involve leakage and affect valve operation. Taper pins lost from butterfly valves can also interfere with the operation of other plant components in fluid systems. The inspectors also noted that the vendor manual detailed the requirement for the pin ends to be ground below the surface of the disk before staking; however, the instructions were confusing and difficult to follow (at least partly due to the instructional drawing depicting flush ground pins) and were apparently misinterpreted by both the vendor and licensee.

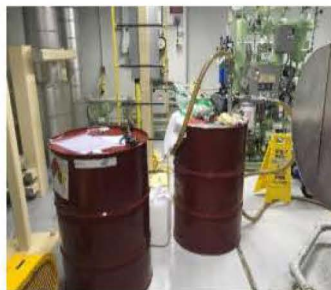
Unattended drums of lube oil in EDG enclosure without a fire prevention permit.

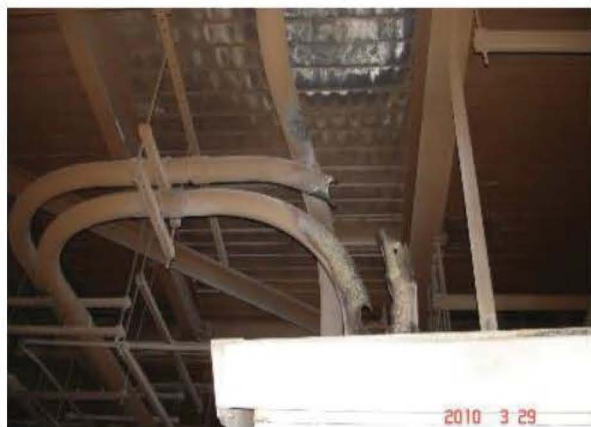
Robinson Fire Damage, 2010

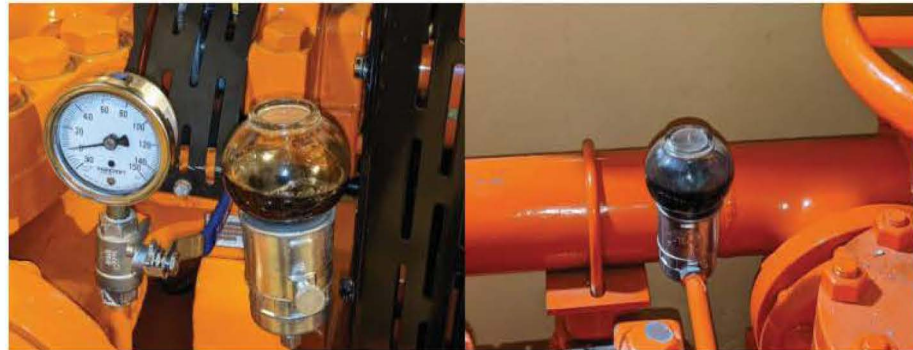
This quarter's Eagle Eyes Award goes out to **Matt Hardgrove**, Salem Resident Inspector. On December 30, 2019, during a plant status walkdown of the auxiliary building, Matt observed that the oil in all three FLEX AFW pump oilers appeared very dark compared to other oilers (see pictures below). Matt promptly informed the control room SRO who initiated actions to have the oil replaced and sampled. On January 10, the licensee received the sample results that indicated that the pre-existing oil was not of the correct viscosity or water content. The FLEX AFW pumps have not been tested since coming onsite in November 2015, no oil sampling was planned in the future, and the pump casing internals were not made of corrosion resistant material. The licensee's additional corrective actions included replacing the oil in all three FLEX AFW pumps and creating periodic maintenance plans that ensure that the oil in the pumps is sampled. The inspectors identified an associated licensee performance deficiency as the licensee did not follow their procedures for periodic testing and oil sampling of the FLEX AFW pumps. For additional details, check out IR 05000272 & 311/2020001. **Great catch, Matt!**

FLEX AFW Pump #1 Oil Bubbler

FLEX AFW Pump #3 Oil Bubbler

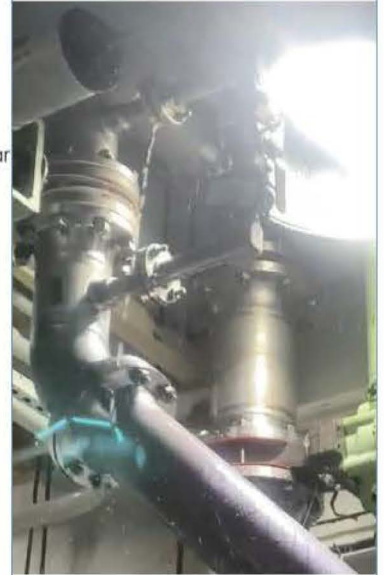
You're the inspector, find the leaking flange above.

Just before 7:00 AM on Sunday December 1, 2019, the safety-related service water supply to the Millstone 2A EDG began to leak from a flanged joint (see picture below). This portion of the service water system provides cooling water to the EDG lube oil and jacket water heat exchangers. A security officer on rounds discovered the leak and promptly notified the control room. The shift manager dispatched plant equipment operators (EOs) to investigate. Upon arrival to the 2A EDG room, the EOs located the leak and immediately requested that control room operators secure all service water to the 2A EDG. While communicating with the control room, the water spray from the leak caused an electrical fire in an emergency lighting electrical outlet, which was immediately extinguished by the EOs (fire brigade). The isolation of service water to the 2A EDG rendered the diesel inoperable and the licensee entered a 72-hour Technical Specification LCO action statement. The inspectors responded to the site on that Sunday to assess licensee corrective actions, repair activities, and reportability. The inspectors reviewed the licensee's subsequent causal evaluation and questioned the licensee's assessment of the contributing cause. Initially, the licensee attributed the cause to a previous design change that had reduced the orifice thickness by a half of what it was. The licensee stated that this reduced thickness created a gap which caused the uneven compression of the gasket. Based on the inspector's questions, the licensee re-performed a causal evaluation (causal evaluation) and determined that the

maintenance procedure for work control practices for threaded fasteners failed to provide adequate acceptance criteria for the tightening of the joint. Specifically, the licensee determined that the failure of the gasket material on the flange was attributed to uneven compression when it was installed on October 11, 2018. The maintenance procedure only provided vague criteria for visual indication of bulging around the bolts, which with this type of flange could not be seen. Additionally, no torque values were specified in the procedure for use of red rubber gaskets. The licensee replaced the failed gasket using a procedure with appropriate acceptance criteria to ensure that the tightening was satisfactorily performed. The licensee also created corrective actions to: 1) replace the gaskets on a 12-month interval with appropriate torque values specified by engineering, 2) conduct a review to determine whether a different gasket type material would be more suitable for this application, and 3) performed an extent-of-condition investigation for similar joints and systems on both Units 2 and 3 EDGs. (See NRC Inspection Report 05000336/2020001 for more details.)

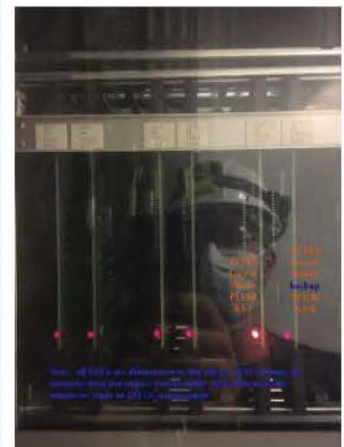
D ELS Cabinet with all LEDs illuminated. Picture taken by MK1 Mod 0 HC SRI, Adam Ziedonis.

The opportunity: From May 2019 to September 2019, PSEG documented in their CAP three occurrences of a failed primary LOP module associated with the D ELS. A nuclear equipment operator identified these three cases when they noted an LED extinguished on the LOP module card during their rounds (see picture below). For each occurrence, operators performed an immediate operability determination for the D ELS. PSEG documented that the

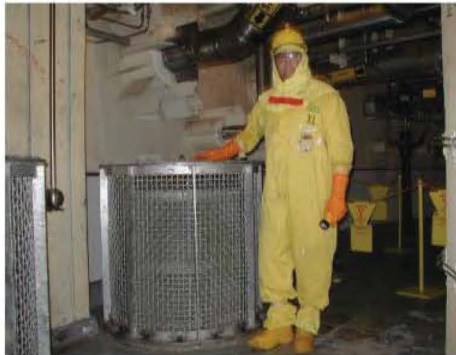
This is what a small ECCS strainer looks like

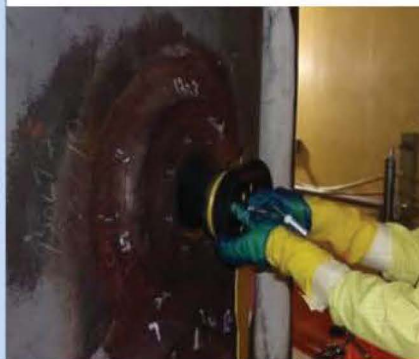
SG hand hole plug.

This quarter's "Catch of the Day" recognition goes out to **Scott Wilson**, Senior Health Physicist, RI/DNMS. On February 25, 2020, operators tripped Salem Unit 1 from 20 percent power due to equipment challenges associated with a steam generator tube leak. In response to Salem's emergent forced outage, Scott Wilson reached out to the resident inspectors to discuss and coordinate an inspection of the potential high risk evolutions. He demonstrated initiative and thorough planning in performing an unscheduled inspection during a period of high risk RP/HP evolutions and led directly to the identification of program weaknesses in LHRA controls. On March 12, 2020, Scott identified two potential performance deficiencies (PDs) during his one-day inspection. The PDs involved U1 TS 6.12.2 High Radiation Area controls. Scott found two locations that were not adequately controlled: the reactor head stand and the secondary hand-holes on steam generator 12 (see pics below). The areas were posted and controlled as locked high radiation areas (LHRAs); however, the barriers could be defeated easily and found to be less than adequate when challenged by an RP Tech. In other words, the areas could be accessed by any individual extending his/her arm into the area. The reactor head stand has shielded access doors to allow entry under the head. The access doors were secured by one long chain around the circumference of the stand, weaving through three access doors and locked with a padlock. The access doors could still be opened approximately four inches, allowing for an individual's arm to be placed in the LHRA. Regarding the steam generator hand-hole access ports, when the port covers are removed a lockable plug is placed in the opening and locked to secure the LHRA from entry. When the plugs were challenged by pulling on them, two of them came out of the ports leaving the LHRA unlocked and accessible. No individuals had entered these LHRAs inadvertently or purposely that were not authorized. The head stand chain was secured preventing the doors from being opened, the locking plugs were secured adequately, and the licensee entered the issue into their CAP following Scott's identification. **Great catch, Scott!**

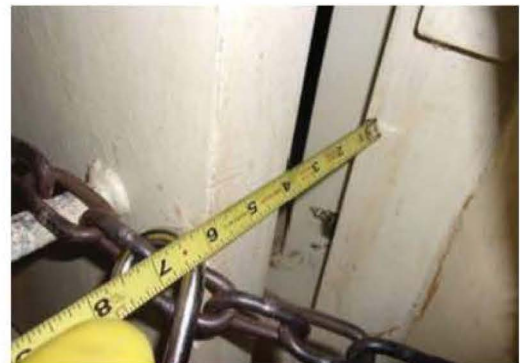
Gap in the locked doors leading to the RX head stand area.

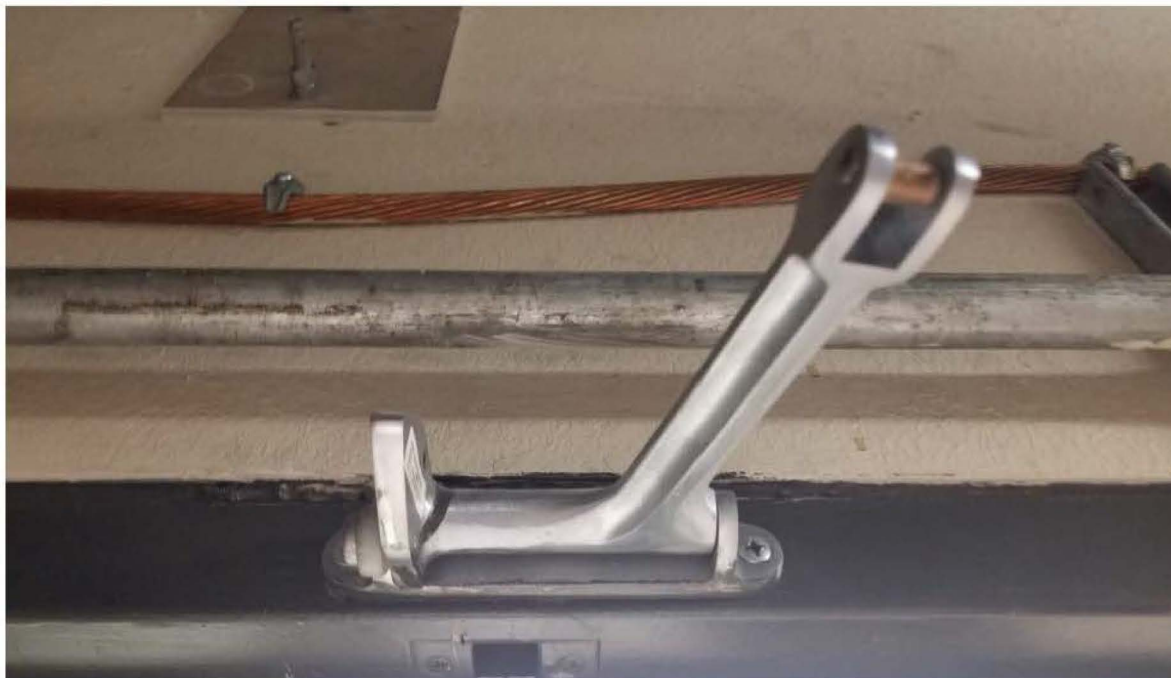
What's Wrong with This Picture: #1?

What's wrong with the above picture? After pondering the picture for a few minutes, flip back to page 7 for the answer.

The subject of the photo is a fire door coordinator device. A door coordinator is a simple mechanical device that ensures that the two leaves of a double-leaf fire door close and latch the proper sequence. While performing a fire protection 7111.05 inspection tour of the lower cable spreading rooms of Units 1, 2, and 3, Palo Verde Resident Inspector Russ Bywater observed that four out of six door coordinators were missing the rubber roller on the active leaf side of the door coordinator arm. These fire doors, held open by magnetic locks and interlocked with a halon fire suppression system, separate rooms with the halon-protected rooms with potential ignition sources from the cable spreading rooms. Without the rubber rollers, the door coordinator arm causes a deepening indentation each time the door closes. If the door coordinator arm were to become stuck, the fire door would not close and latch as required. Russ brought this deficiency to the licensee's attention. The licensee tested the doors to prove they would still close properly when needed, and repaired the door coordinators by replacing the rubber rollers.

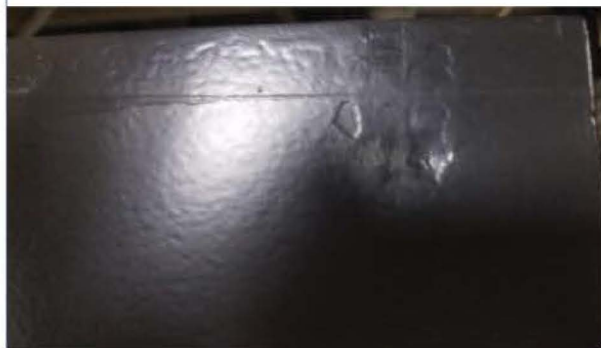
Fire door showing minor damage caused over time by door coordinator arm striking the door without a rubber roller.

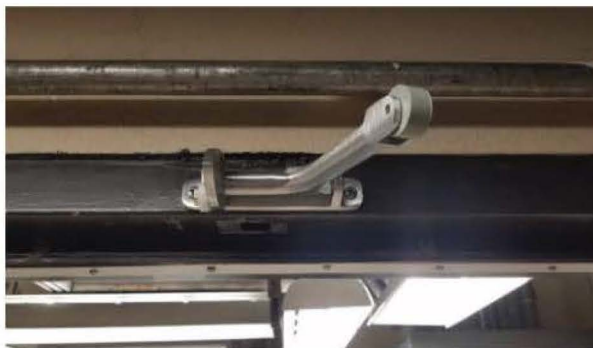
Restored door coordinator.
