*This report provides the results the Accident Sequence Precursor Program for 2023. In addition, trends and key insights are provided for the past 10 years (2014 through 2023).*

# **U.S. Nuclear Regulatory Commission Accident Sequence Precursor Program 2023 Annual Report**

April 2024

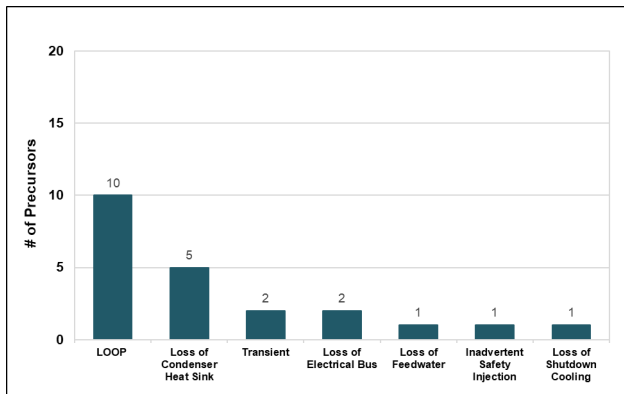
Figure 8. Most Frequent IE Precursor Types

The most frequent IEs that resulted in precursors were LOOPS and losses of a condenser heat sink.

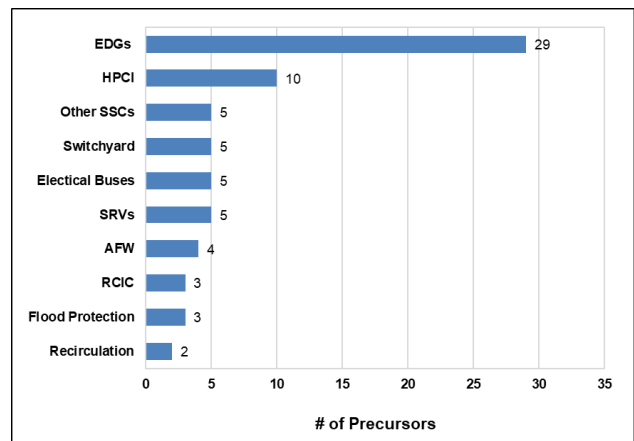
Figure 10. Most Frequent Precursor SSC Failures

The most frequent structure, system, and component (SSC) failures observed in precursors were associated with EDGs and high-pressure coolant injection (HPCI) failures.

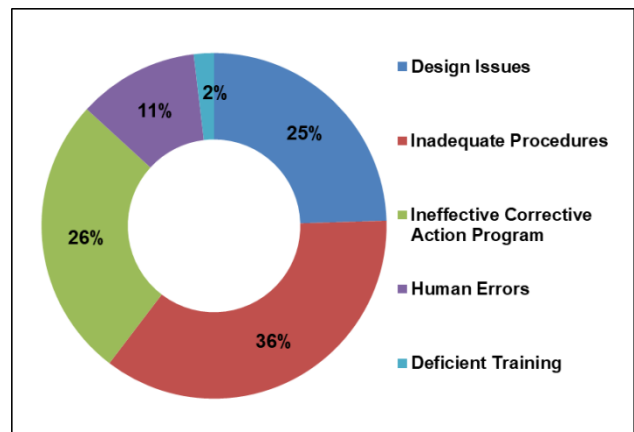
Figure 11. Dominant Precursor SSC Failures

A review of the precursors associated with inspection findings that had a significant impact on the risk of the event were most likely due to inadequate procedures, ineffective corrective action programs, or design issues.
