TEMPORARY INSTRUCTION 2515/194 REVISION 3

INSPECTION OF THE LICENSEES' IMPLEMENTATION OF INDUSTRY INITIATIVE ASSOCIATED WITH THE OPEN PHASE CONDITION DESIGN VULNERABILITIES IN ELECTRIC POWER SYSTEMS (NRC BULLETIN 2012 01)

Effective Date: 10/10/2024

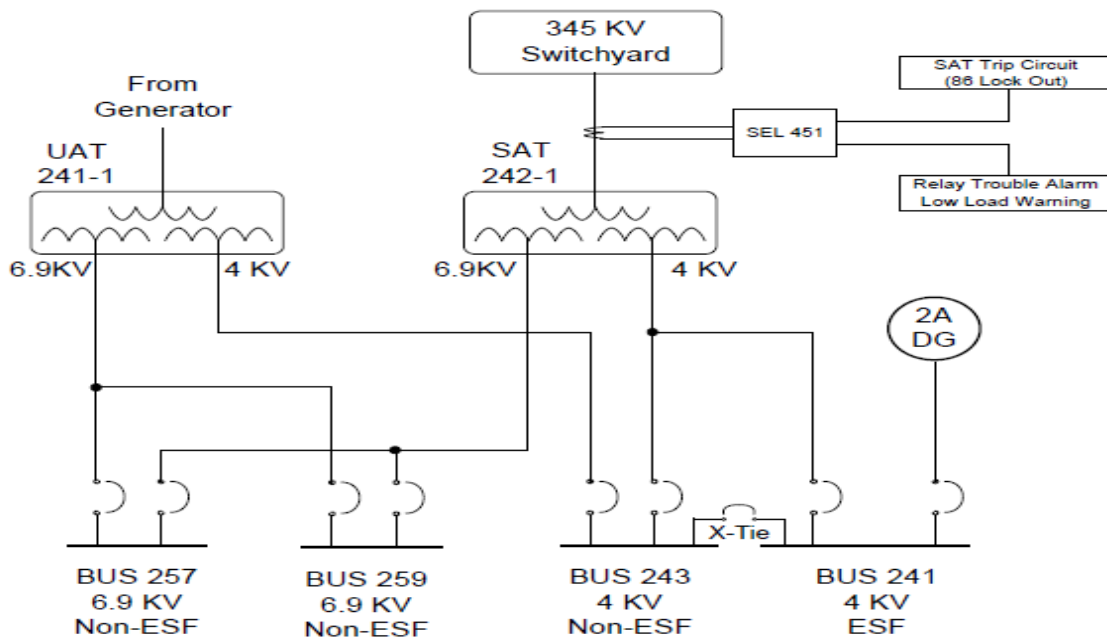
Figure 1. Simplified Schematic of Electrical busses associated with one train (Unit 2)

Byron Station is a two-unit pressurized water reactor plant. The electrical distribution system for each unit consists of four non-safety 6.9-kV buses, two non-safety 4-kV buses, and two engineered safety features (ESF) 4-kV station buses. During normal plant operation, the safety (or ESF buses) and non-safety buses (or non-ESF) are powered from the Unit Auxiliary Transformers (UATs). On the day of the event, two non-ESF 6.9-kV station buses that power two of the RCPs and the two 4-kV (ESF and non-ESF) buses were supplied by station auxiliary transformers (SATs) connected to the 345-kV offsite power switchyard (Figure 1 below). The other two 6.9-kV and 4-kV buses were powered from the UATs. The undervoltage condition on the SAT powered buses was caused by a broken inverted porcelain insulator stack of the phase C conductor for the 345-kV power circuit that supplies both SATs. The insulator failure caused the associated phase C conductor to break off from the power line disconnect switch resulting in a high impedance ground fault through the fallen phase C conductor and a

sustained open phase condition (OPC) on the high voltage side of the SAT. The open circuit created an unbalanced voltage condition on the two 6.9-kV non-ESF RCP buses and the two 4.16-kV (ESF and non-ESF) buses. After the reactor trip and subsequent generator trip, the two 6.9-kV buses, which were aligned to the UATs, automatically transferred to the SATs, as designed. As a result of the open circuit on C phase, the load current in phases A and B increased and caused the remaining two operating RCPs to trip on phase overcurrent. In the absence of any operating RCPs, control room operators performed a natural-circulation cooldown of the plant.

The SATs continued to power the 4.16 kV ESF buses A and B because of a design vulnerability that did not isolate the safety related buses from the degraded offsite power system. Some ESF loads that were energized relied on equipment protective devices to prevent damage from an unbalanced overcurrent condition. The phase overcurrent condition caused by the OPC actuated relays to trip several ESF loads.
