EA-24-126

SUBJECT: NORTH ANNA POWER STATION, UNIT 2 - FINAL SIGNIFICANCE
DETERMINATION OF A WHITE FINDING AND NOTICE OF VIOLATION AND
ASSESSMENT FOLLOWUP LETTER; NRC INSPECTION REPORT
05000339/2024090

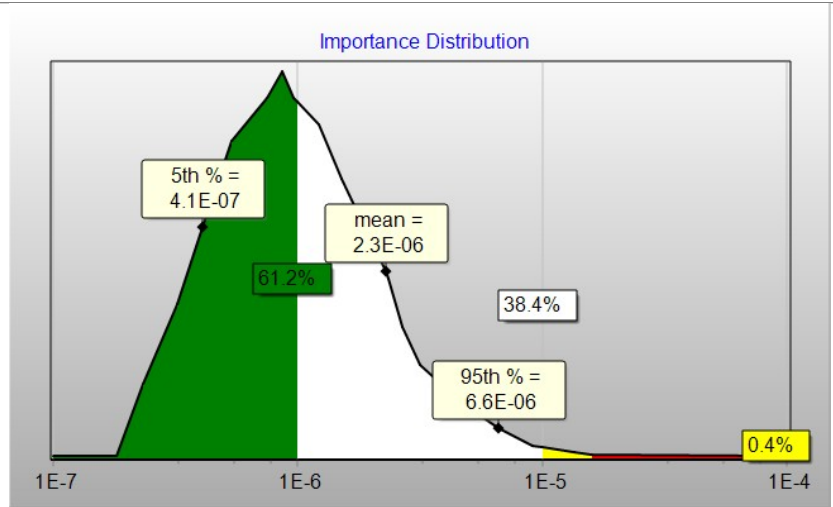
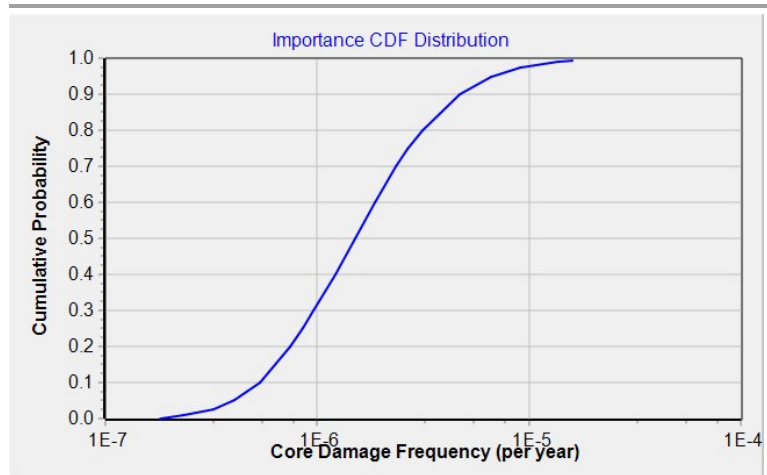
Importance Distribution

5%	Median	Point Estimate	Mean	95%	Seed	Sample Size	Method
4.082E-7	1.508E-6	2.064E-6	2.283E-6	6.637E-6	12345	3825	Monte Carlo

Event Tree Dominant Results

Only items contributing at least 1.0% to the total conditional core damage probability (CCDP) are displayed.

The dominant accident sequence is a dual unit Weather Related Loss of Offsite power with a failure of the 2H EDG, Failure of the SBO EDG, Failure of the FLEX RCS Make up pumps, and failure to recover offsite power or the 2H EDG in 24 hours.
