Subject: Reply to a Notice of Violation; EAF-NMSS-2025-0102

Attachment 1: Reply to a Notice of Violation; EAF-NMSS-2025-0102

Apparent Violation A:

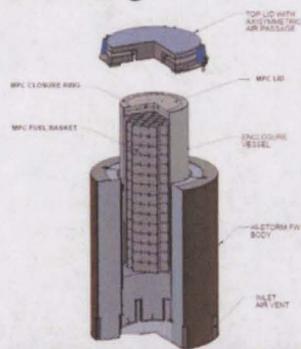
- Apparent violation claims that Holtec had created a new possibility that air inlet vents to be blocked from rainwater in the Version E and E1 design of the HI-STORM FW

- ✓ Previous Design:

- NRC claims, "Holtec failed to obtain a CoC amendment pursuant to 10 CFR 72.244, prior to implementing a design change that raised the air inlet vents from the bottom of the HI-STORM FW overpack to above ground positions, which created a low point for water to collect in the overpack after normal rainfall. When Holtec made this change and evaluated the design change with their design control change process, Holtec failed to recognize that this created a possibility for all air inlet vents to become blocked for a period greater than what was analyzed in the FSAR when rainwater entered the overpack."
