NP-33-99-005-00

Docket No. 50-346

LER 1999-005  
Davis-Besse Nuclear Power Station, Unit No. 1  
Date of Occurrence – October 27, 1999

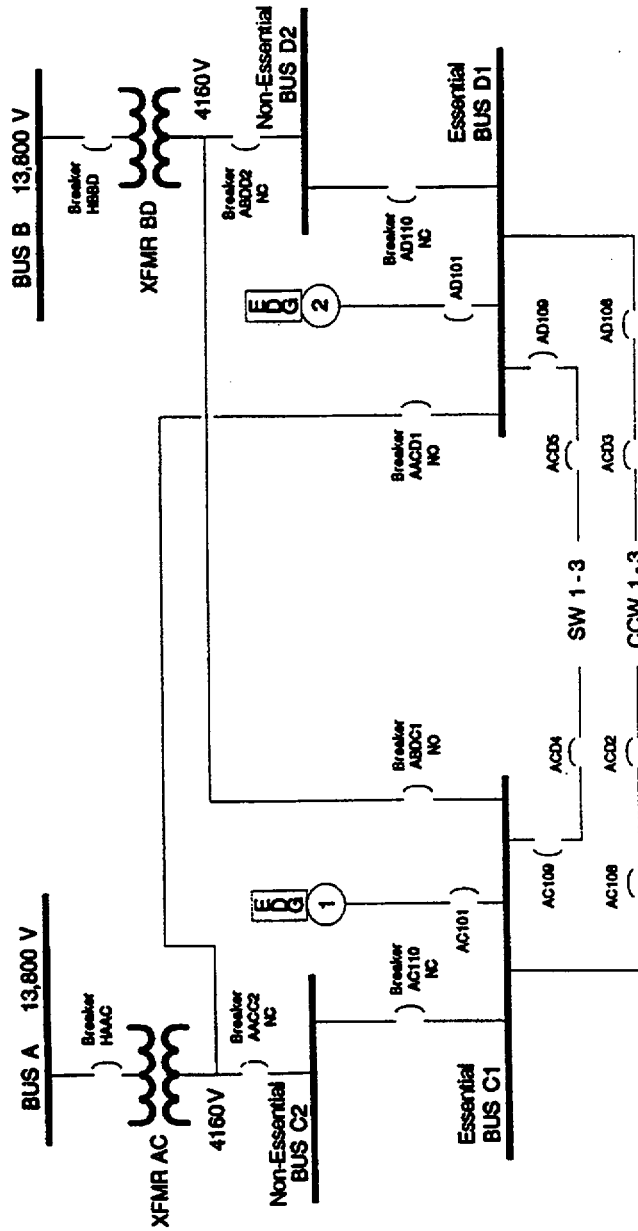
FIGURE 1

4160 VAC SIMPLIFIED DIAGRAM

On October 27, 1999, with the unit in Mode 1 at approximately 100 percent power, preventative maintenance was planned for breaker HBBD [EA-BKR], the source breaker for Bus Tie Transformer BD [EA-XFMR]. Transformer BD steps down voltage from the 13,800 Volt bus B [EA-BU] to supply the essential and non-essential 4160 volt buses D1 [EB-BU] and D2 [EA-BU]. A simplified schematic of the electrical distribution system for the Davis-Besse Nuclear Power Station (DBNPS) is included as Figure 1.

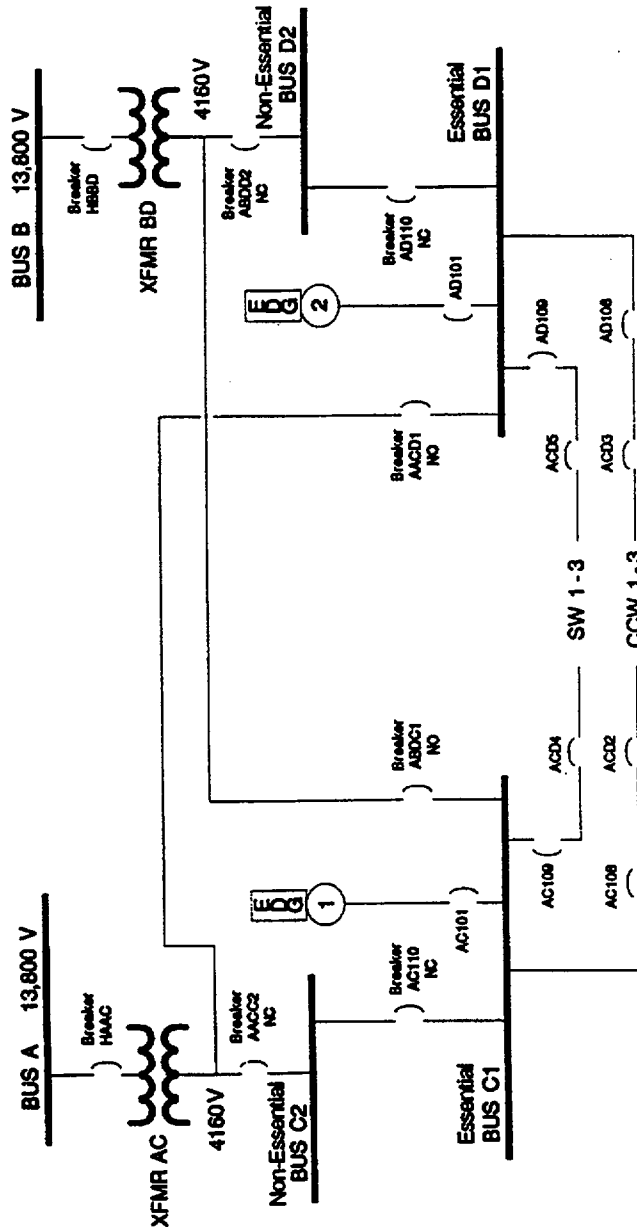
FIGURE 1

4160 VAC SIMPLIFIED DIAGRAM
