**DOCKET 50-255 - LICENSE DPR-20 - PALISADES PLANT
LICENSEE EVENT REPORT 99-004, "CONTROL ROD DRIVE SEAL HOUSING
LEAKS AND CRACK INDICATIONS"**

FACILITY NAME (1)
CONSUMERS ENERGY COMPANY - PALISADES NUCLEAR PLANT

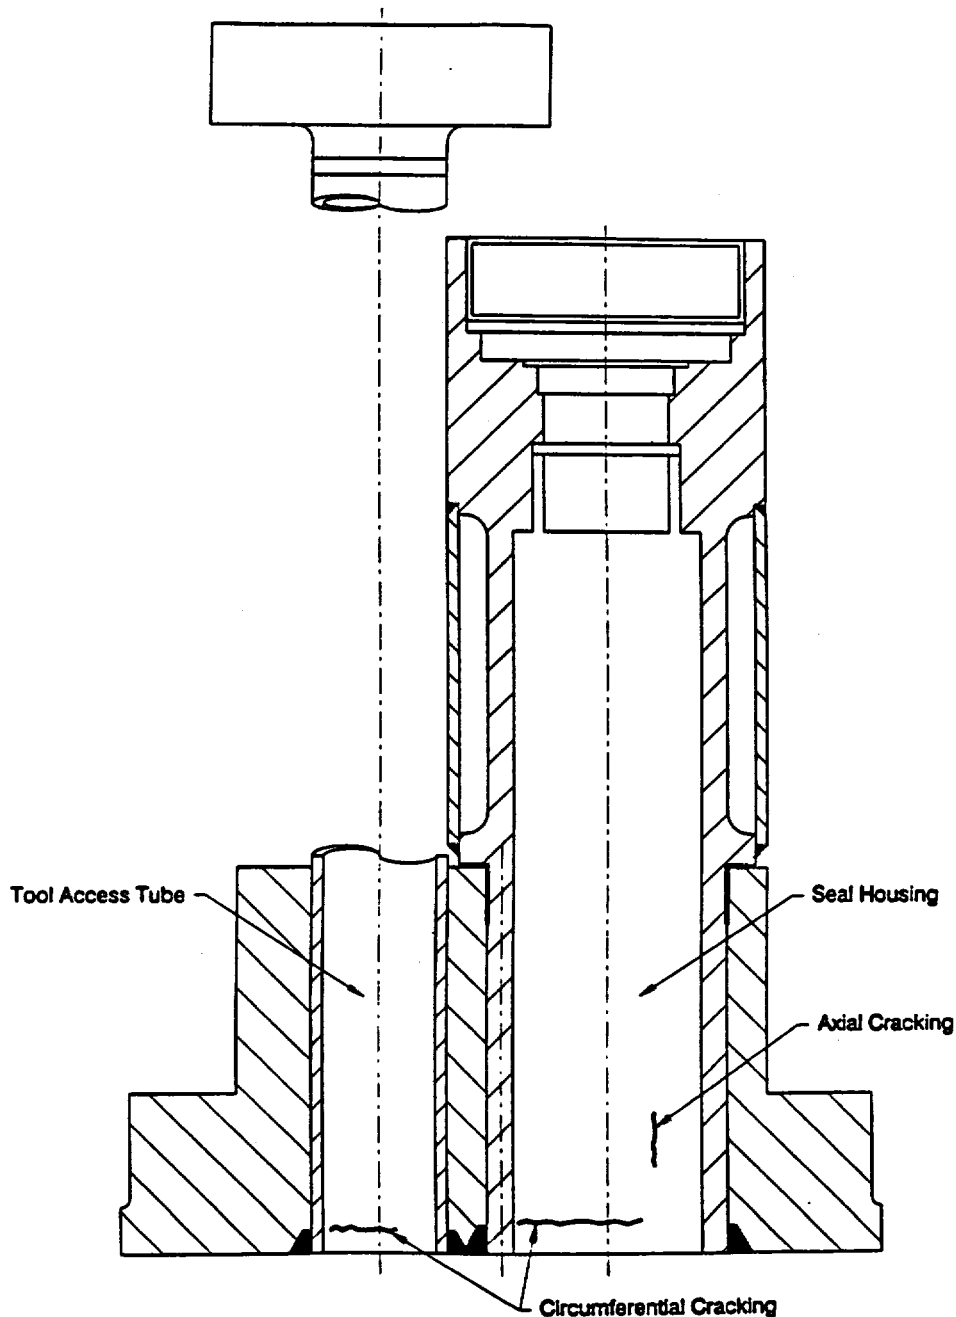
FIGURE 1

Control Rod Drive Seal Housing

Each control rod at Palisades is driven by an electric motor through a drive shaft and bevel gears which engage a rack assembly coupled to the control rod. The drive shaft is offset from and parallel to the axis of its associated control rod. Figure 1 provides a sketch of the CRD seal housing assembly configuration. The primary coolant pressure boundary is provided by a rotating mechanical seal located at the top of the seal housing tube. The lower flange of the seal housing (autoclave flange) is fastened to the support tube with the autoclave nut. The lower region of the seal housing below the mechanical seal provides the primary coolant pressure boundary. The drive motor and clutch assembly mount on the atmospheric side of the mechanical seal at the top of the seal housing. The tool access tube penetrates the autoclave flange directly above the rack assembly. The tool access tube provides access for coupling and uncoupling rods, and is closed with a blank flange when the primary coolant system is filled.
