CLOSEOUT OF GENERIC SAFETY ISSUE B-55, "IMPROVED
 RELIABILITY OF TARGET ROCK SAFETY RELIEF VALVES"

The purpose of this memorandum is to document the resolution of Generic Safety Issue (GSI) B-55, entitled "Improved Reliability of Target Rock Safety Relief Valves." Target Rock safety relief valves (SRVs) are currently installed in 22 boiling water reactors (BWRs), and there have been several occurrences of improper operation both in spuriously opening and blowing down the reactor coolant and in opening at pressures significantly above the technical specification requirements. There are two different designs of Target Rock SRVs. The earlier design is the three-stage SRV which had a history of spuriously opening and failing to reseat during several events in the 1970s. The later design is the two-stage SRV which is a modification of the three-stage SRV and was designed to eliminate the spurious opening and blowing down problem. GSI B-55 was prioritized in 1983 as a "medium" priority issue, based on the concerns with the three-stage SRVs. Beginning in 1978, two-stage SRVs were installed in several BWRs, and during operation and surveillance testing, had problems with opening at pressu

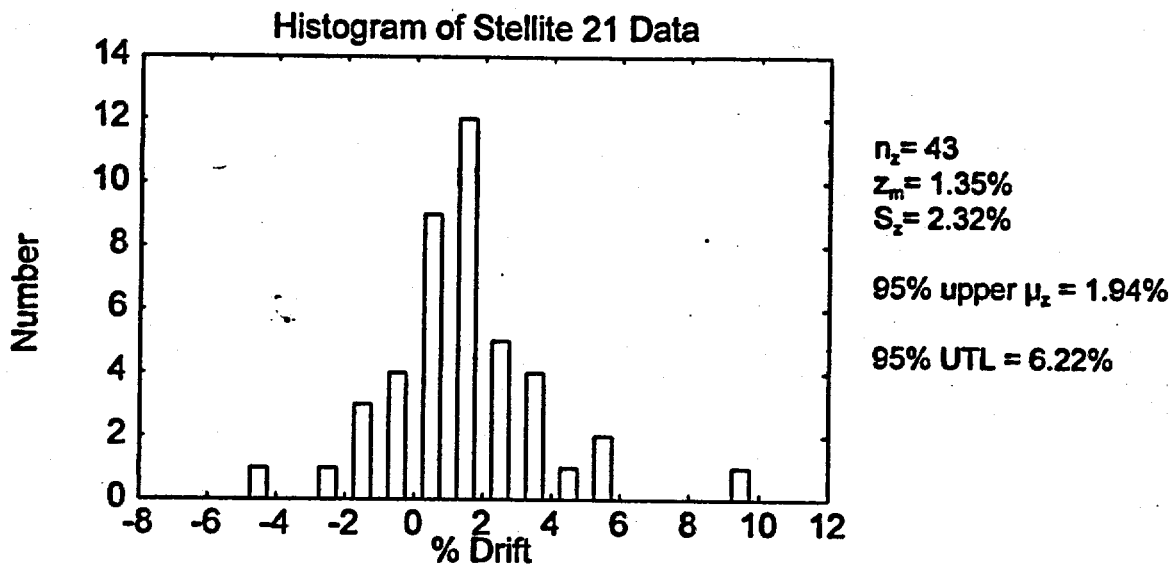
Statistical Analysis of Stellite 6B, Ion-Beam Platinum, and Stellite 21 Disk Setpoint Performance Data

Histograms of the setpoint performance data for the three different disk materials are provided below. The parameters and statistics shown beside each histogram are described below.

where: n = sample size

x_m, y_m, z_m = means of samples x, y, z
