Foreword

This analysis of upstream dam flooding leads the staff to conclude that the issue deserves further evaluation to determine what else the NRC might need to do. No immediate safety concerns were identified during the preparation of the analysis. The NRC conducted this analysis as part of the third, or screening, stage of the agency's five-stage Generic Issues (GI) Program. The NRC staff conducts this screening solely to determine, based on readily available information, whether an issue requires more detailed evaluation within the GI program. This analysis says nothing about whether existing nuclear power plant (NPP) licensing bases, design requirements, or regulations are adequate, nor whether plants comply with those standards. Although the analysis discusses some current regulatory actions regarding flooding issues at specific plant sites, it is silent regarding the performance of those or any other licensees. Plant performance is judged by other regulatory processes, primarily the Reactor Oversight Process (ROP). Finally, this analysis reaches no regulatory conclusion about dam reliability or the likelihood of beyond-design-basis failure events. Those decisions are addr

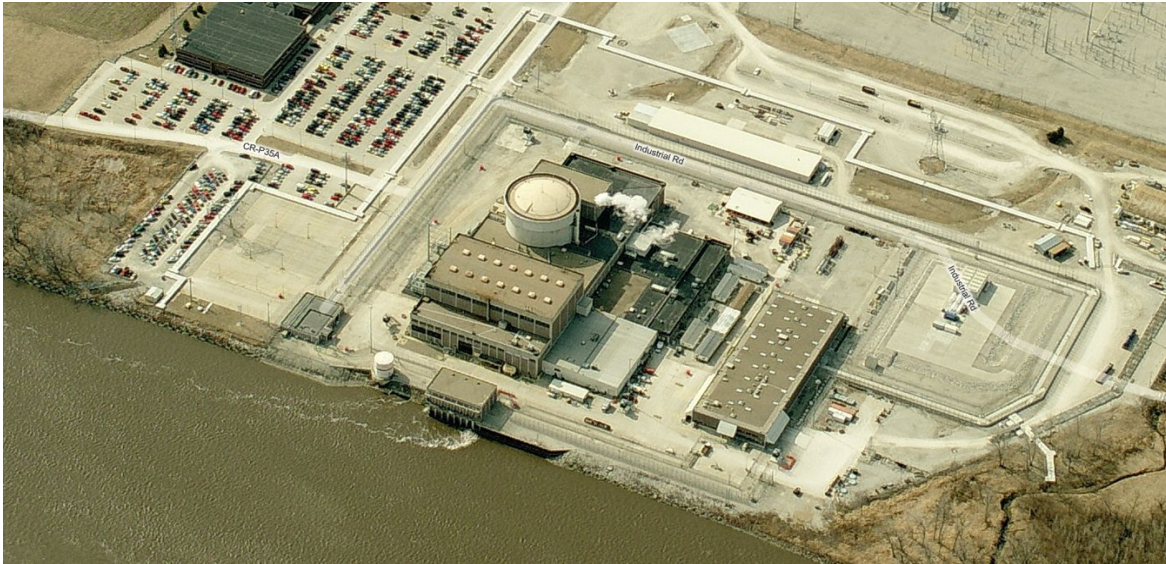
Figure 1: Aerial Photograph of Fort Calhoun Station

Fort Calhoun Station is located on the west bank of the Missouri River 19 miles north of Omaha. Figure 1 shows an aerial photograph of Fort Calhoun Station relative to the adjacent river. The base plant elevation (1,004ft MSL) is not substantially higher than normal river levels. The Updated Safety Analysis Report (USAR) specifies that the design flood elevation is 1,006ft MSL (FCS 2010, p. 8). In 1993, the U.S. Army Corps of Engineers estimated the probable maximum flood (absent upstream dam failure) to be 1,009.3ft MSL (FCS 2010, p.7). Without special provisions, safety-related components at the plant are protected from flooding by hardened features up to an elevation of 1,007ft MSL. Floodgates permanently mounted adjacent to openings can be installed to provide further flood protection of most components up to an elevation of 1,009.5ft MSL (FCS 2010, p.8). The intake structure is located at an elevation of 1,007.5ft MSL (FCS n.d., p. 5-24). Protection of the intake structure to an elevation of 1,009.5ft MSL is accomplished through a combination of both floodgates and sandbags (FCS 2010, p.8). The licensee has indicated that it will use sandbags, temporary earth levees, and other methods to allow safe shutdown up to an elevation of 1,013ft MSL (FCS 2010, p. 8). Based on more recent information (USACE 2004), NRC documents (USNRC 2010d, USNRC 2010h) have questioned the accuracy of existing flood estimates included in plant specific documents. Figure 2 illustrates the flood water levels for a variety of flood events (based on estimates produced by different agencies, as indicated in plant specific documents) as well as flood protection elevations.

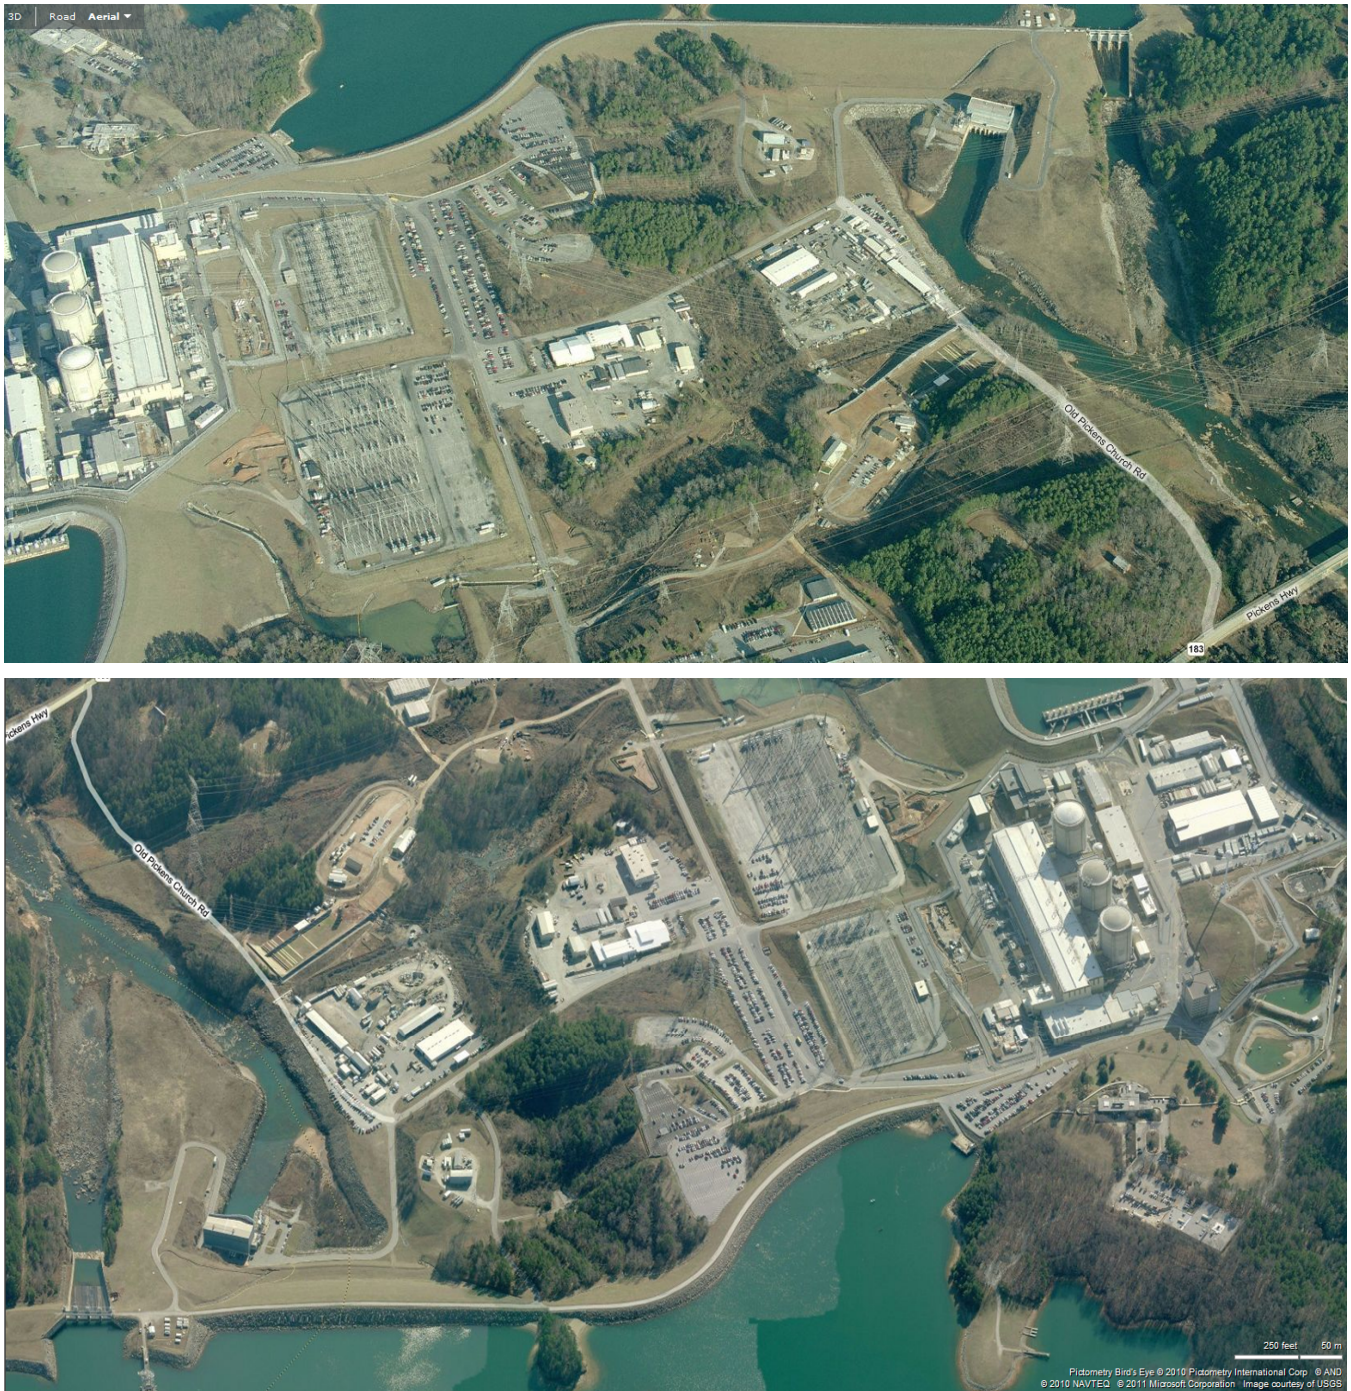
Figure 5: Aerial Photographs of Oconee Nuclear Station

Oconee Nuclear Station (ONS) is located about 30 miles west of Greenville, South Carolina. The site is downstream from Jocassee Dam and adjacent to Keowee Dam (Figure 4 provides a map and Figure 5 provides aerial photographs of Oconee Nuclear Station). [REDACTED]

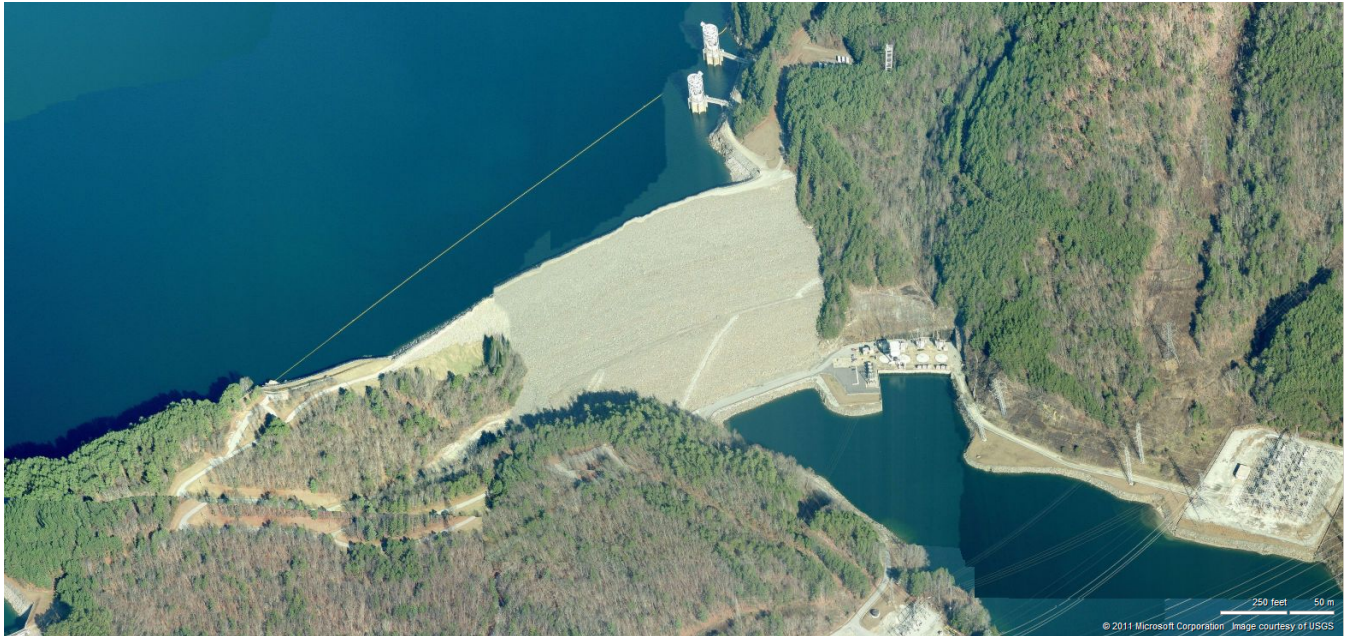
Figure 7: Aerial Photograph of Jocassee Dam

¹¹ Jocassee Dam is a large rockfill dam (Figure 7), Watts Bar Dam is an earth and concrete gravity structure (Figure 8), and Lock and Dam #2 has earth and concrete sections (Figure 9). Thus, the probability of failure associated with each dam may differ due to different structural classification

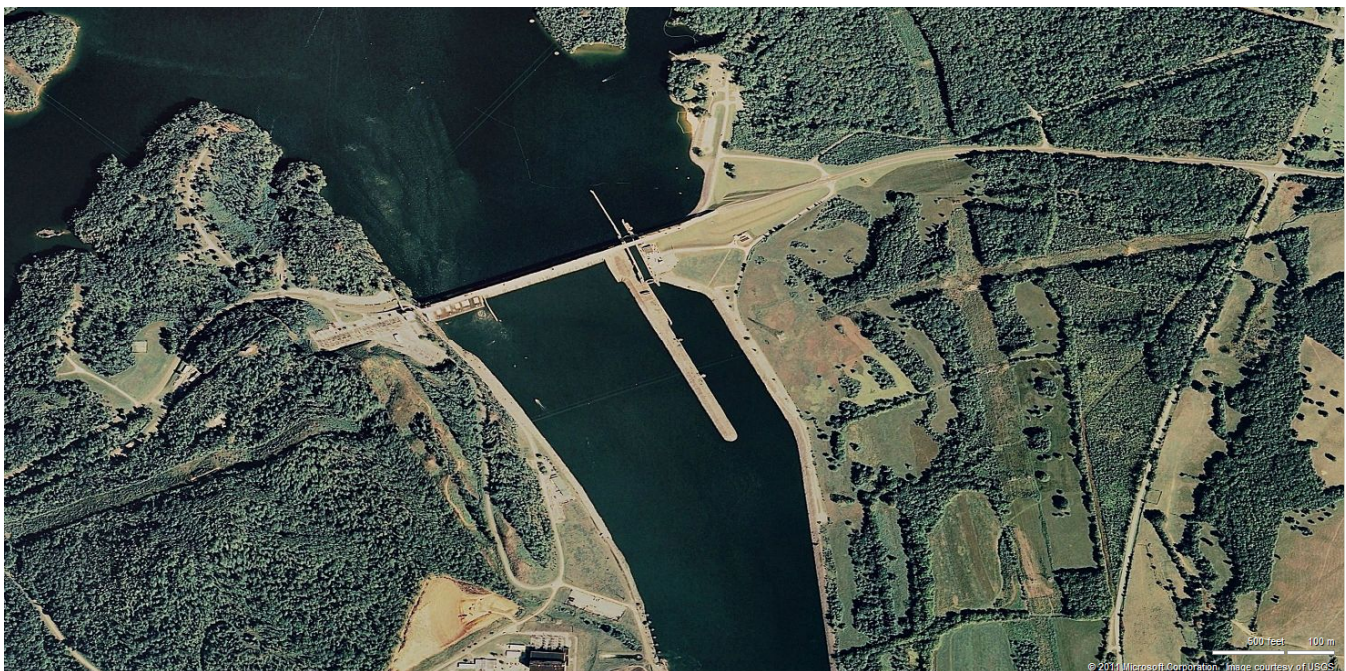
Figure 8: Aerial Photograph of Watts Bar Dam

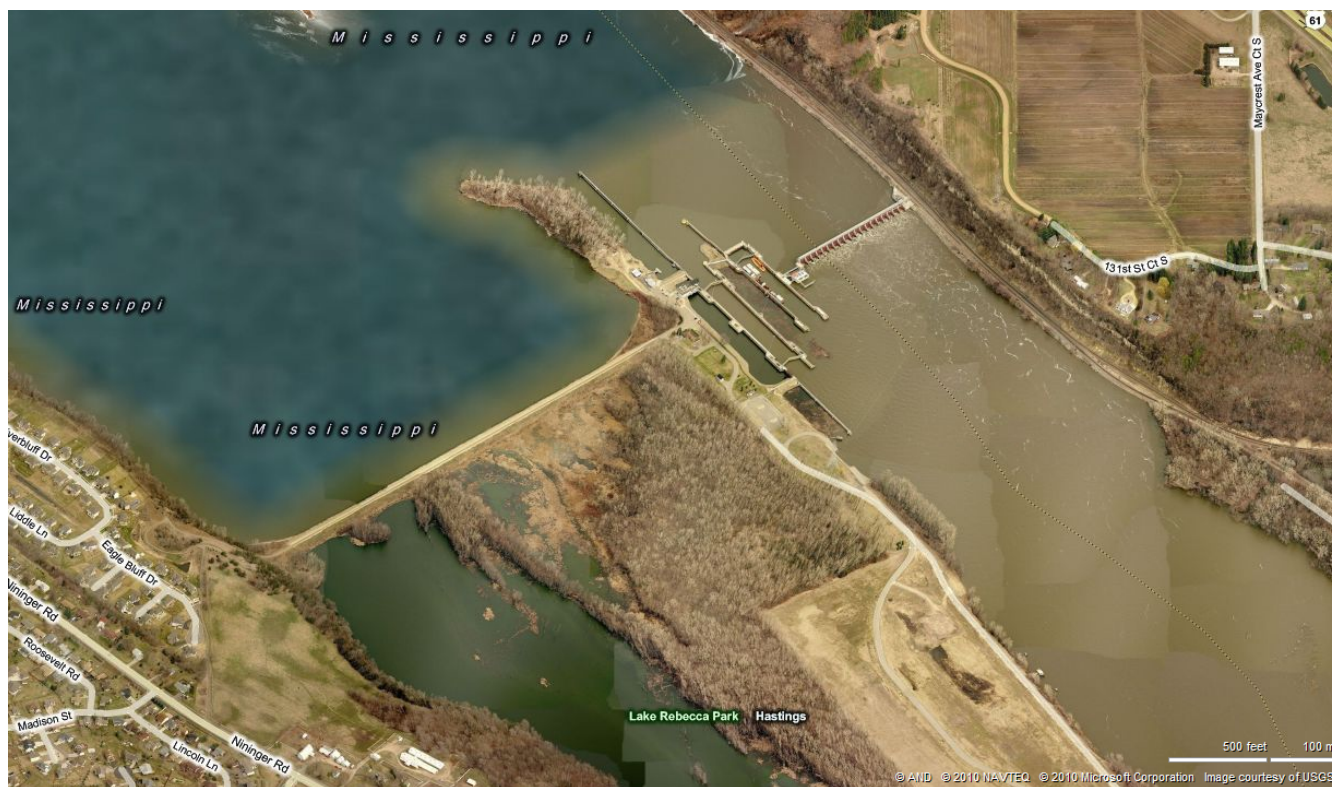
Figure 9: Aerial Photograph of Lock and Dam #2 (Earth and Concrete Sections)

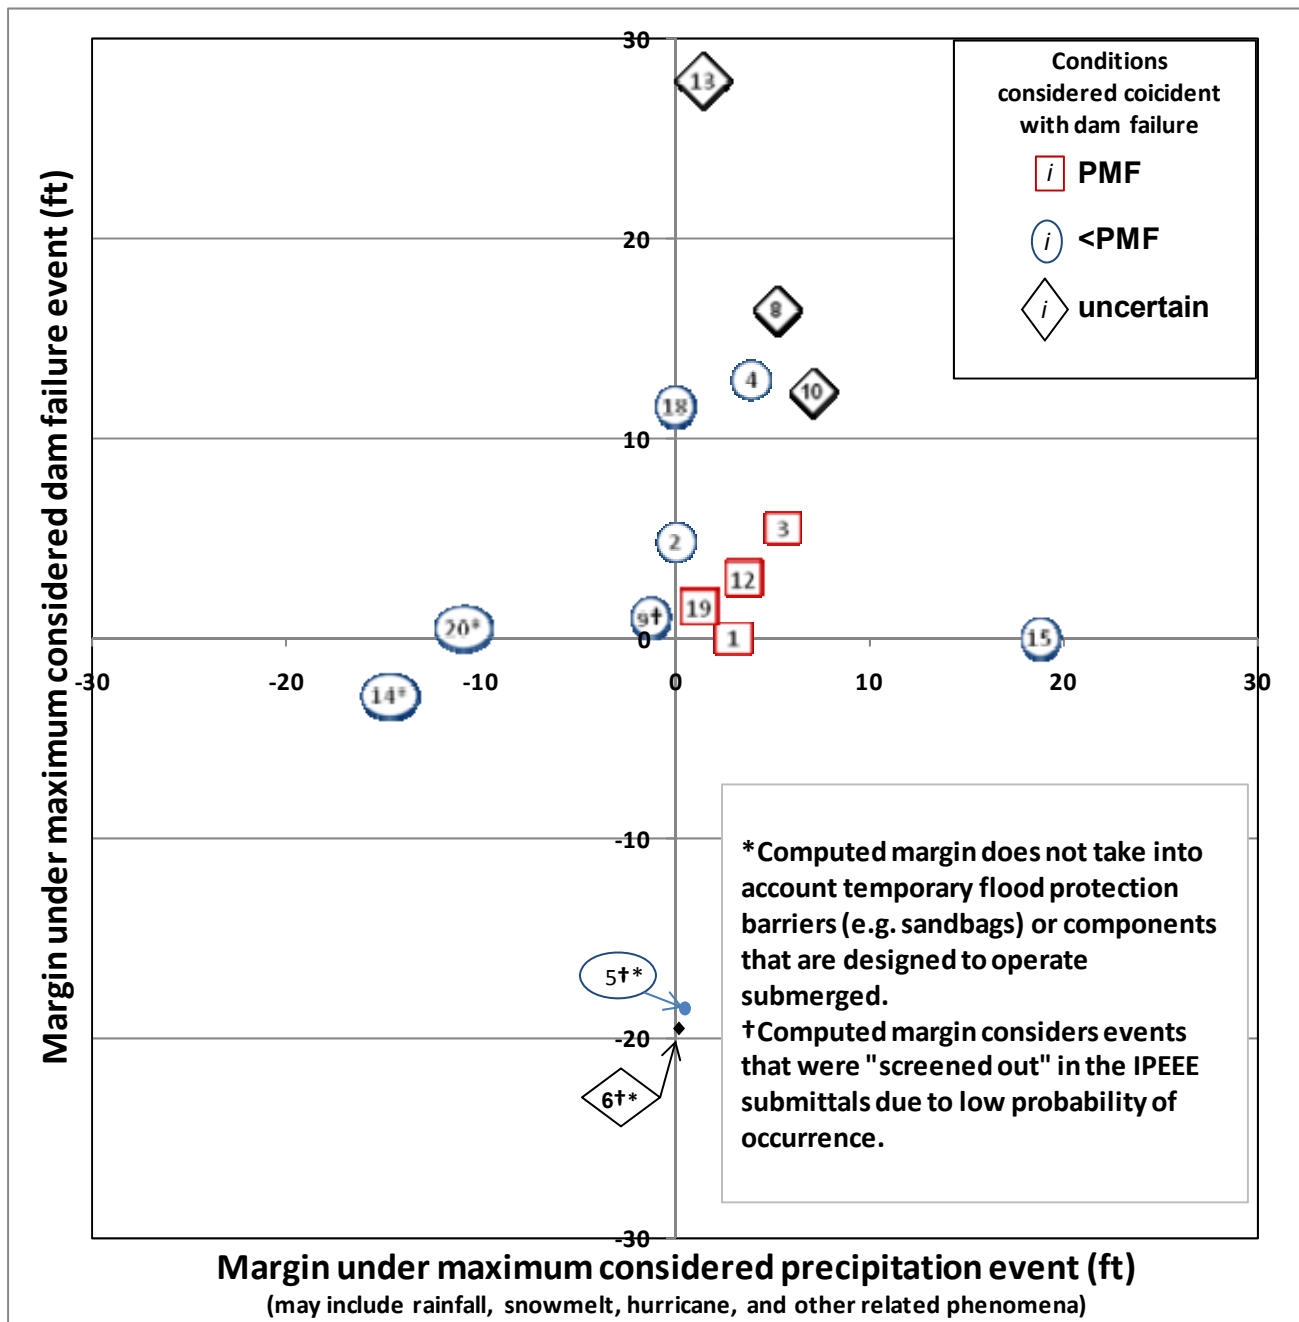
Figure 12: Available Margin Under Maximum Precipitation and Maximum Dam Failure Events Considered at Each Plant Site

Figure 12 compares possible margins at selected plants under flood events, based on certain assumptions regarding the performance of features (as stated below). The x-axis corresponds to margin under the flood caused by the maximum considered precipitation-induced event (excluding wave effects in most though not all cases), which may include floods due to weather-related phenomena such as the probable maximum flood and hurricanes. The y-axis shows computed margins under the flood caused by the maximum considered dam failure event (excluding wave effects in most though not all cases), coincident with a concurrent flood (as indicated by shapes around numbers). In this report, margins are computed using the best numerical information that could be located in the FSAR and IPEEE submittals. In general, margins are computed relative to the minimum flood protection elevation of safety-related facilities, structures, systems, and equipment/components. The flood protection elevation of individual critical facilities, structures, systems, and components may be higher. Moreover, margins are generally computed crediting hardened features such as floodwalls and hatches/doors but not temporary barriers such as sandbags. In this report, the computed margin does not generally take into account components that are designed to operate submerged (e.g., see Watts Bar and Sequoyah Nuclear Power Plant FSARs). When conflicting information is found, the margin is computed using the lowest flood protection elevation and highest static water level available in existing documents (e.g., see FSAR and IPEEE submittals for Arkansas Nuclear One). Flood levels that result from events that were "screened out" in the IPEEE due to low probability of occurrence, if reported in the licensee's IPEEE submittal, are considered when computing available margin (e.g., see Fort Calhoun and Cooper IPEEE submittals).

Figure 12 also demonstrates whether dam failure was considered under the PMF or a lesser flood as indicated by shapes. A square around a number indicates the dam failure event was considered coincident with a PMF, a circle indicates that the dam failure event was considered with a different (typically smaller) flood, and a diamond indicates that it was not clear what flood conditions were considered coincident with dam failure. Table 1 gives the sources for data used to construct Figure 12. In cases where a flood less than the PMF is considered, several plants indicate that the dam is designed such that a PMF event will not fail the dam.

Sites plotted in the upper right quadrant of Figure 12 have a positive margin under both the maximum precipitation and dam failure events. However, several of the sites do not consider failure of the dam under a PMF event and thus the magnitude and sign of this margin may change if dam failure coincident with the larger flood is considered. Sites plotted in the lower left quadrant have a negative margin under both precipitation and dam failure events. However, as noted in Regulatory Guides 1.102 and 1.59, this negative margin is acceptable if the plant can be shutdown before floodwaters reach the site and safely maintained throughout the duration of the flood event. Sites plotted in the lower right quadrant have a positive margin under precipitation events but a negative margin under a dam failure event. These sites are controlled by flooding due to dam failure. Sites plotted in the upper left quadrant have a positive margin under dam failure events but a negative margin under precipitation events. Sites plotted in this quadrant consider a flood less than the PMF coincident with dam failure. These sites may have a lower (or negative) margin under dam failure if a large precipitation event (i.e., PMF) is considered coincident with dam failure.

Because of the extremely diverse methods used and disparate level of detail provided in plant documentation (i.e., FSAR and IPEEE submittals), care should be given to drawing strong conclusions from Figure 12 because it does not capture important distinctions and subtleties between the sites and the definitions used in plant-specific documentation. Because of the important differences between the sites and the estimation methods used, the original data source referenced in Table 1 should be consulted before drawing conclusions based on the numerical values in Figure 12. However, despite the disparate nature of the data, this figure serves to demonstrate that, for many plants, the reported margin between flood levels and flood protection is small for dam failure and/or precipitation and related weather events. This margin is further reduced when accounting for the effects of wind-generated waves and runup. Moreover, several sites do not consider dam failure coincident with a PMF event and, therefore, the available margin may degrade further if dam failure coincident the larger precipitation event is considered. The necessity of considering dam failure coincident with such extreme events is an area warranting further study.
