SUBJECT: PALISADES NUCLEAR GENERATING PLANT
NRC SPECIAL INSPECTION REPORT 50-255/03-05

Enclosure: Inspection Report 50-255/03-05(DRP)

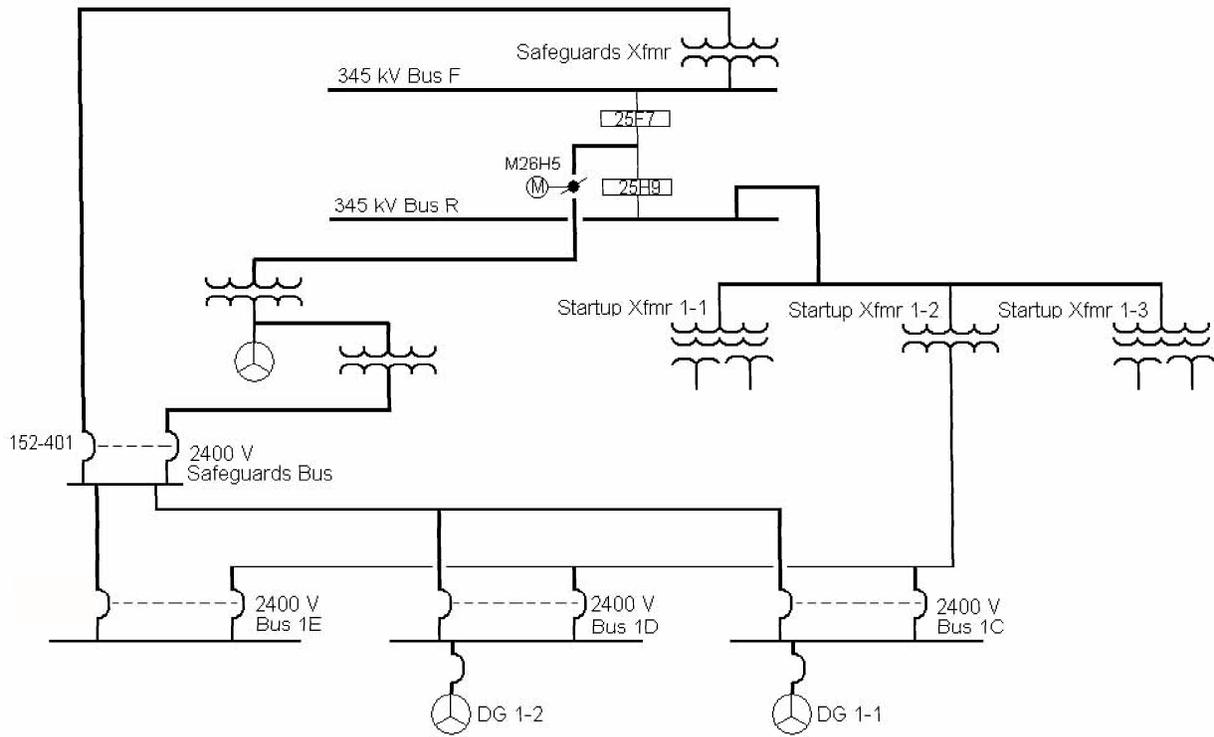
Palisades Simplified Electrical Distribution System

The team reviewed the offsite and onsite electrical distribution system as described in various licensing and design bases documents such as the Updated Final Safety Analysis Report. In particular, the team focused on the facility's design with respect to electrical and cable separation requirements. This issue was of concern in light of the event being caused by damage to multiple conductors in a single cable. This cable contained protective relay circuitry which affected the normal and alternate power sources to both safety-related buses.
