SECY-13-0036

SUBJECT: ANNUAL REPORT TO THE COMMISSION ON LICENSEE  
PERFORMANCE IN THE MATERIALS AND WASTE PROGRAMS  
FISCAL YEAR 2012

# **Nuclear Material Events Database**

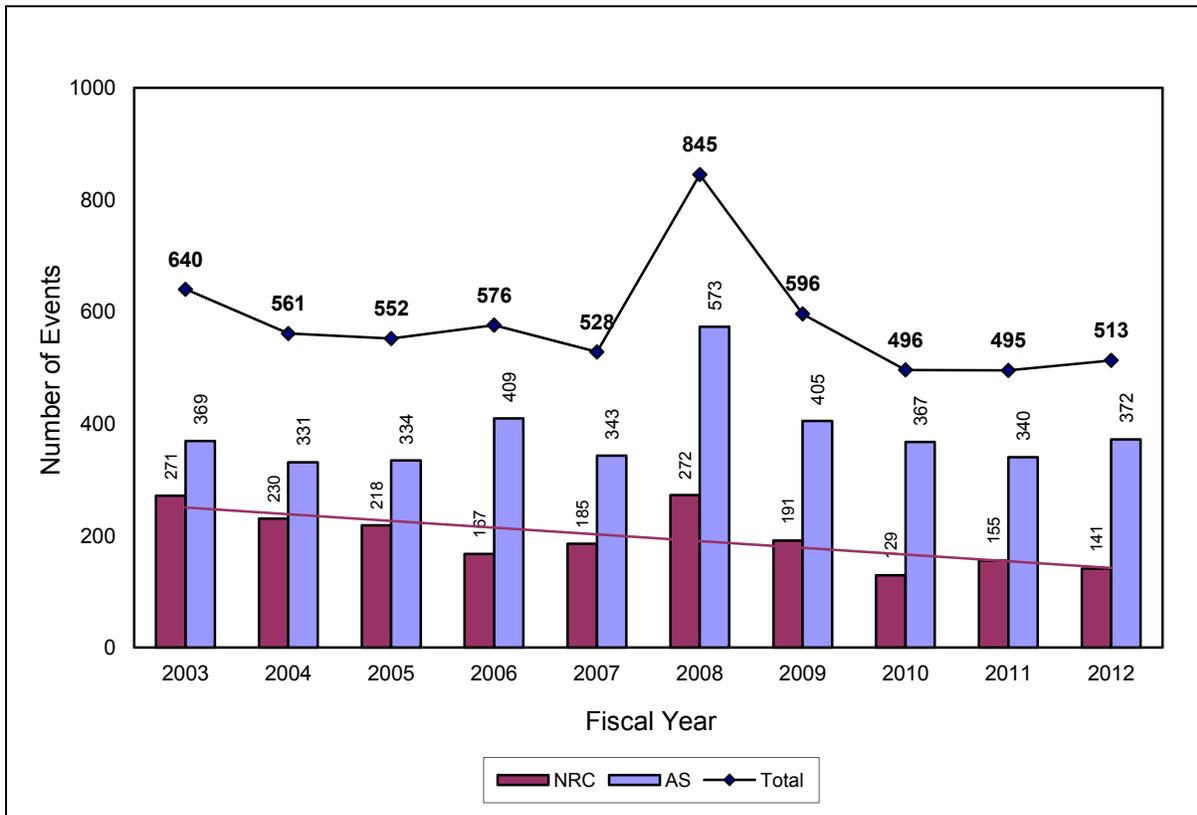
Figure 1 displays the annual number and trend of NMED events that occurred during the 10-year period. The trend analysis determined that the NRC-regulated events represent a statistically significant decreasing trend (indicated by the trend line). However, the Total events and Agreement State-regulated events do not represent statistically significant trends (indicated by the absence of trend lines). Therefore, variations within the Total and Agreement State values represent random fluctuation around the average of the data.

Figure 1. All NMED Events (5,802 total)

The following observations are made regarding the data in Figure 1.

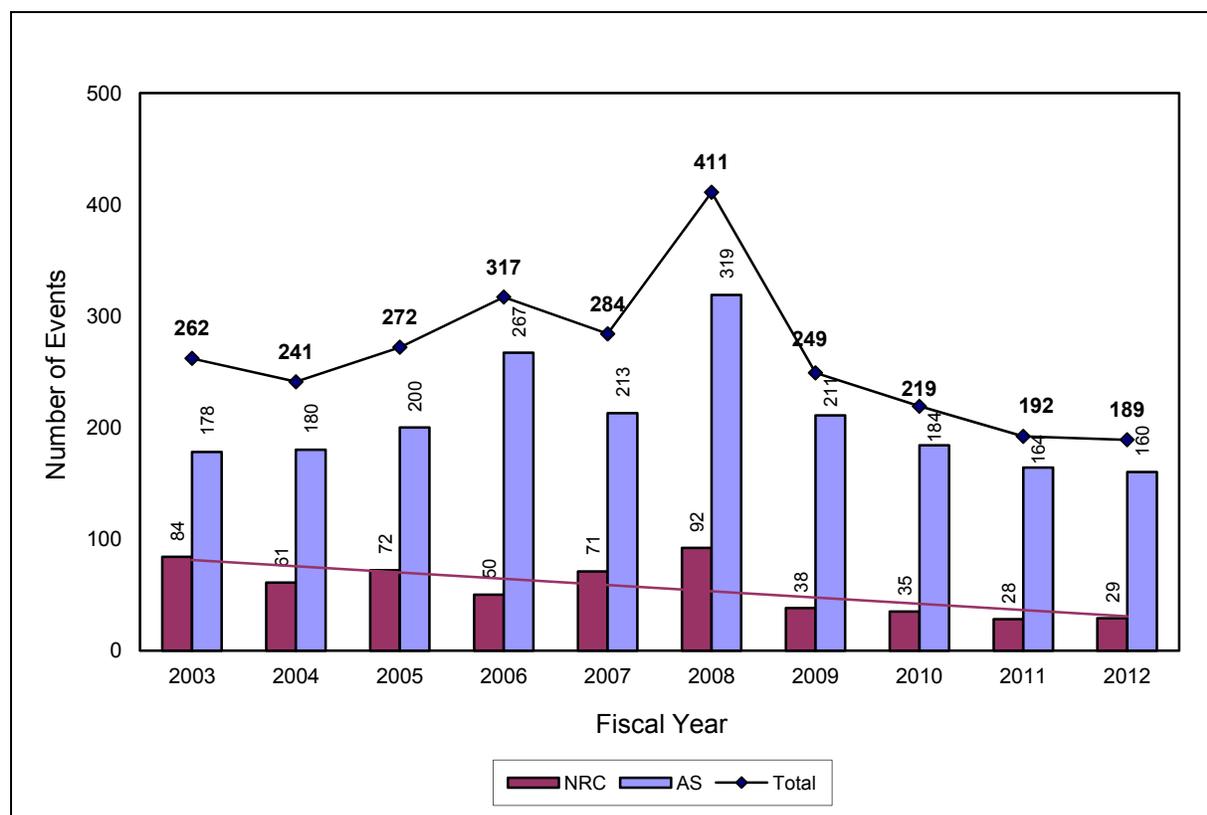
Figure 2 displays the annual number and trend of LAS events that occurred during the 10-year period. The trend analysis determined that the NRC-regulated events represent a statistically significant decreasing trend (indicated by the trend line). However, the Total events and Agreement State-regulated events do not represent statistically significant trends (indicated by the absence of trend lines). Therefore, variations within the Total and Agreement State values represent random fluctuation around the average of the data.

Figure 2. Lost/Abandoned/Stolen Material Events (2,636 total)

The FY08 and 09 data include 142 and 45 LAS events respectively that resulted from Wal-Mart's one-time review of their tritium exit sign inventory. Excluding these events results in a statistically significant trend in the total remaining events.

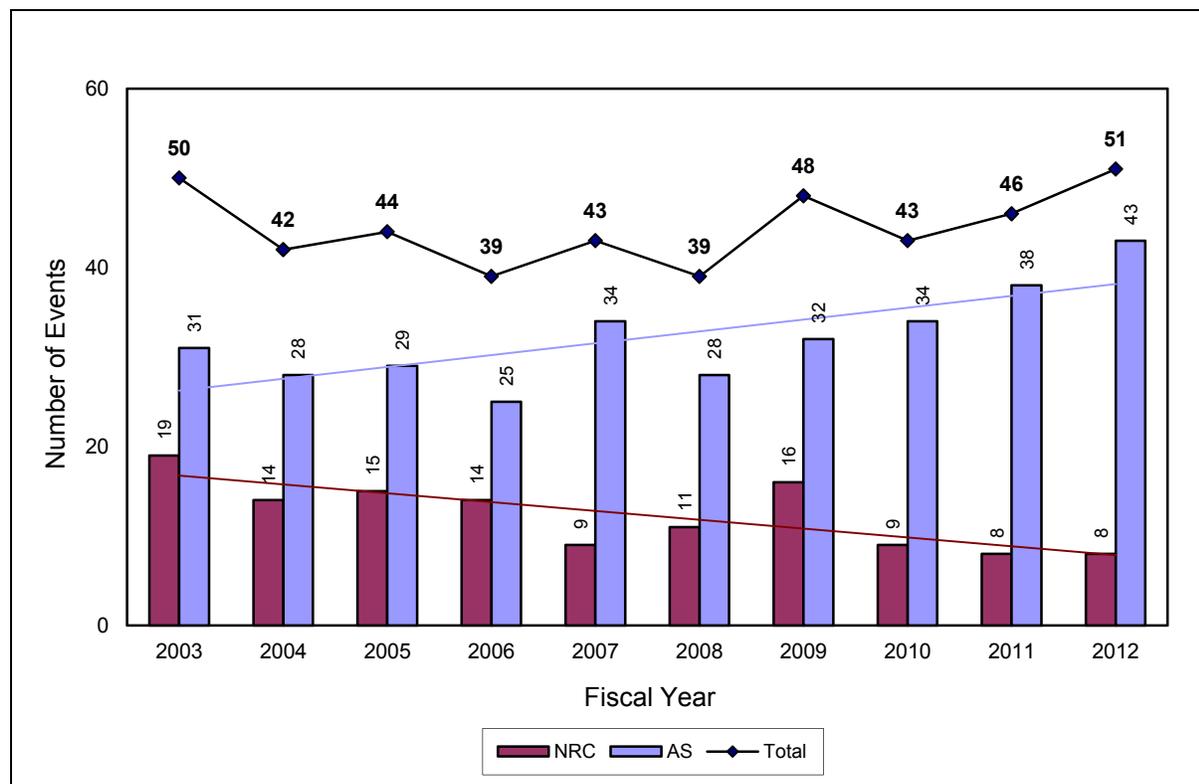
Figure 3 displays the annual number and trend of MED events that occurred during the 10-year period. The trend analysis determined that the Agreement State-regulated events represent a statistically significant increasing trend and the NRC-regulated events represent a statistically significant decreasing trend (indicated by the trend lines). However, the Total events do not represent statistically significant trends (indicated by the absence of a trend line). Therefore, variations within the Total values represent random fluctuation around the average of the data.

Figure 3. Medical Events (445 total)

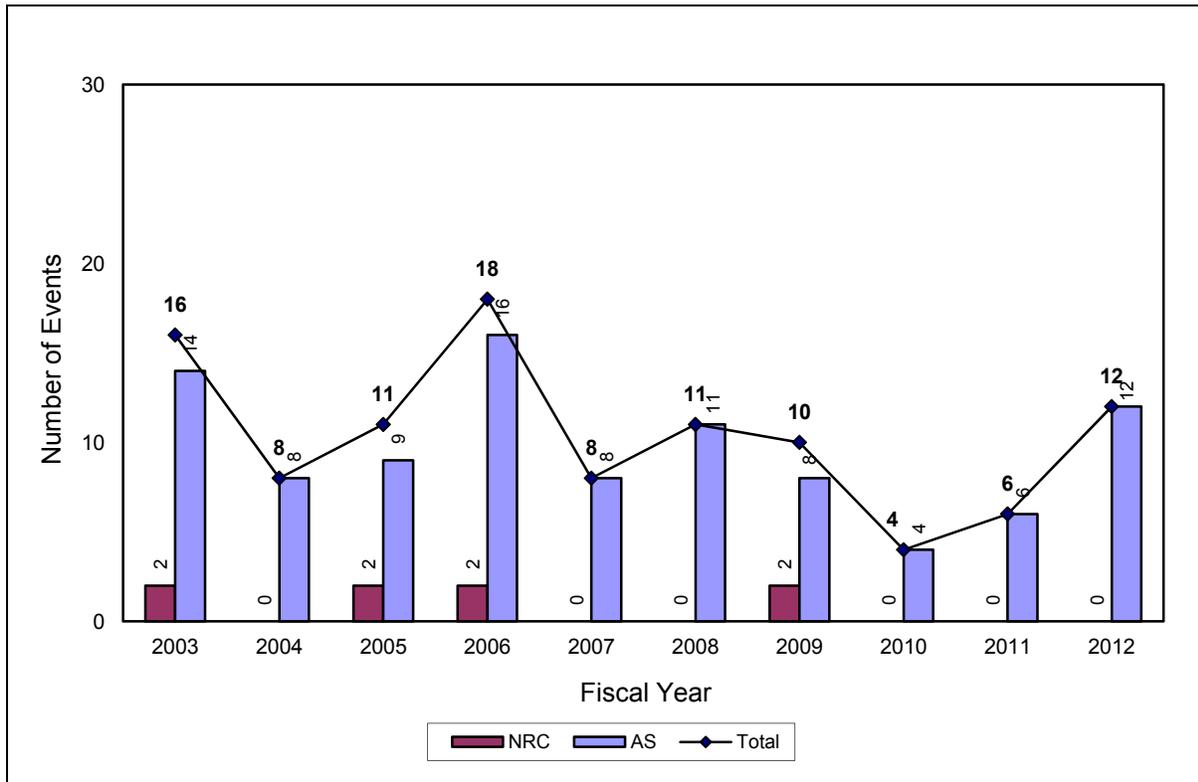
Figure 4 displays the annual number and trend of EXP events that occurred during the 10-year period. The trend analysis determined that the data does not represent statistically significant trends in the number of events (indicated by the absence of trend lines). Therefore, variations within the annual values represent random fluctuation around the average of the data.

Figure 4. Radiation Overexposure Events (104 total)

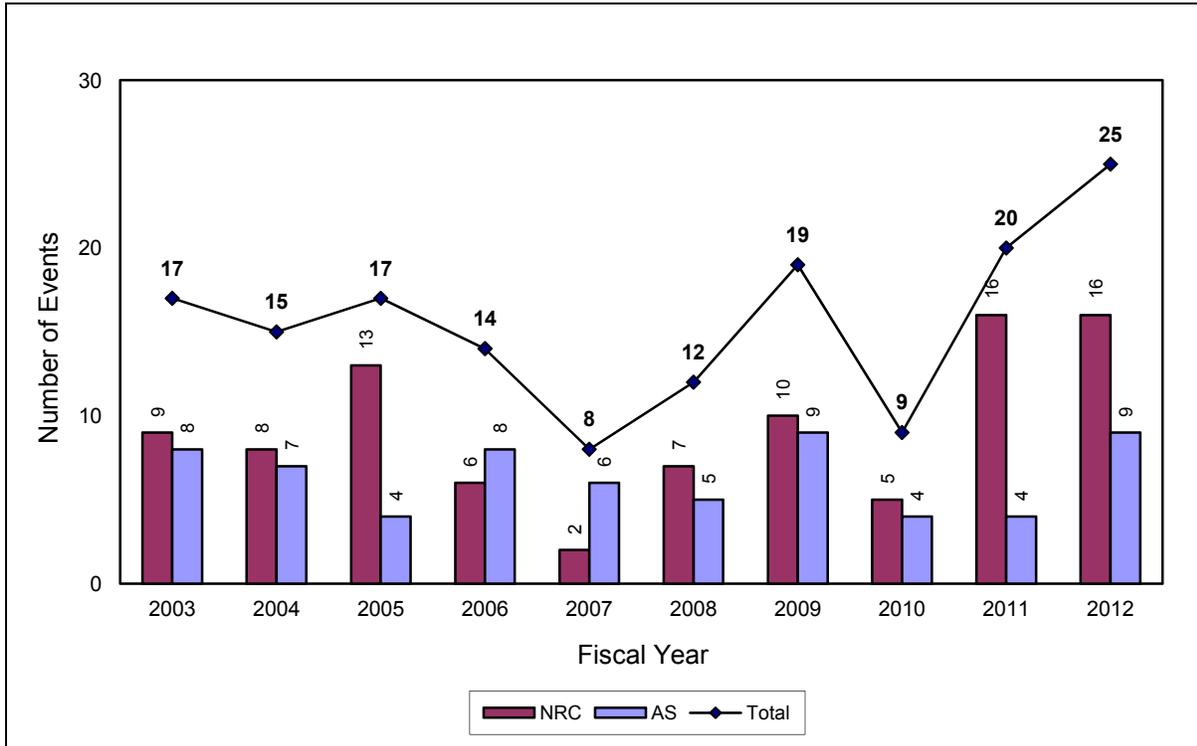
Figure 5 displays the annual number and trend of RLM events that occurred during the 10-year period. The trend analysis determined that the data does not represent statistically significant trends in the number of events (indicated by the absence of trend lines). Therefore, variations within the annual values represent random fluctuation around the average of the data.

Figure 5. Release of Licensed Material or Contamination Events (156 total)

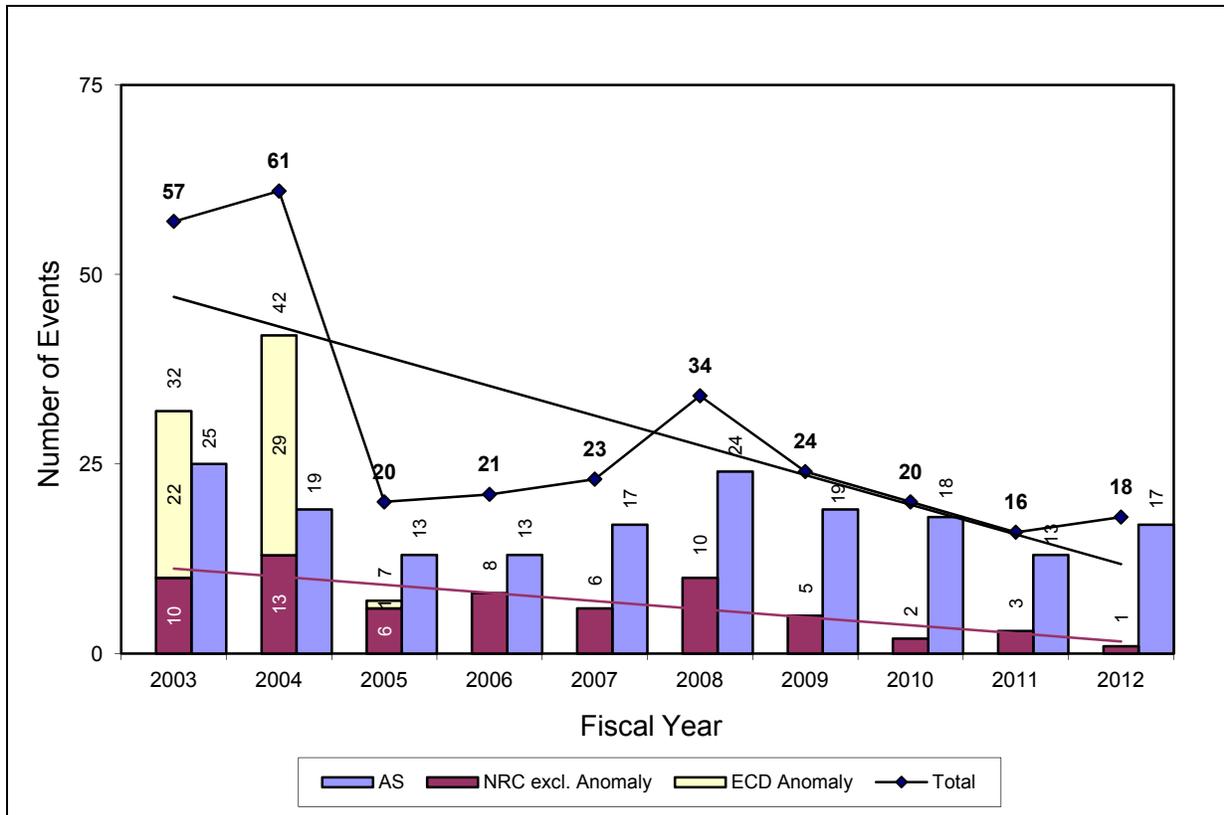
Figure 6 displays the annual number and trend of LKS events that occurred during the 10-year period. An event reporting anomaly associated with a single electron capture detector (ECD) manufacturer occurred from Fiscal Year 2000 through early 2005, which notably increased the number of LKS events. The anomalous events were not significant and involved leaking ECD sources (Ni-63 foil sources) that had been returned to the manufacturer for refurbishment. The manufacturer discontinued refurbishing ECDs and now disposes of the returned sources without leak testing. To show this affect, Figure 6 displays the anomalous events as yellow shaded bars.

The trend analysis determined that the Total events and NRC-regulated events (excluding the anomalous data) represent statistically significant decreasing trends (indicated by the trend lines). The Agreement State-regulated events do not represent a statistically significant trend (indicated by the absence of a trend line). Therefore, variations within the Agreement State-regulated values represent random fluctuation around the average of the data.

Figure 6. Leaking Sealed Source Events (294 total)

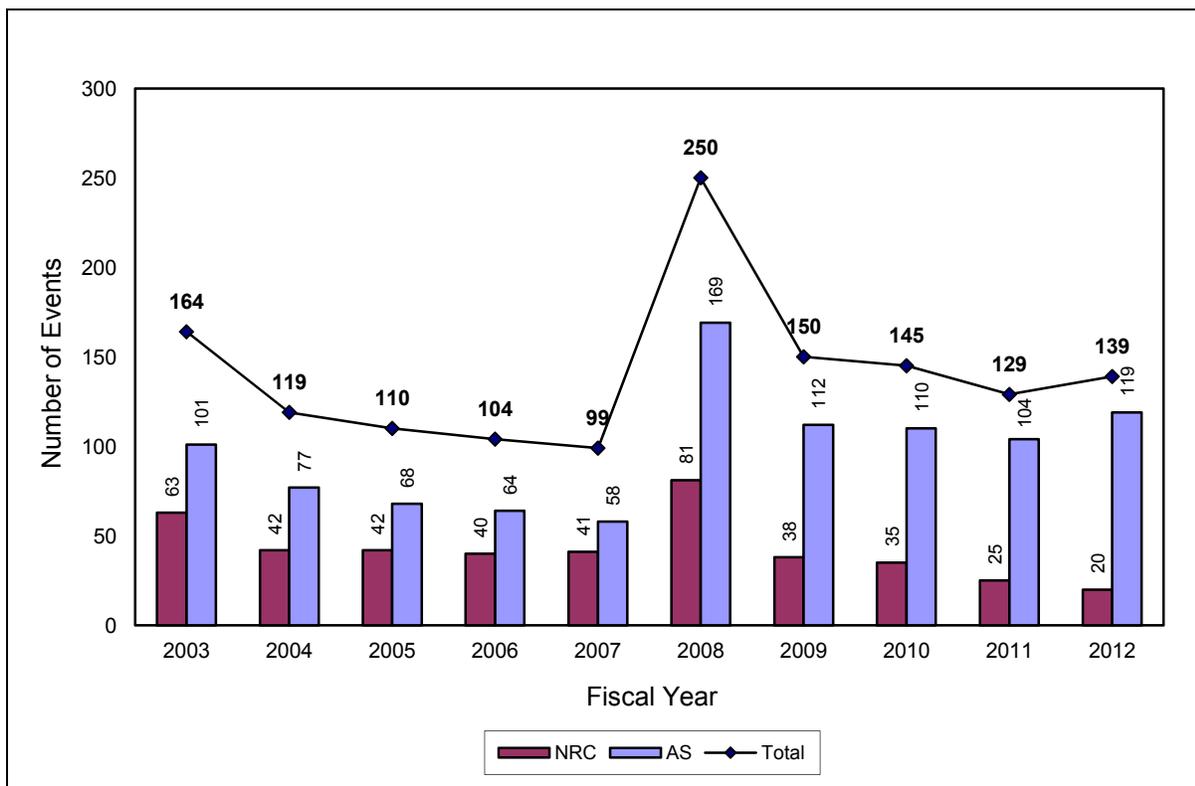
Figure 7 displays the annual number and trend of EQP events that occurred during the 10-year period. The trend analysis determined that the data does not represent statistically significant trends in the number of events (indicated by the absence of trend lines). Therefore, variations within those annual values represent random fluctuation around the average of the data.

Figure 7. Equipment Events (1,409 total)

The FY08 and 09 data include 130 and 20 EQP events, respectively, which resulted from Wal-Mart's one-time review of their tritium exit sign inventory. Excluding these events does not result in a statistically significant trend in the total remaining events.

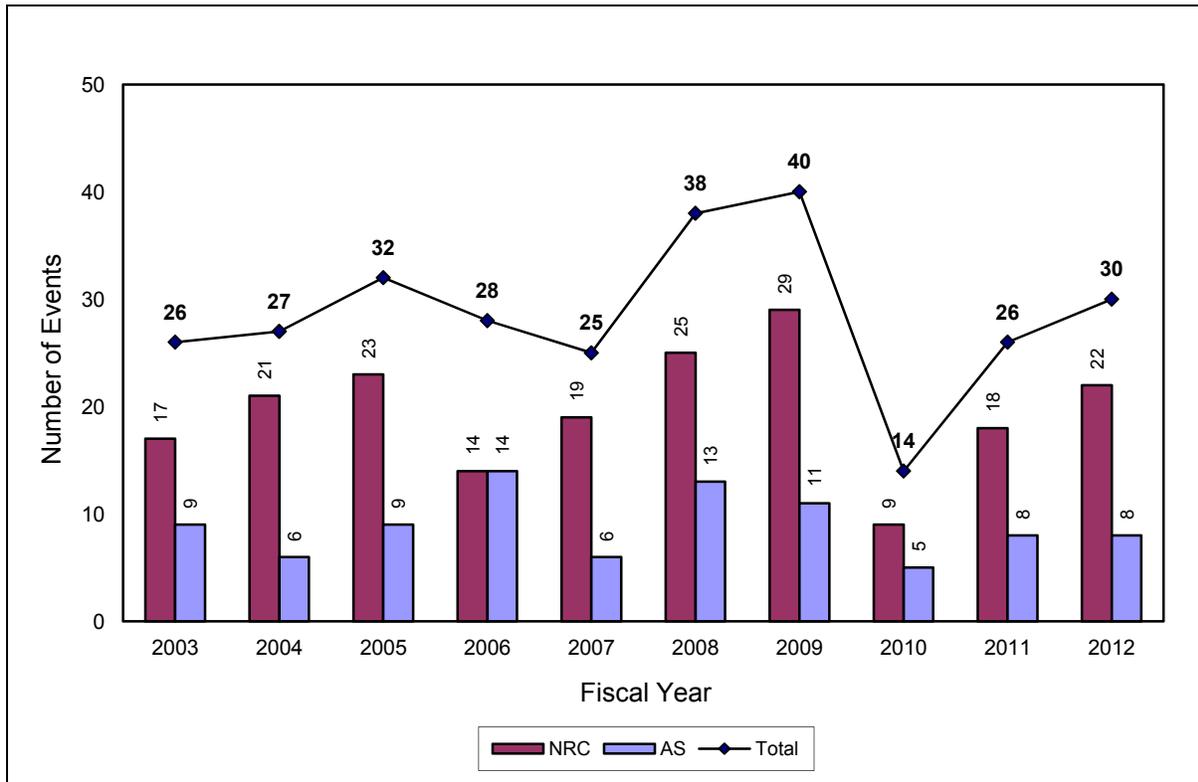
Figure 8 displays the annual number and trend of TRS events that occurred during the 10-year period. The trend analysis determined that the data does not represent statistically significant trends in the number of events (indicated by the absence of trend lines). Therefore, variations within those annual values represent random fluctuation around the average of the data.

Figure 8. Transportation Events (286 total)

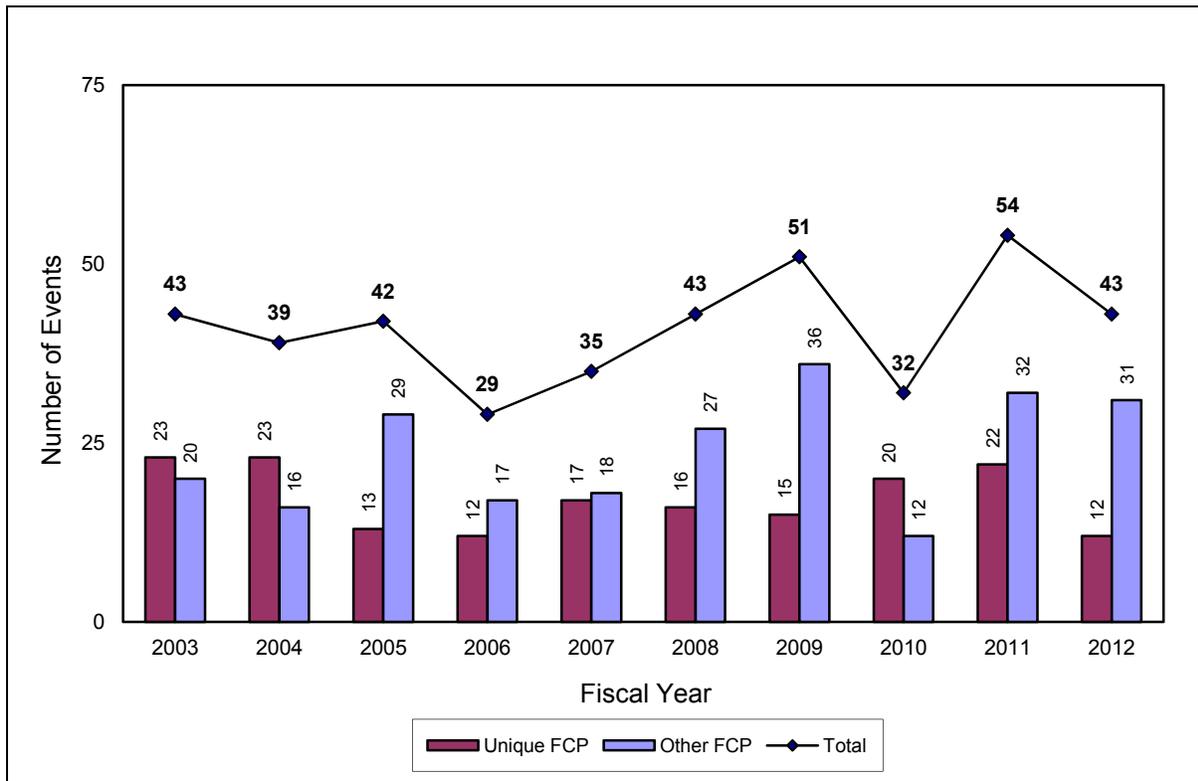
Figure 9 displays the annual number and trend of FCP events that occurred during the 10-year period. This figure differs from those in previous sections of this report because FCP events are only associated with NRC-regulated facilities (not Agreement State-regulated). Additionally, unlike the other event types, NMED incorporates a dual use of the FCP event type; one use (Unique FCP) is for events unique to the fuel cycle process (such as a degradation of criticality controls), while the other use (Other FCP) is for any event occurring at a fuel cycle process facility (such as a lost calibration source).

The trend analysis determined that the data does not represent statistically significant trends in the number of events (indicated by the absence of trend lines). Therefore, variations within those annual values represent random fluctuation around the average of the data.

Figure 9. Fuel Cycle Process Events (411 total)

Starting with this FY12 report, the dual use methodology was expanded such that TRS events involving fuel cycle process facilities are now also coded as FCP events. Thus, a comparison of Figure 9 with previous fiscal year reports will show an increase in the number of FCP events.

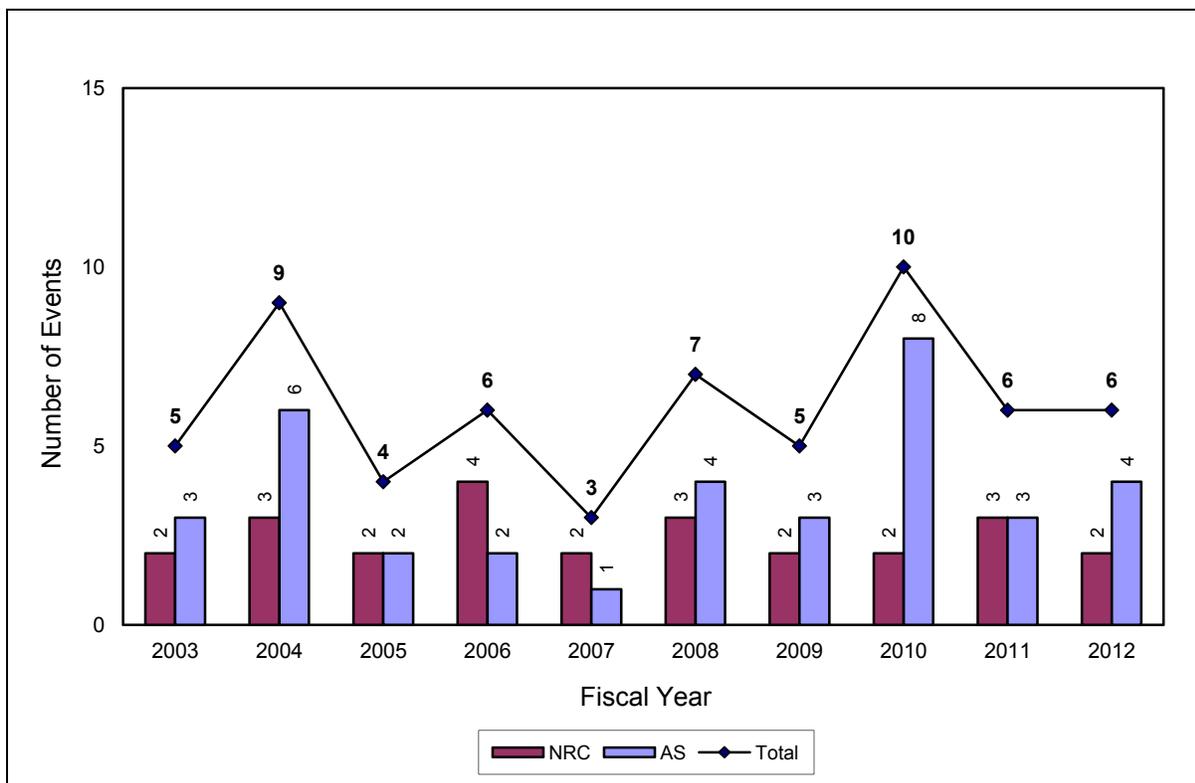
Figure 10 displays the annual number of OTH events that occurred during the 10-year period. Because OTH events do not fit a defined criterion that ensures consistency within the data, trending analysis is not performed on this data.

Figure 10. Other Events (61 total)

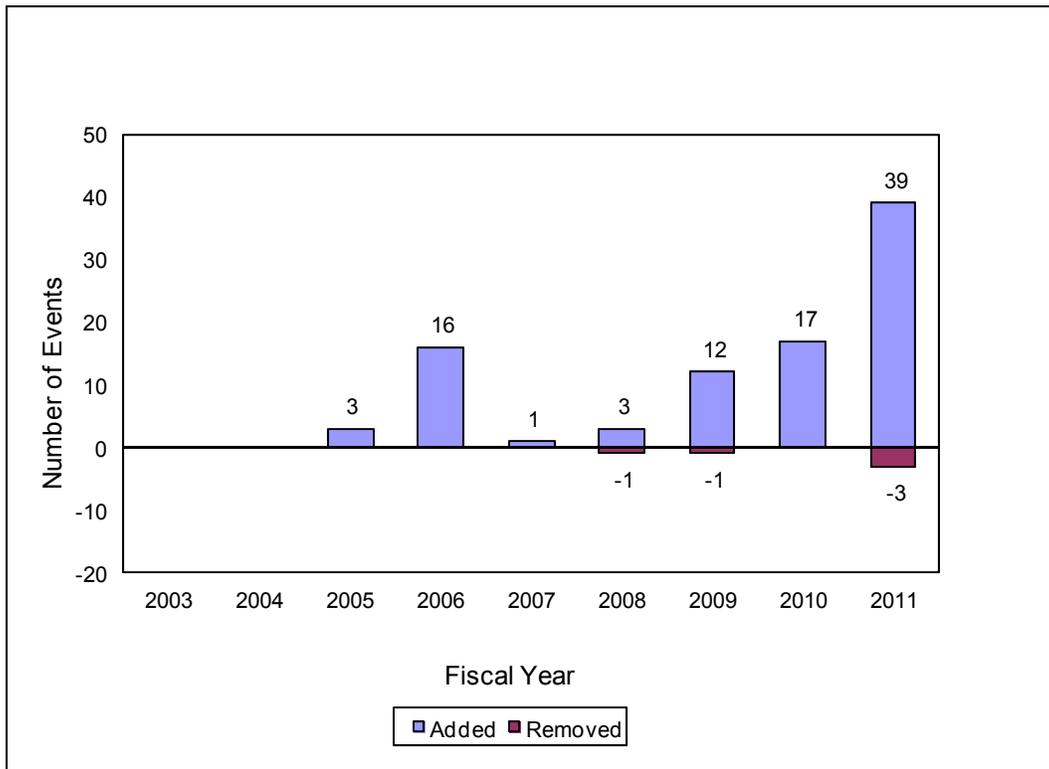
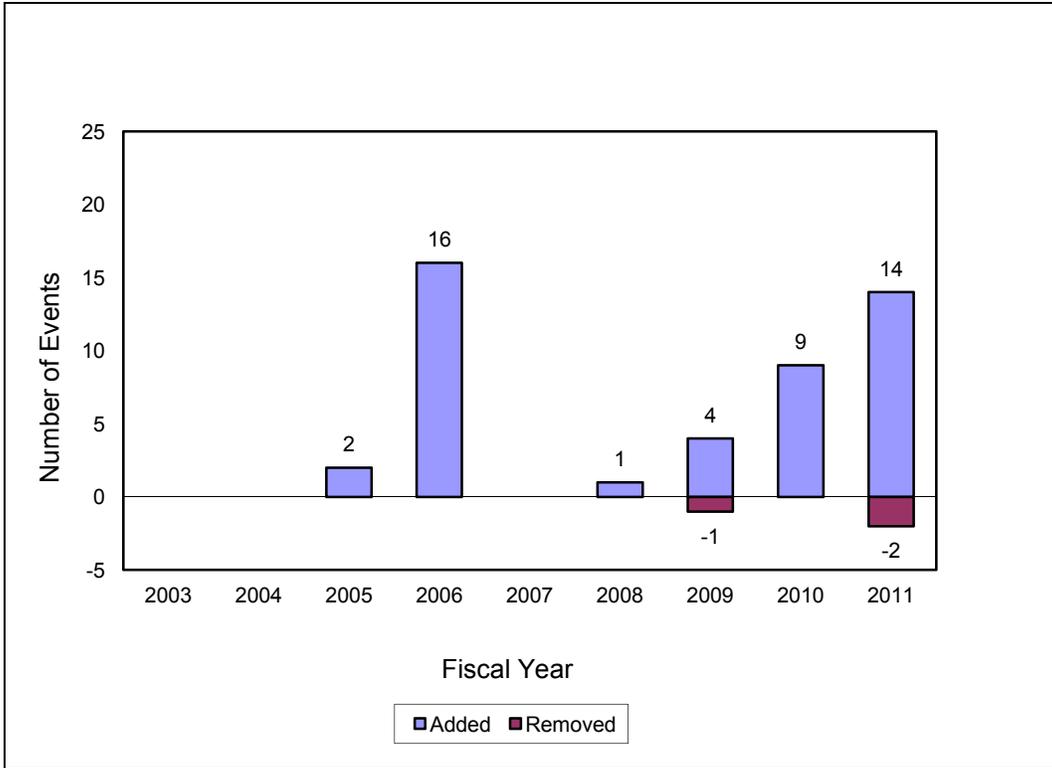
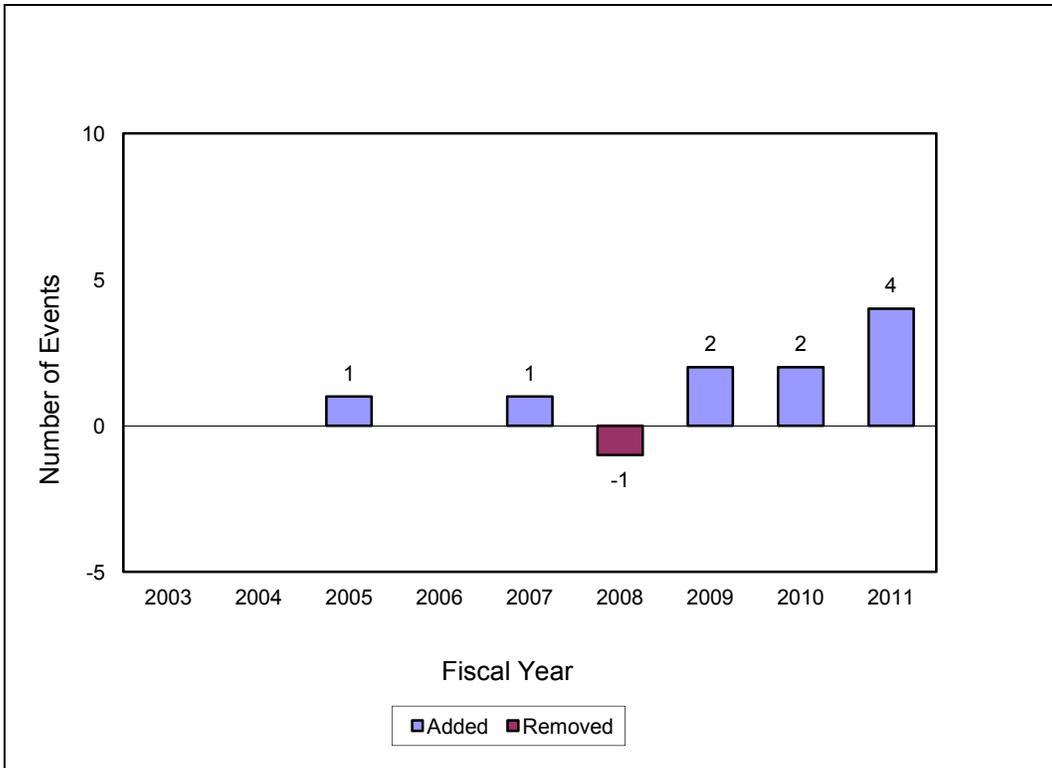
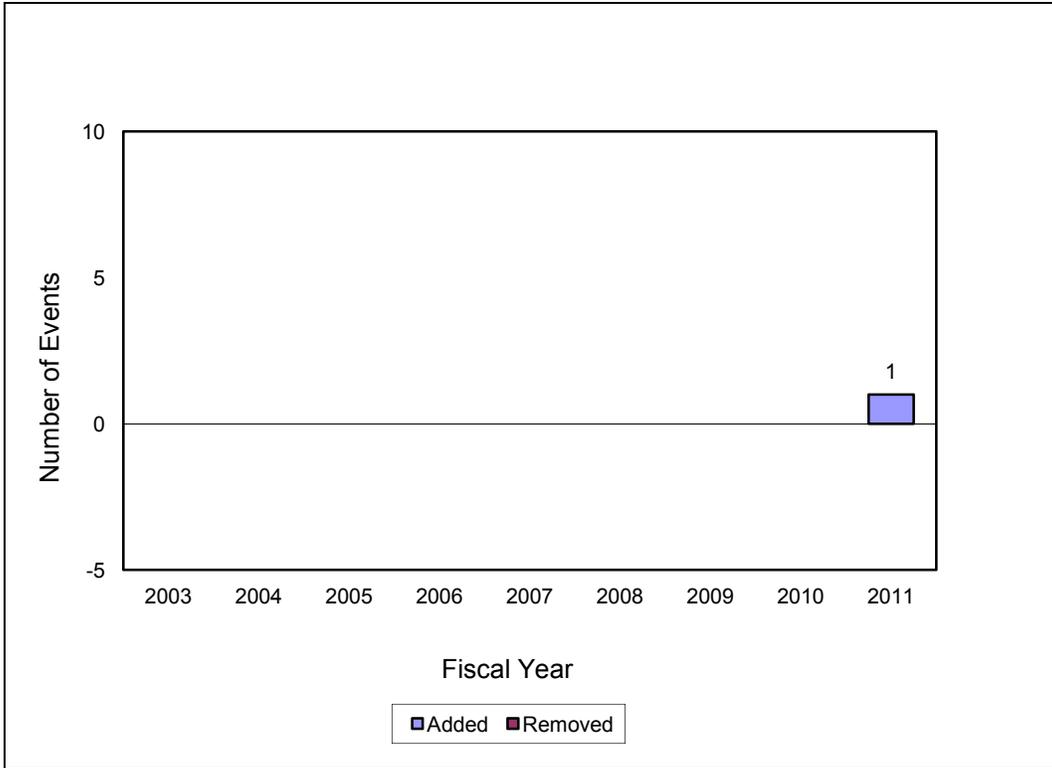
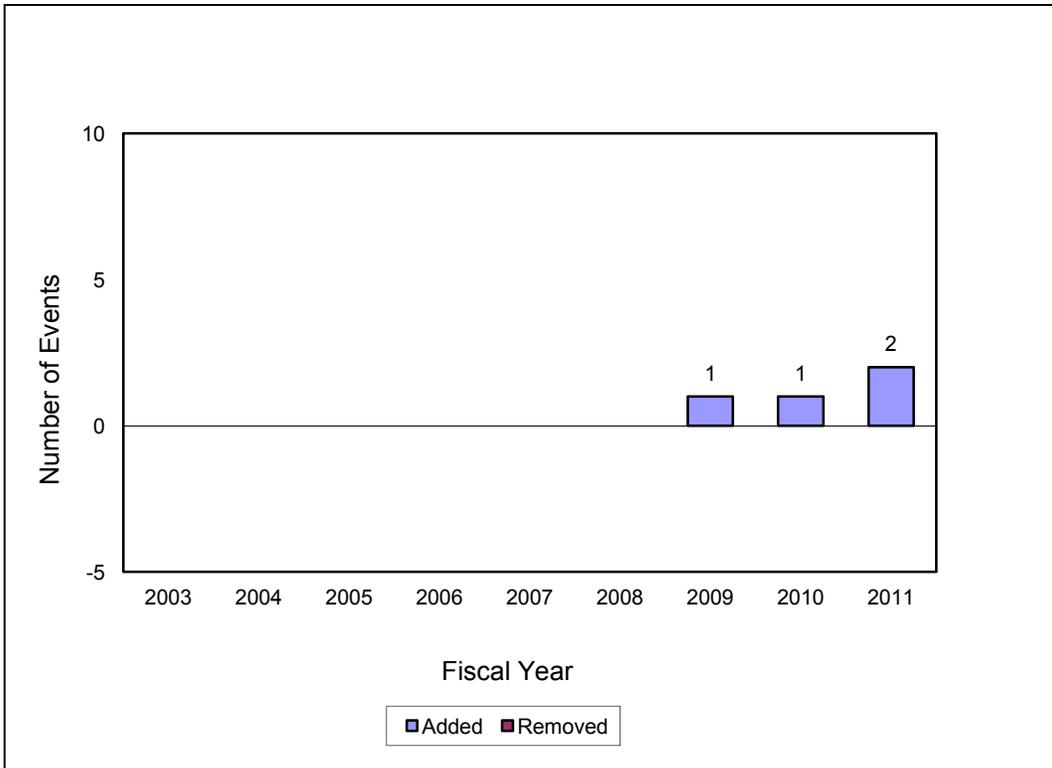
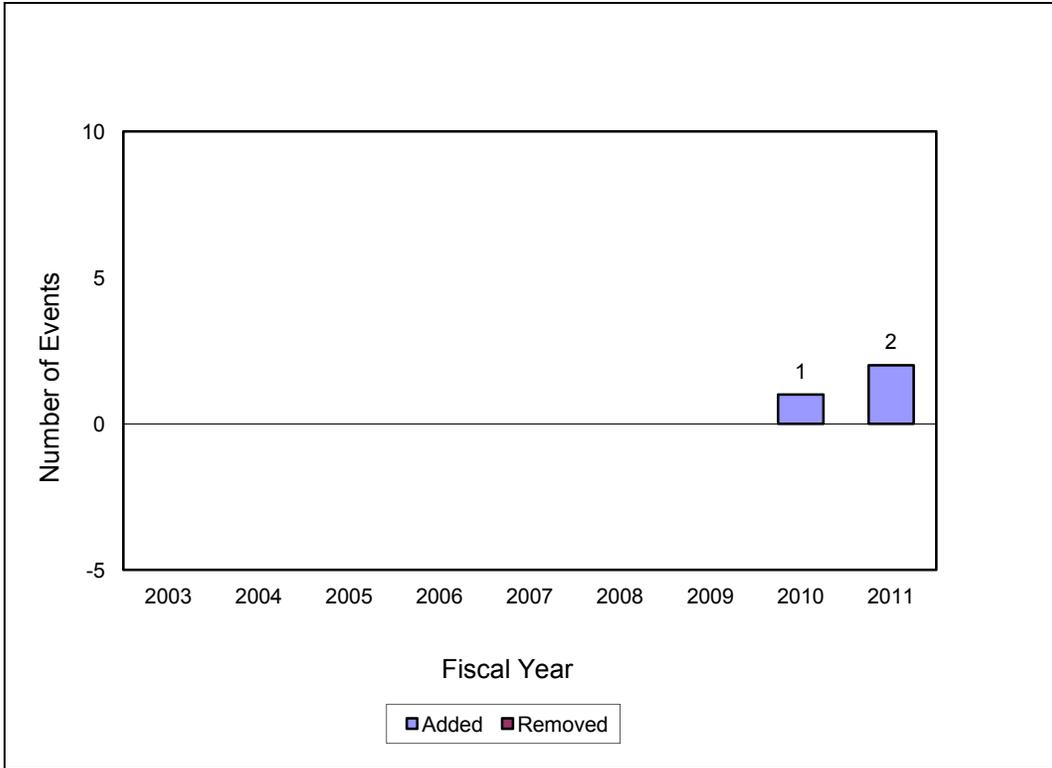
Figures D-1 through D-10 below display the changes in the data published in the previous quarterly report. A positive value indicates that records were added and a negative value indicates that records were removed. Note that Figures D-1 and D-9 do not include all of the additional FCP events that resulted from adding the FCP classification to TRS events involving fuel cycle facilities.
